# PRELIMINARY BUILDING ENVELOPE EVALUATION OF SEAVIEW CONDOMINIUMS

LOCATED AT:  
115 N. MILLER STREET  
ROCKAWAY BEACH, OR 97136

August 2nd, 2022

Client # B22265 Seaview Condominiums

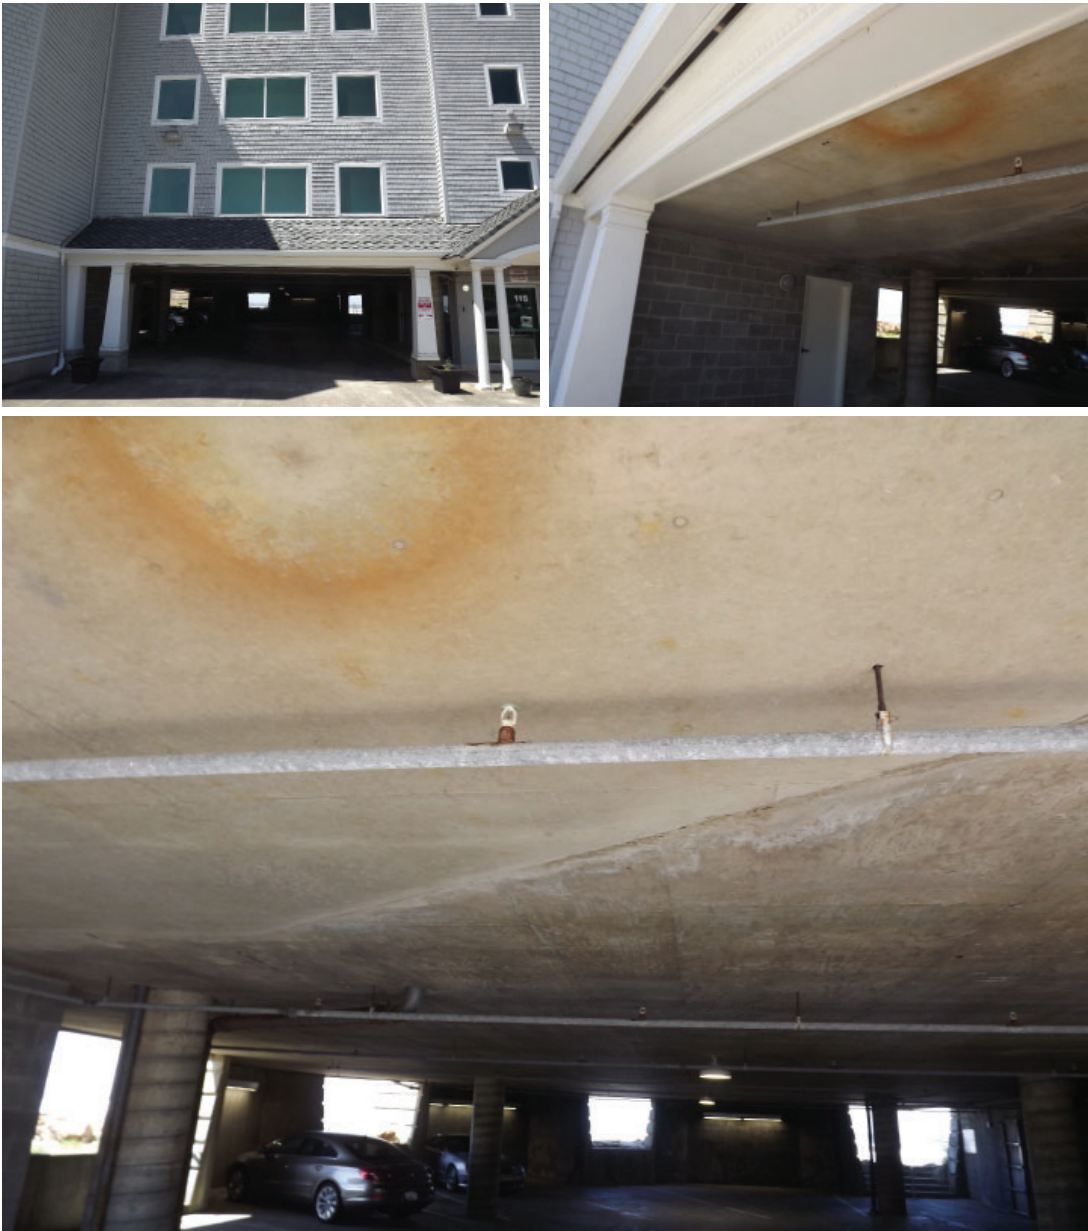
Corrosion.

Significant corrosion on fire protection lines.

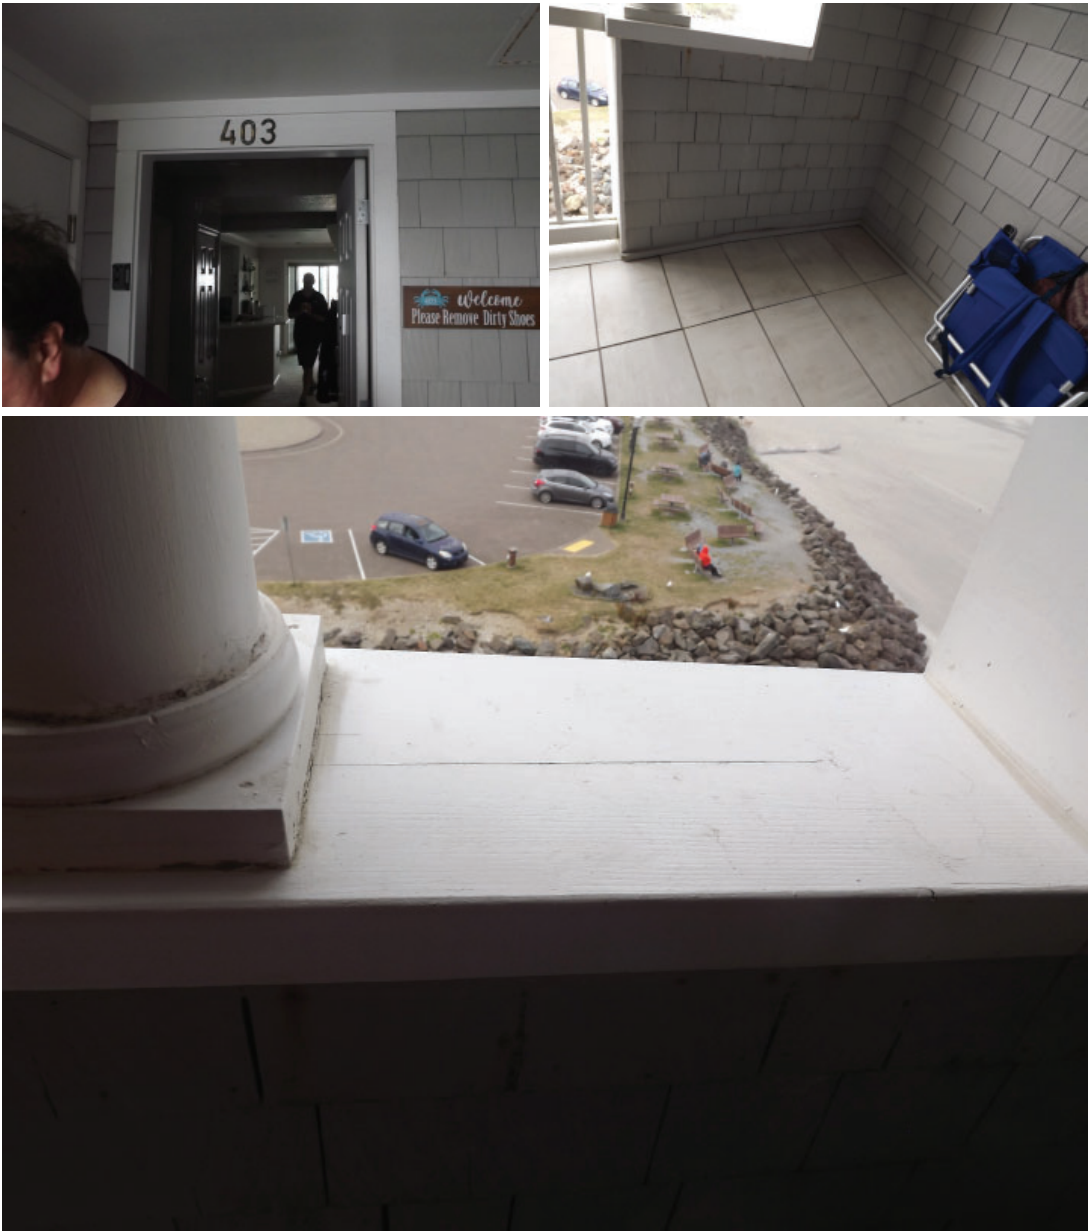
Missing Cap Flashings For Exterior Walls.

Cap flashings are flashings that protect exterior walls. These flashings provide slope and protect from moisture intrusion.

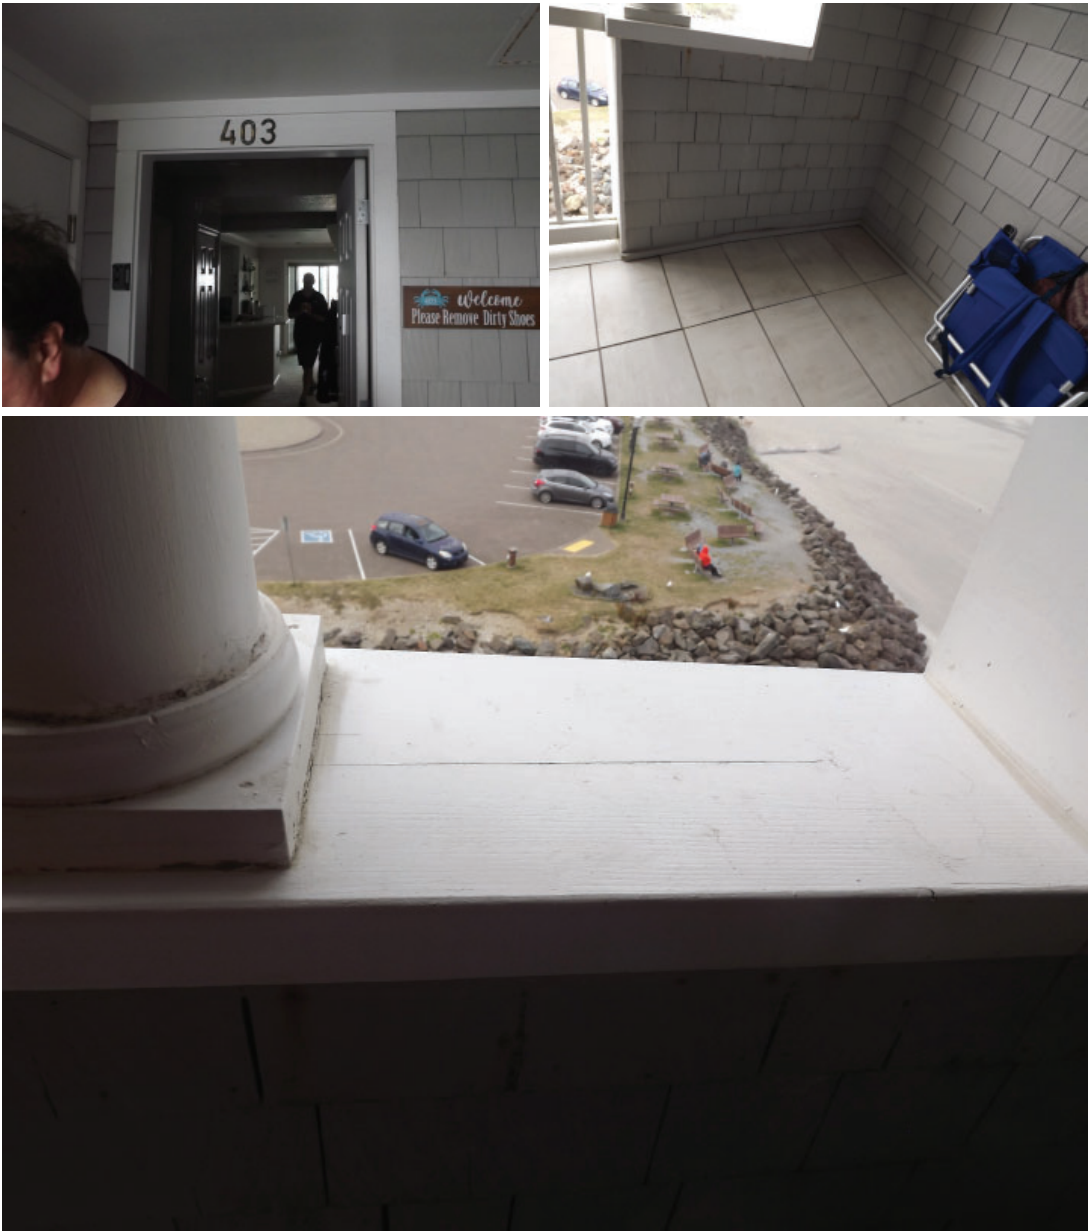
Sealant Failure At Post.

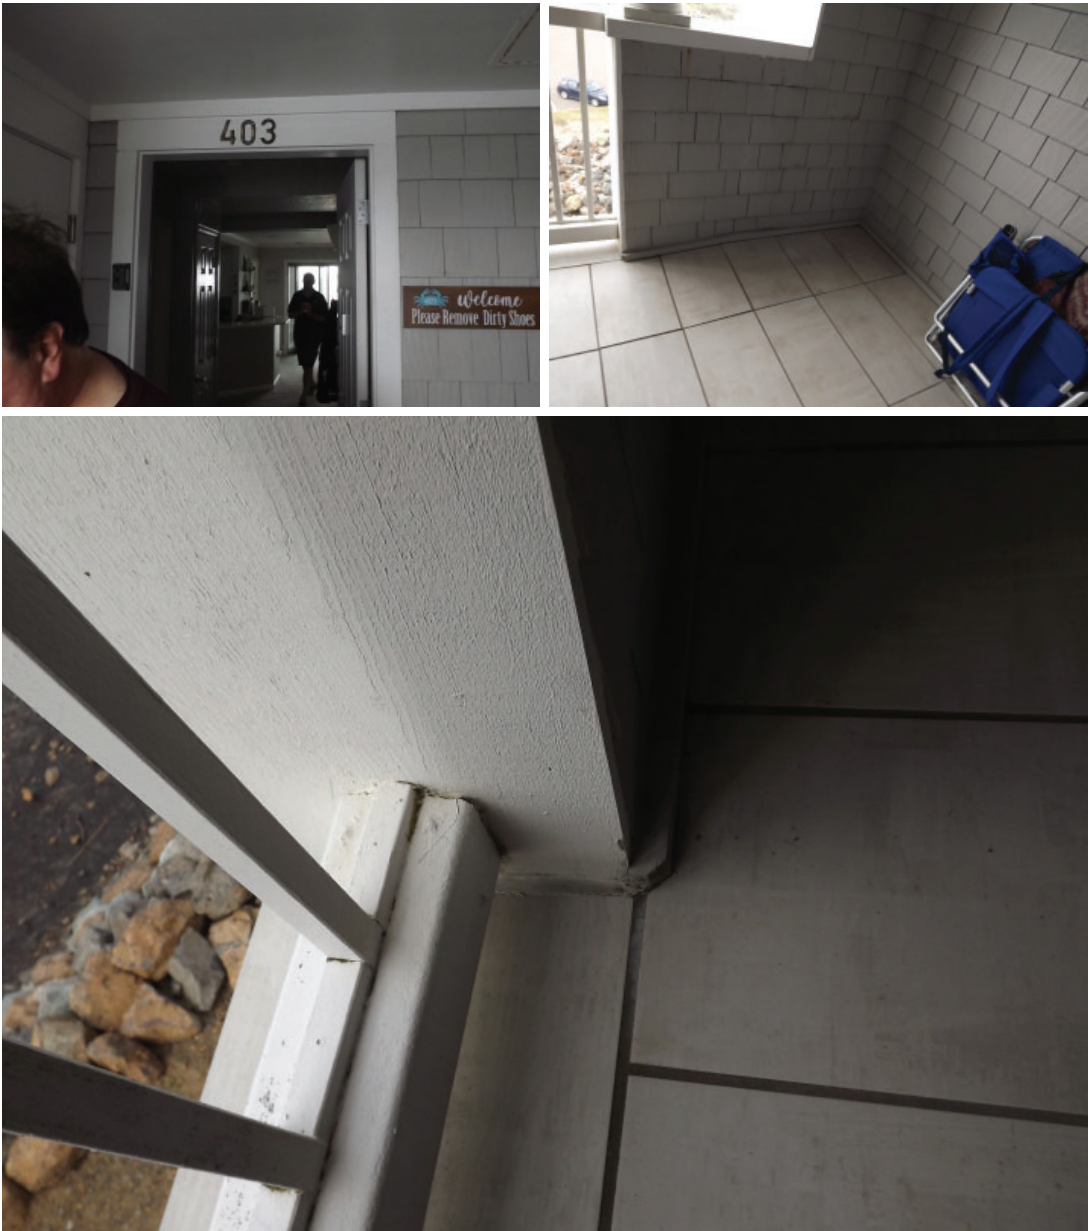
A separation of 1-2” is required between trim or siding and hard surfaces. The gap prevents moisture from wicking into the material and allows moisture to drain effectively. The siding and trim shown below were installed too close to the hard surface.

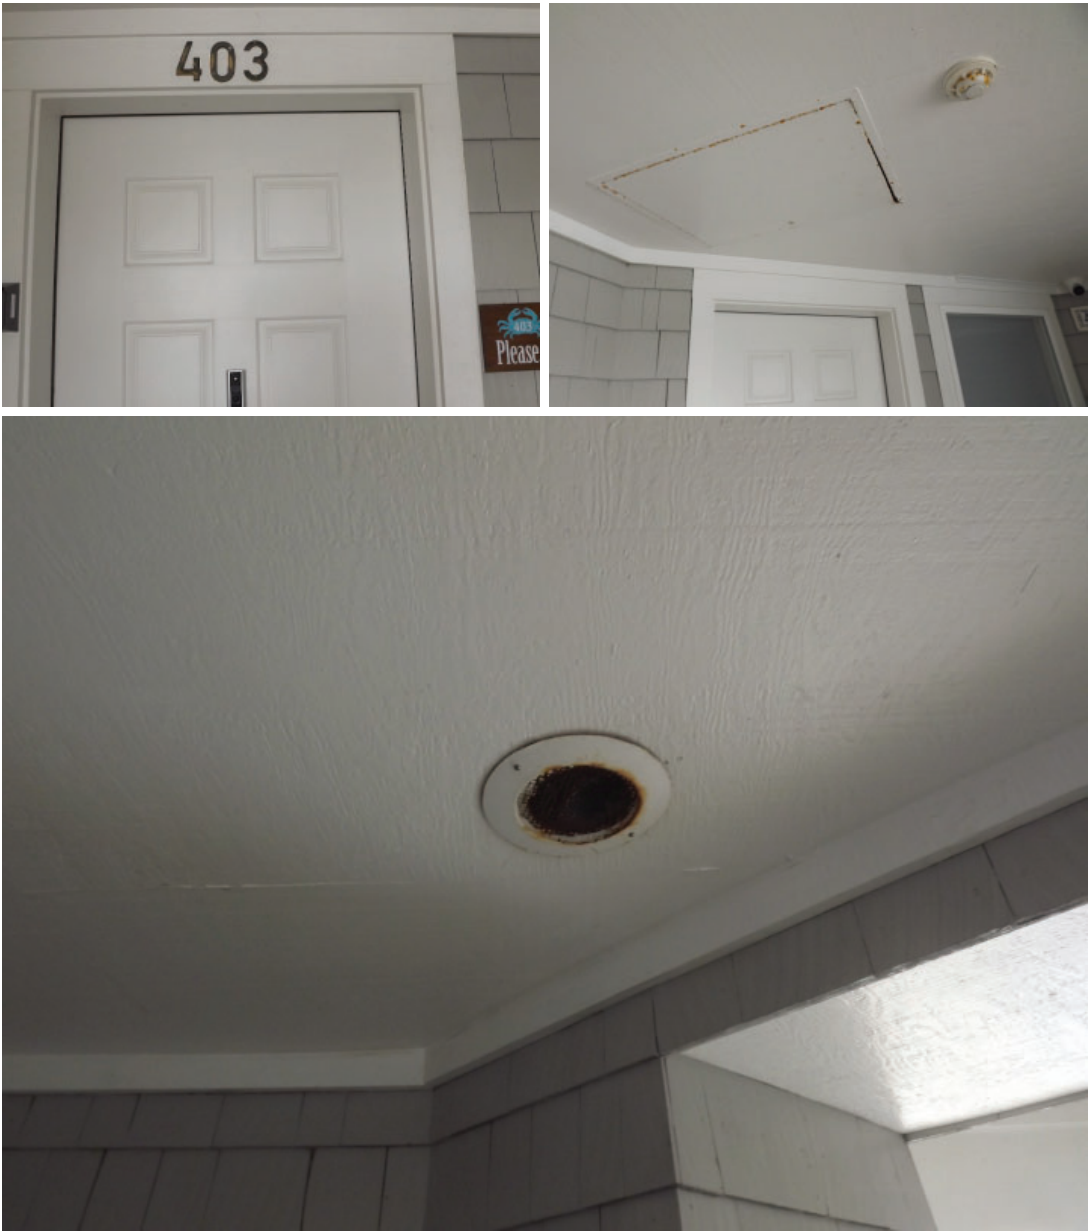
Rust.

Rust has developed on the metal components at this location. Rust is the corrosion of metal products and indicates failure or potential failure. Rust also weakens the product.

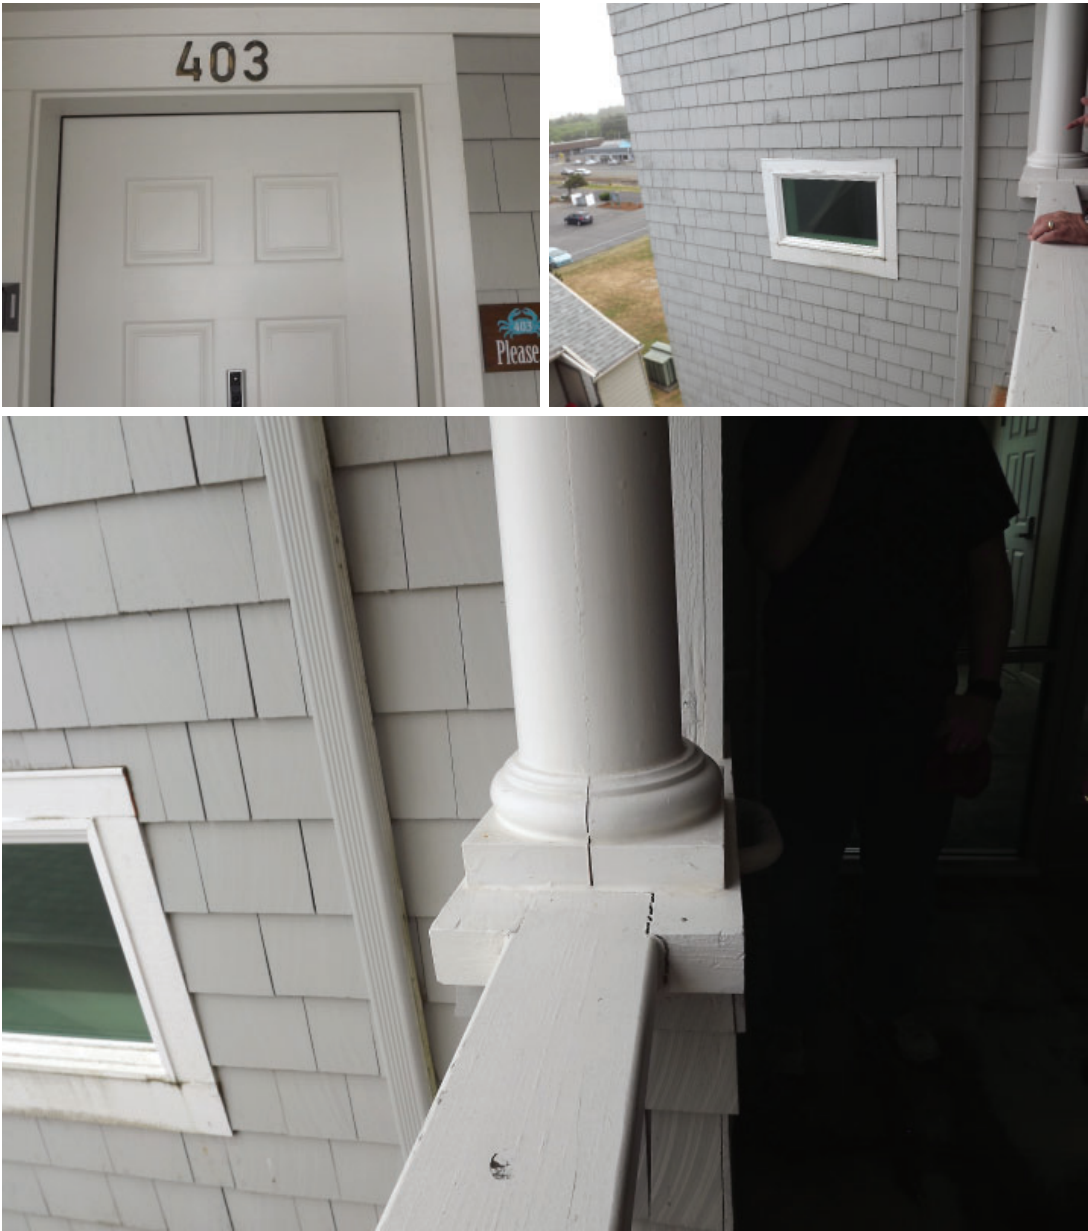
Separation Of Cap, Post Base & Missing Cap Flashings For Exterior Walls.

Cap flashings are flashings that protect exterior walls. These flashings provide slope and protect from moisture intrusion.

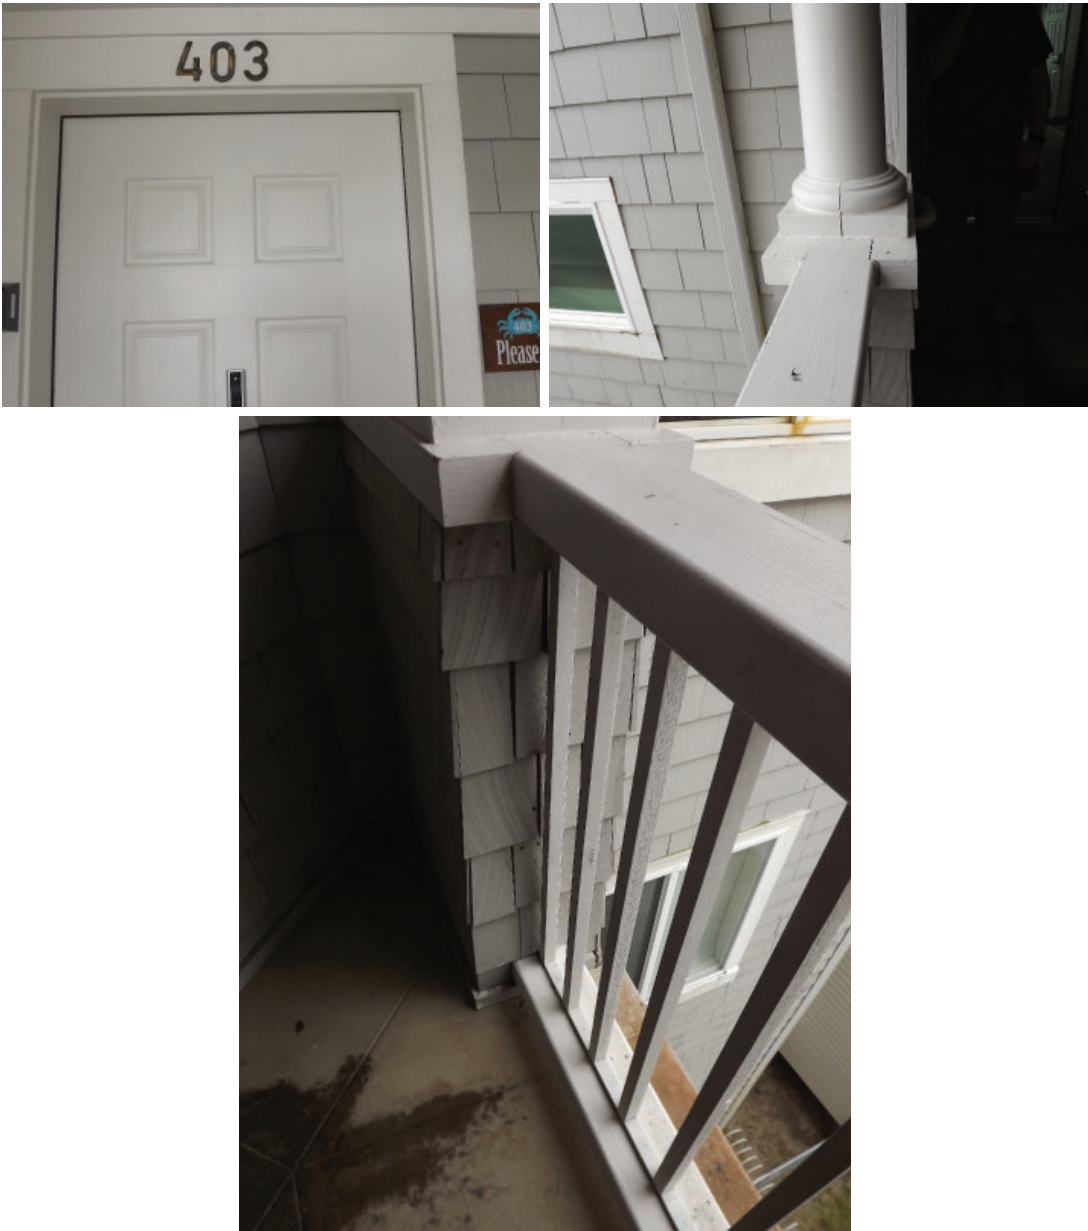
Over-driven Fasteners On Cedar Shingles.

Improper nail application is a critical application issue with shake-side wall product. The fasteners secure the shingle from wind and movement. Fastener application requires the nail to be flush with the surface of the shingle, which has not occurred here.

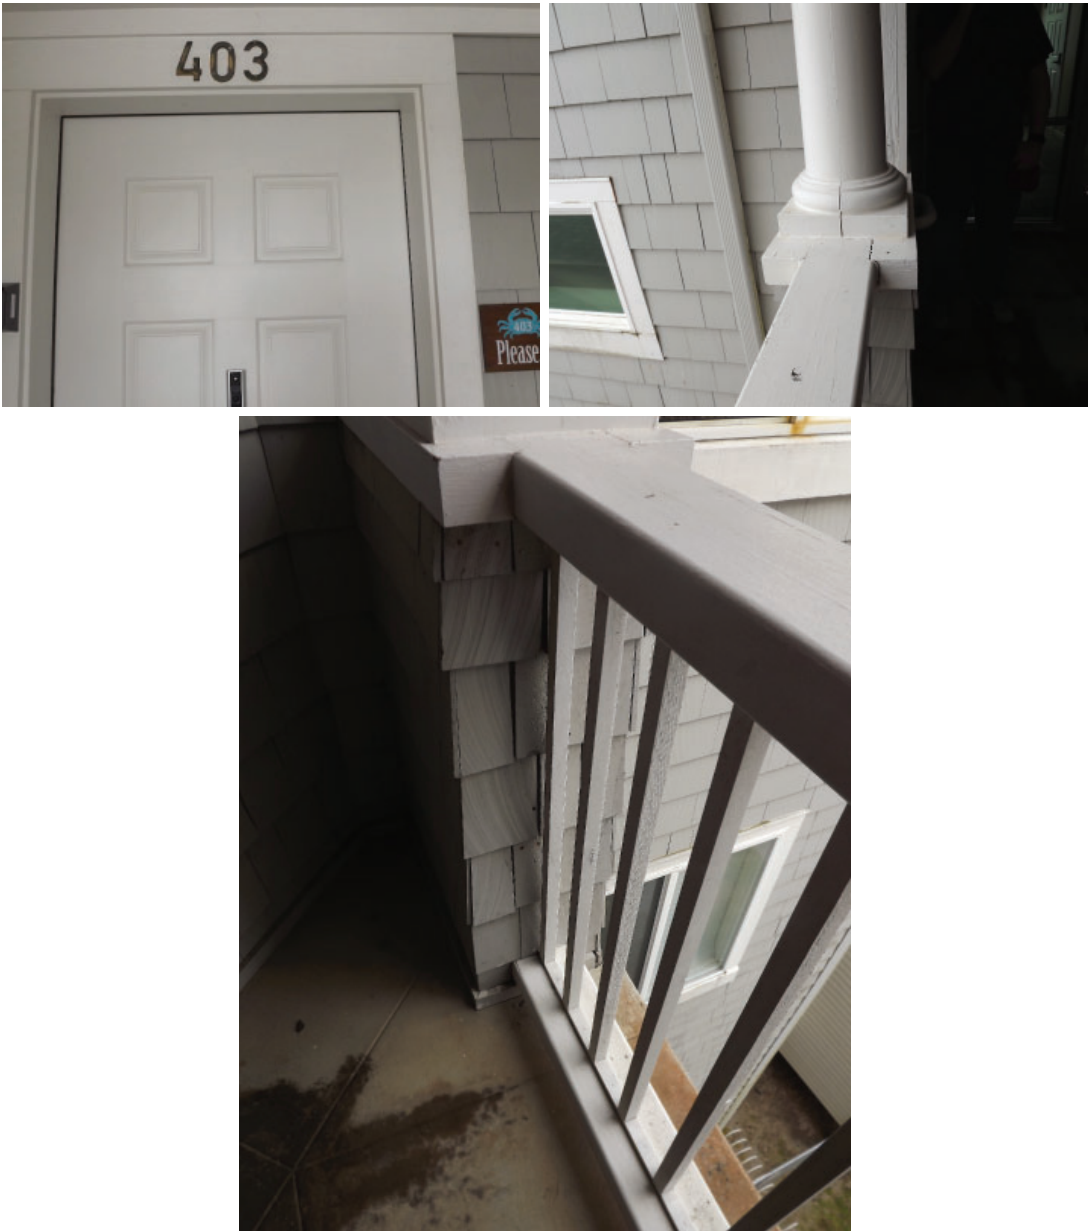
Trim Terminate Too Closely To Hard Surface And Is Surface Applied.

A separation of 1-2” is required between trim or siding and hard surfaces. The gap prevents moisture from wicking into the material and allows moisture to drain effectively. The siding and trim shown below were installed too close to the hard surface.

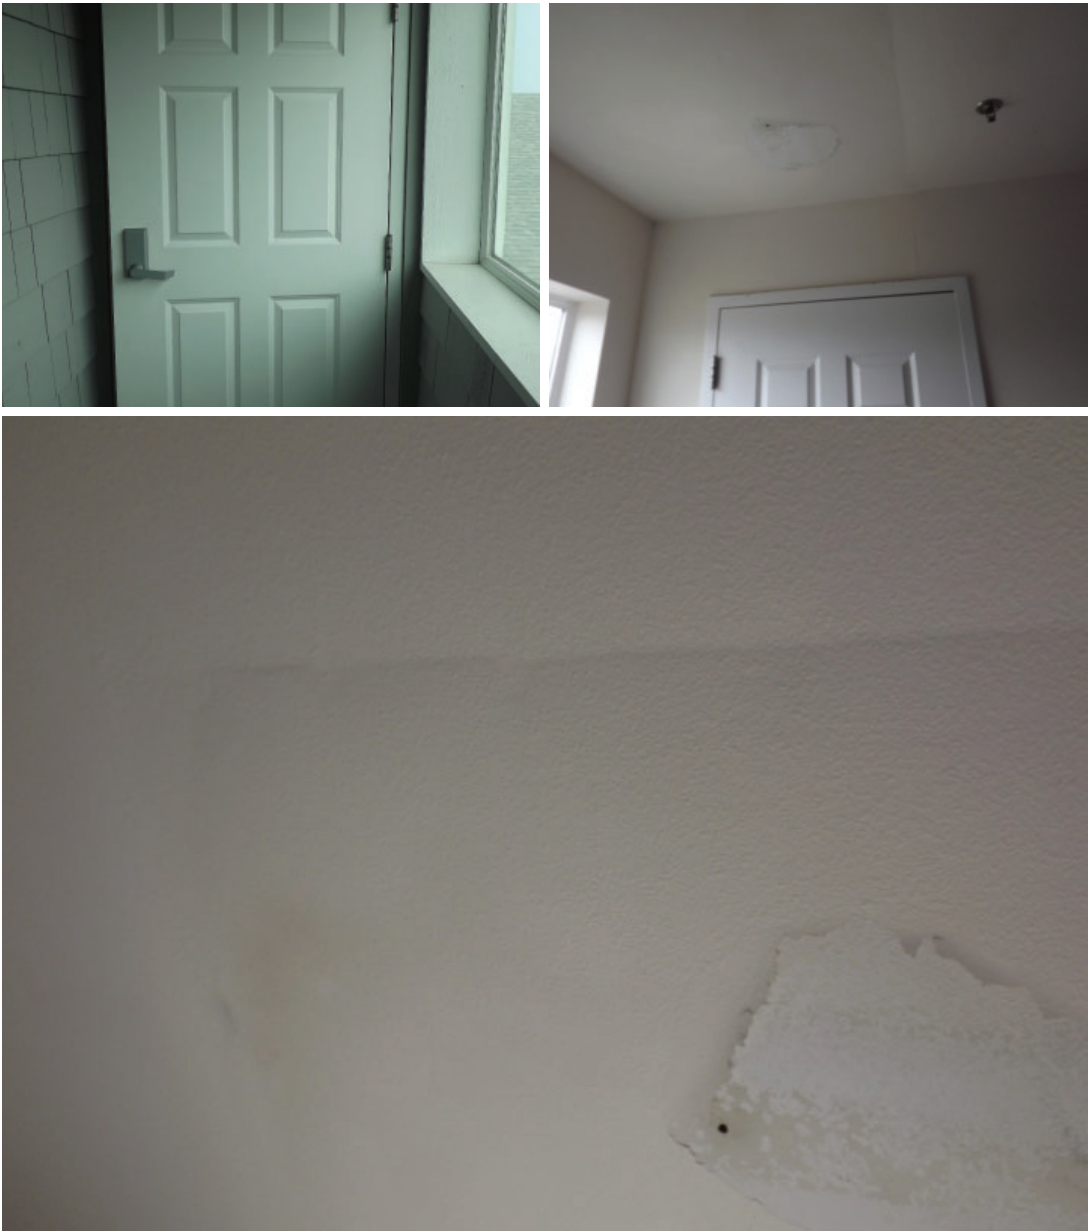
Damage.

Drywall joints; possible water intrusion at this location.

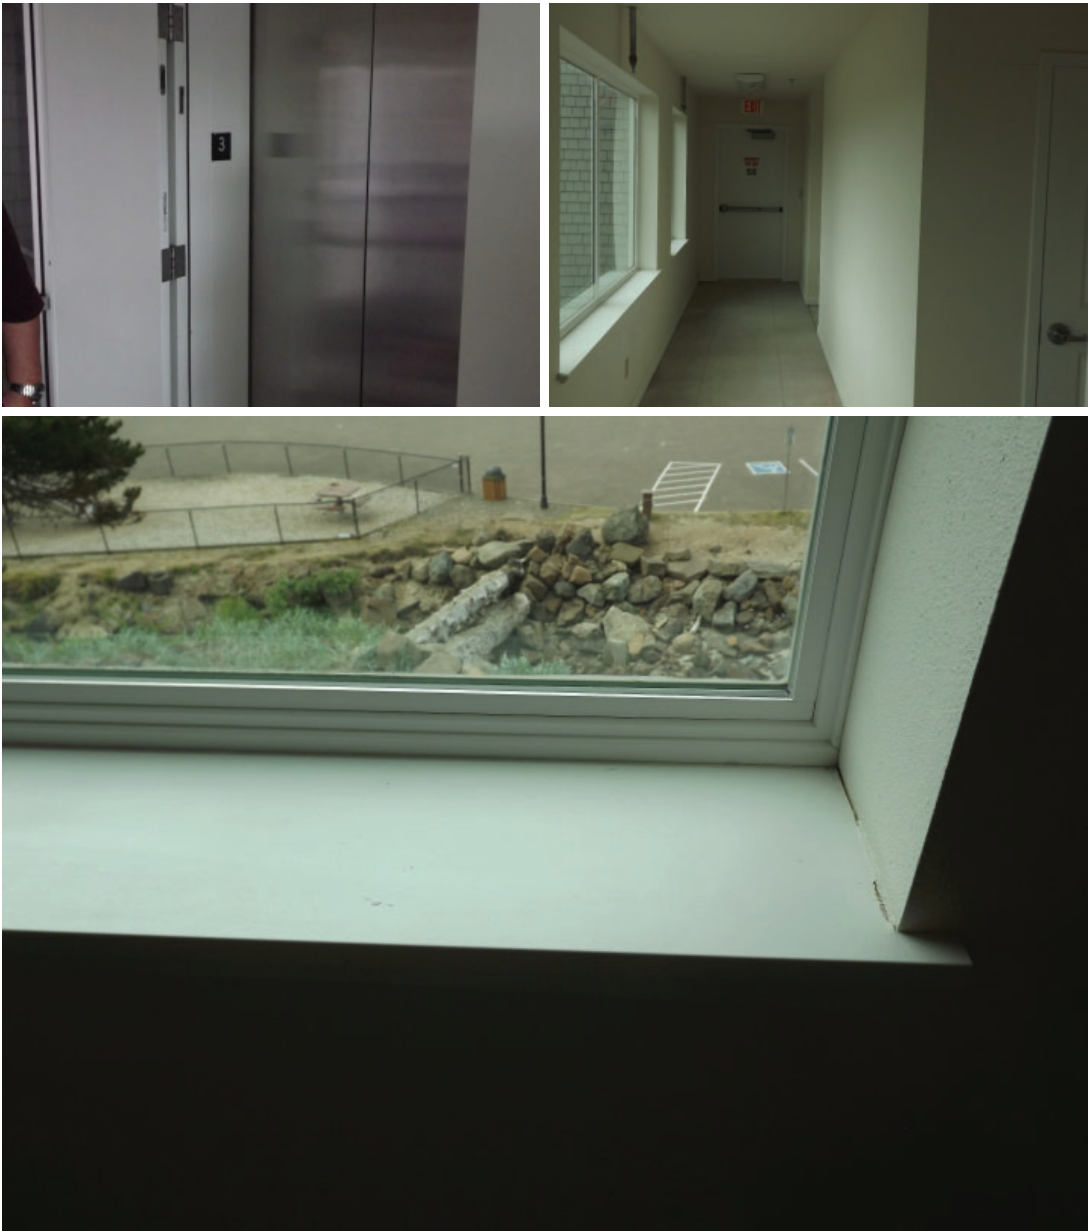
Visible Moisture Intrusion At Window Sill.

Windows may leak from many different reasons. Regardless of the reason, the windows shouldn't be leaking. At this location staining/leaking was visible to the eye.

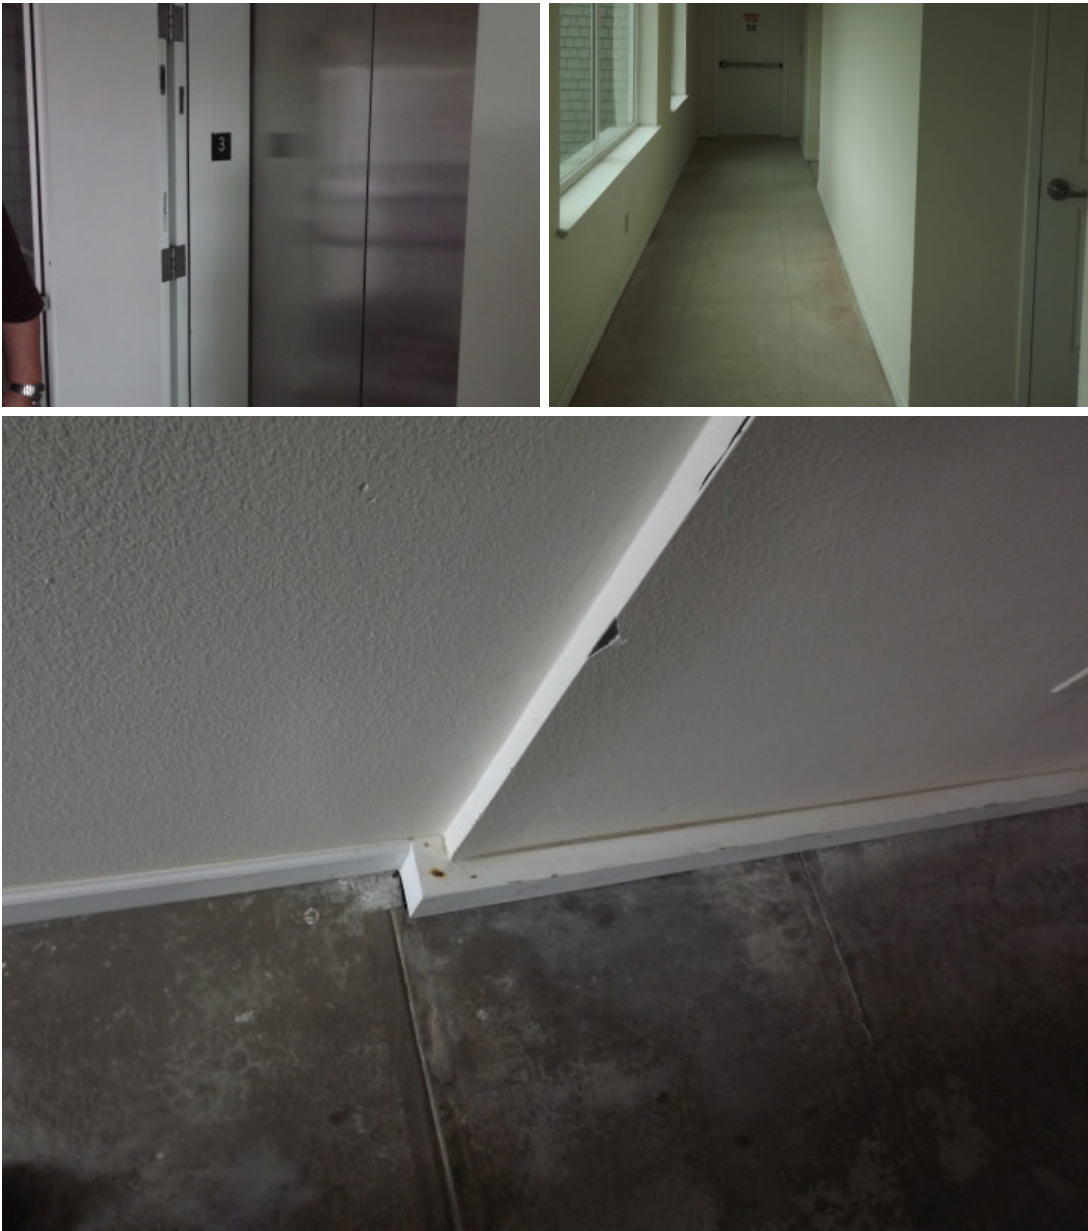
Base Trim Tight To Floor And Damaged.

The trim is damaged at this location and may not function as intended.

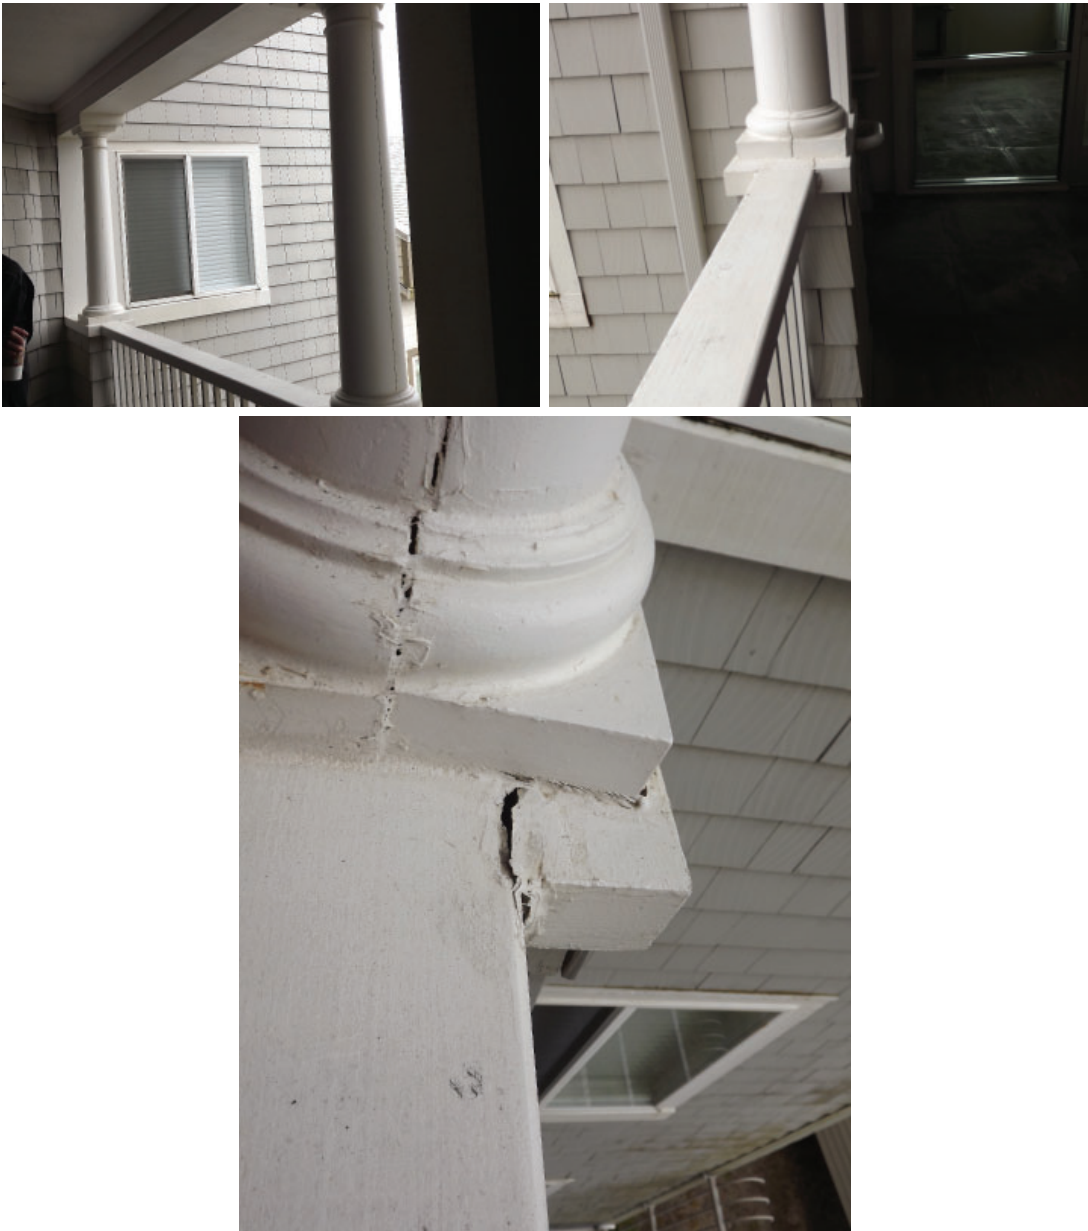
Damage.

The column and trim are damaged and may not function as intended.

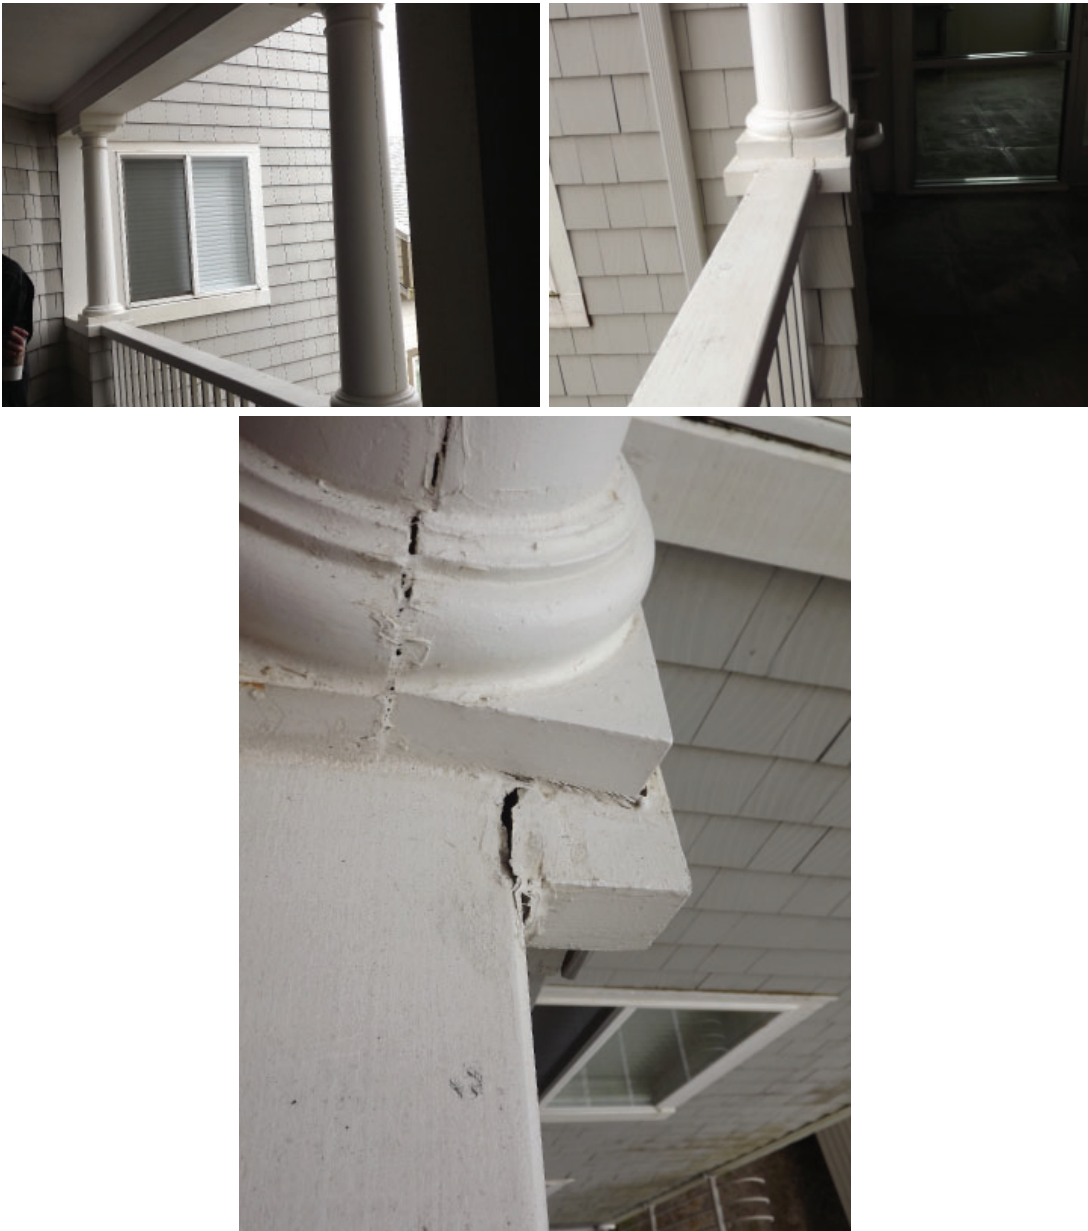
Missing Cap Flashings For Exterior Walls.

Cap flashings are flashings that protect exterior walls. These flashings provide slope and protect from moisture intrusion.

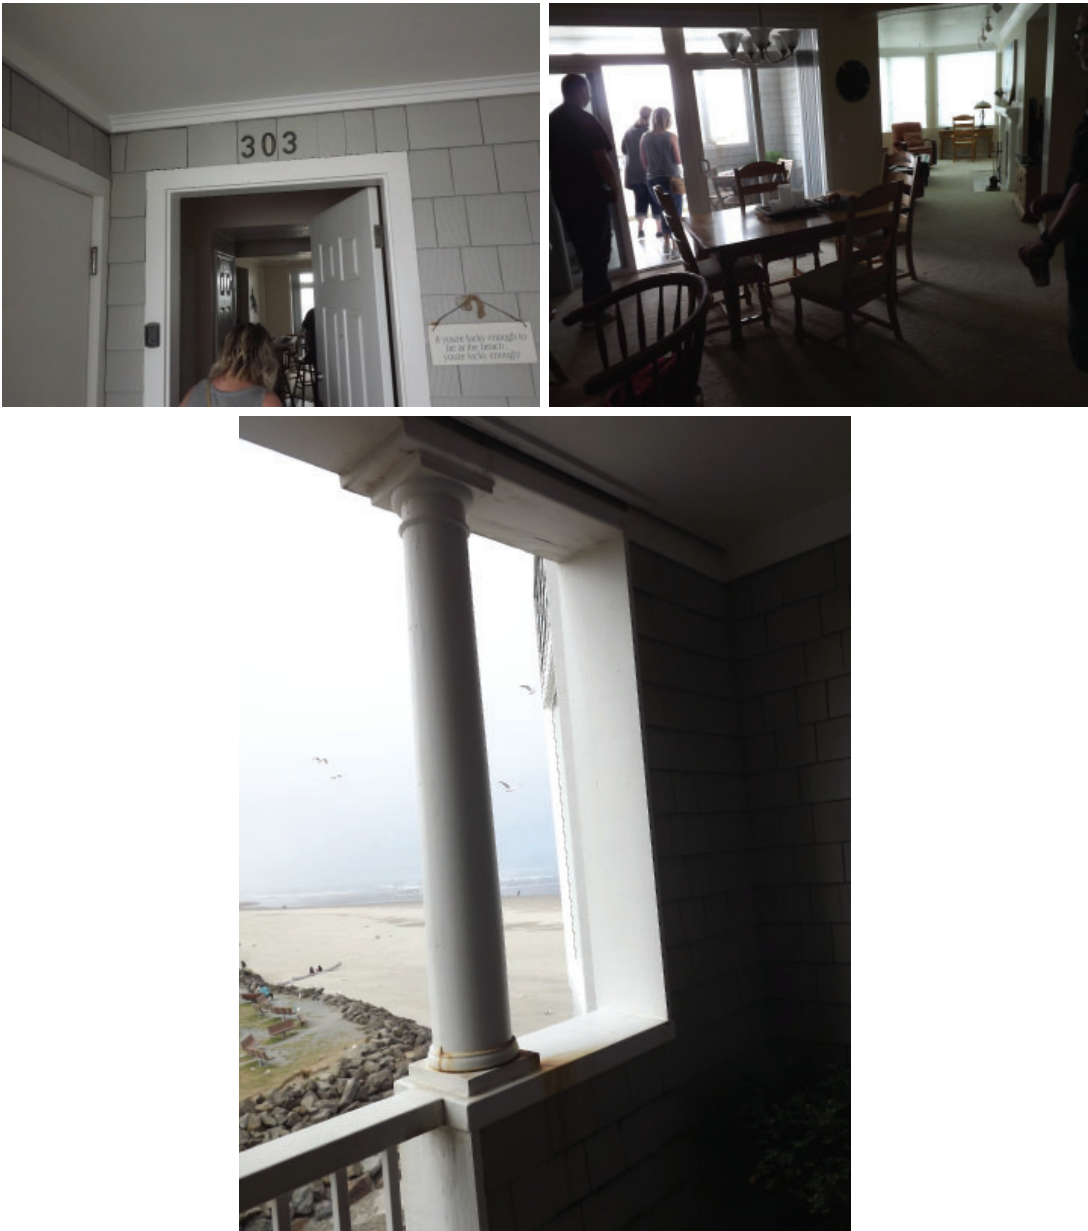
Dry Rot In Trim At Head.

Dry rot is the decay of wood products. One main purpose of exterior envelope waterproofing is to deter dry rot because it causes substantial damage to the building and structural members. Dry rot is present at this location.

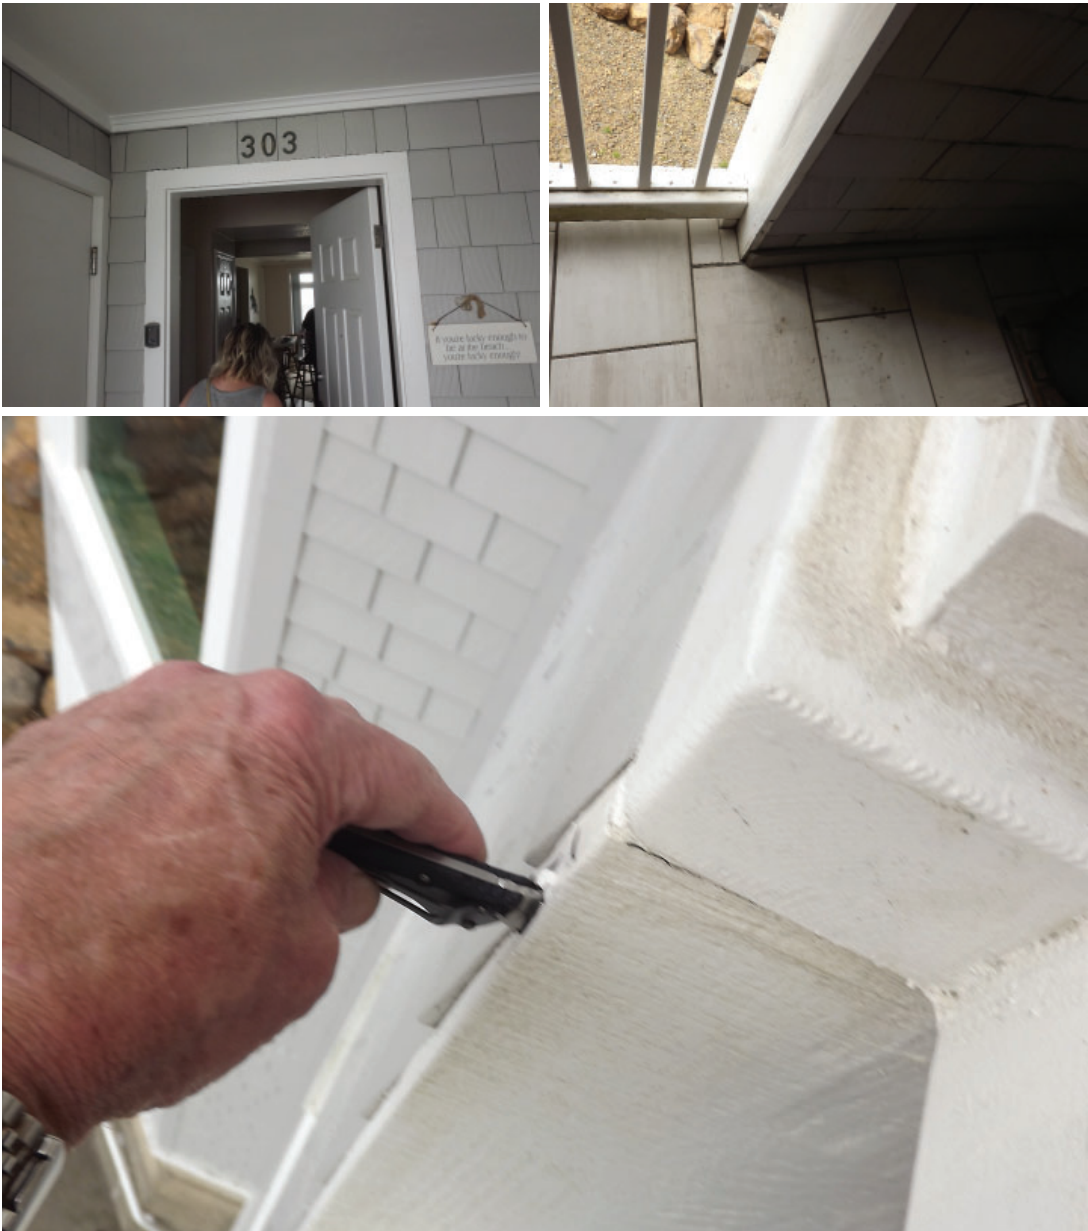
Dry Rot In Trim At Side Of Rail.

Dry rot is the decay of wood products. One main purpose of exterior envelope waterproofing is to deter dry rot because it causes substantial damage to the building and structural members. Dry rot is present at this location.

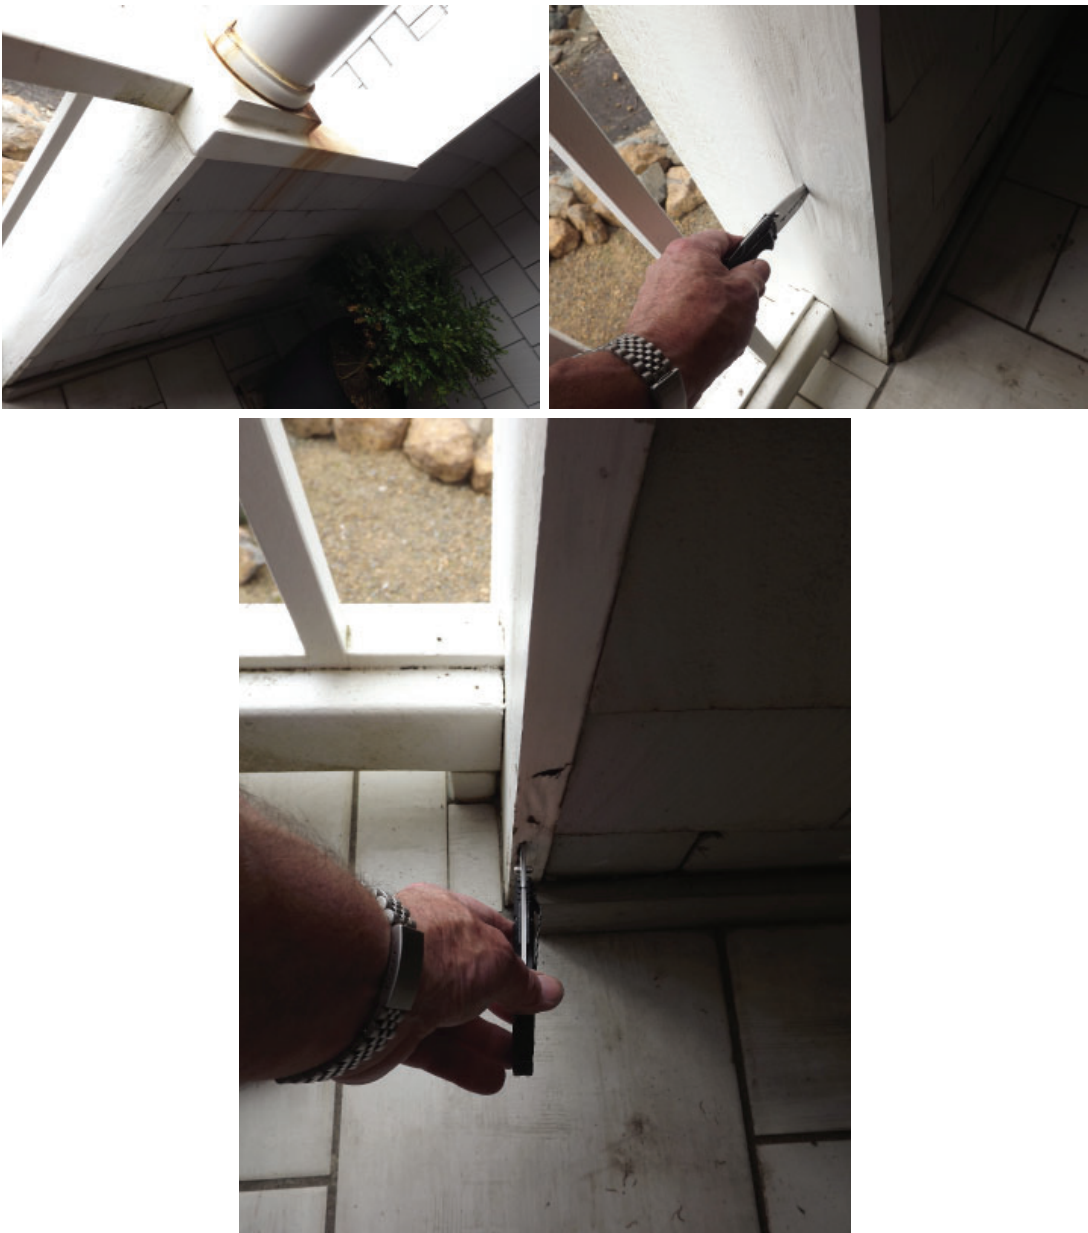
Dry Rot In Trim.

Dry rot is the decay of wood products. One main purpose of exterior envelope waterproofing is to deter dry rot because it causes substantial damage to the building and structural members. Dry rot is present at this location.
