# PRELIMINARY BUILDING ENVELOPE EVALUATION OF SEAVIEW CONDOMINIUMS

LOCATED AT:  
115 N. MILLER STREET  
ROCKAWAY BEACH, OR 97136

August 2nd, 2022

Client # B22265 Seaview Condominiums

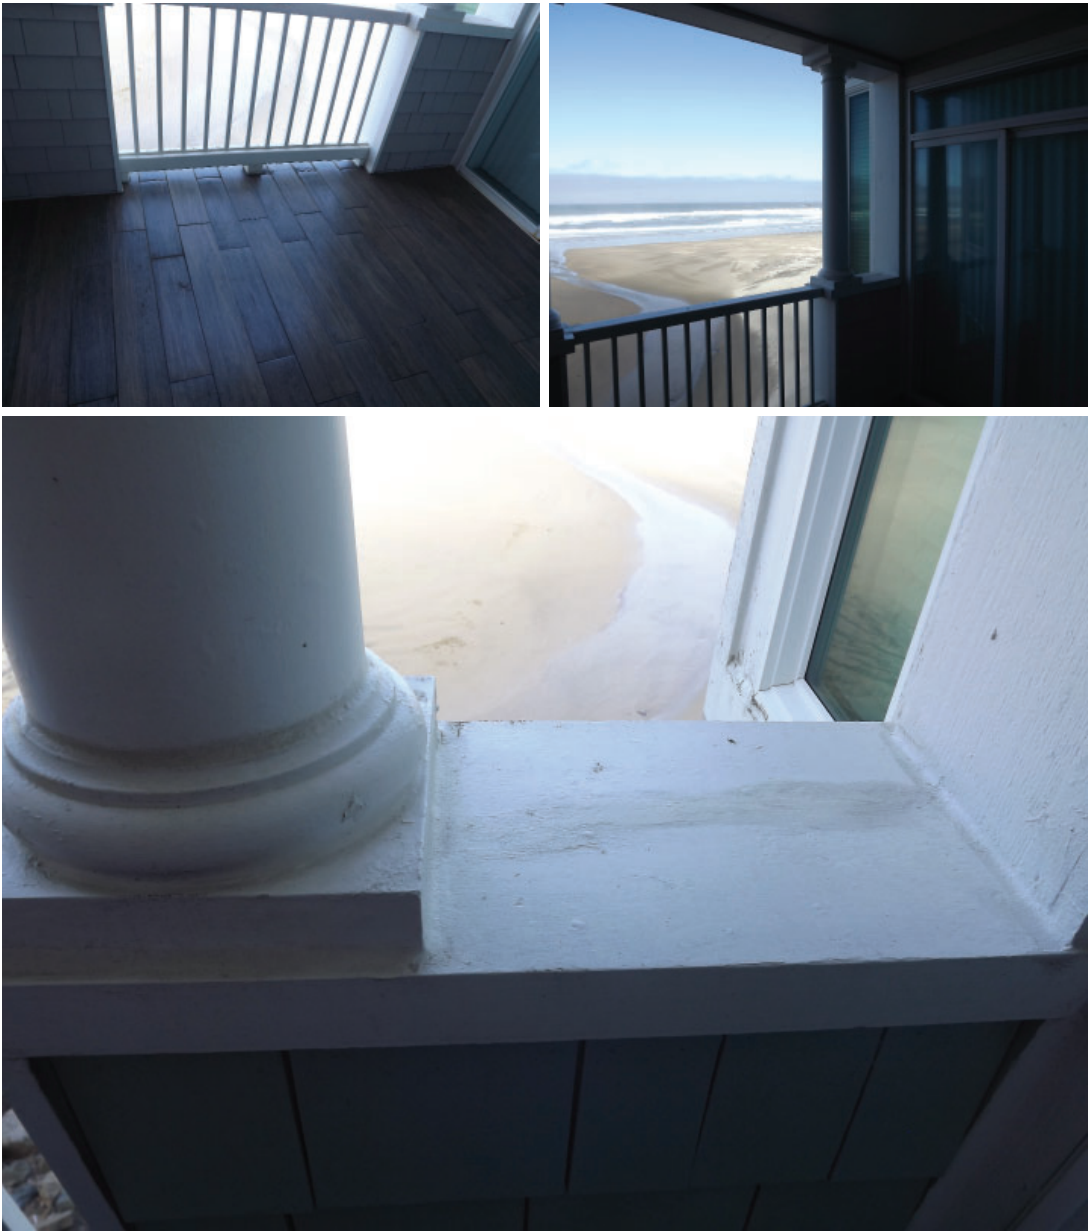
Missing Cap Flashings For Exterior Walls.

Cap flashings are flashings that protect exterior walls. These flashings provide slope and protect from moisture intrusion.

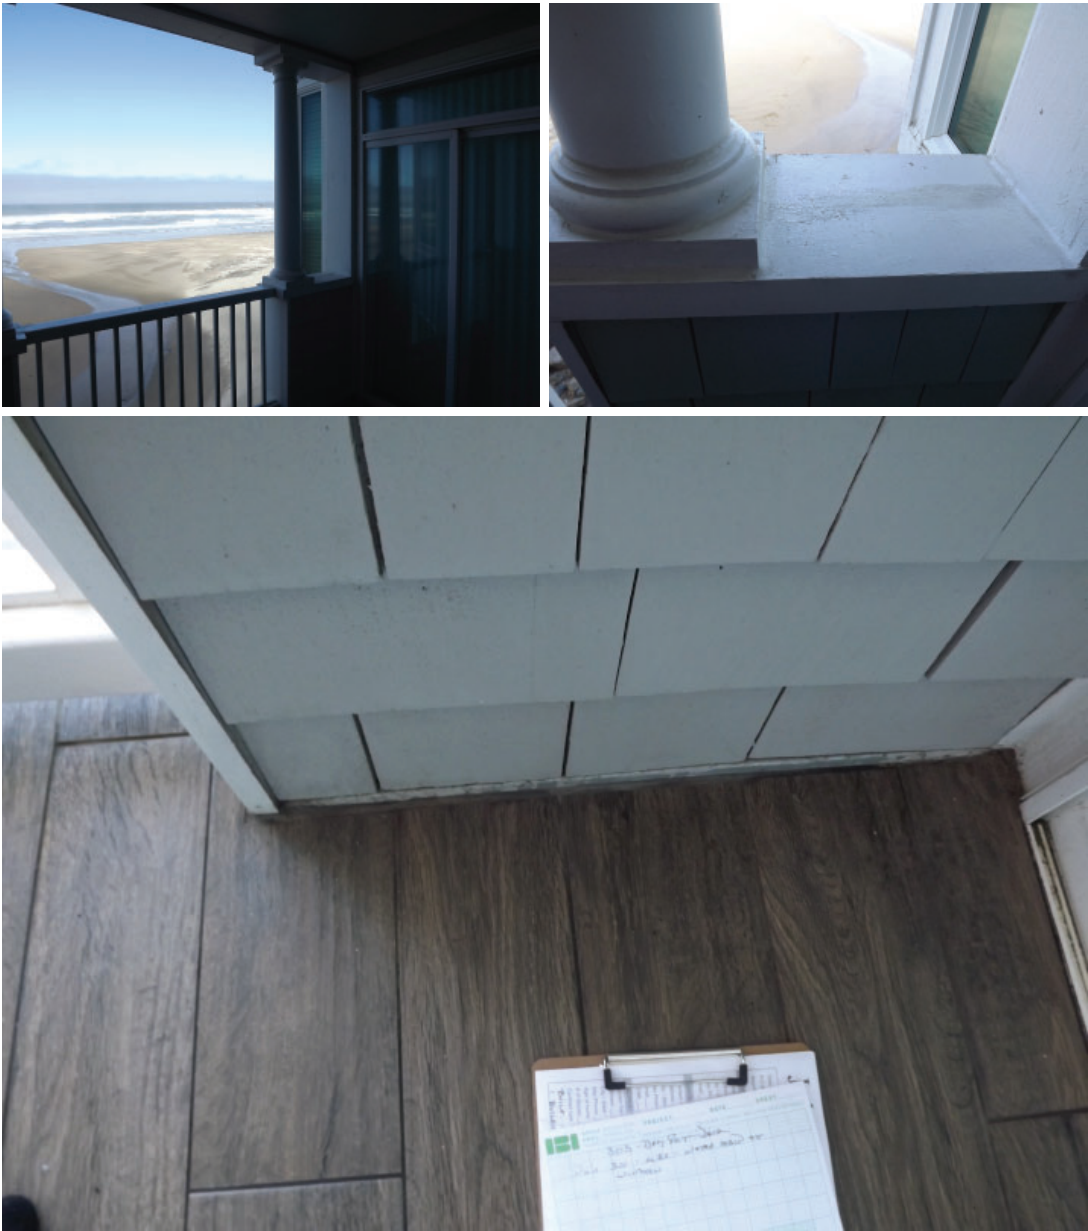
Wood Trim Is Inset And Terminates Too Closely To Hard Surface.

A separation of 1-2” is required between trim or siding and hard surfaces. The gap prevents moisture from wicking into the material and allows moisture to drain effectively. The siding and trim shown below were installed too close to the hard surface.

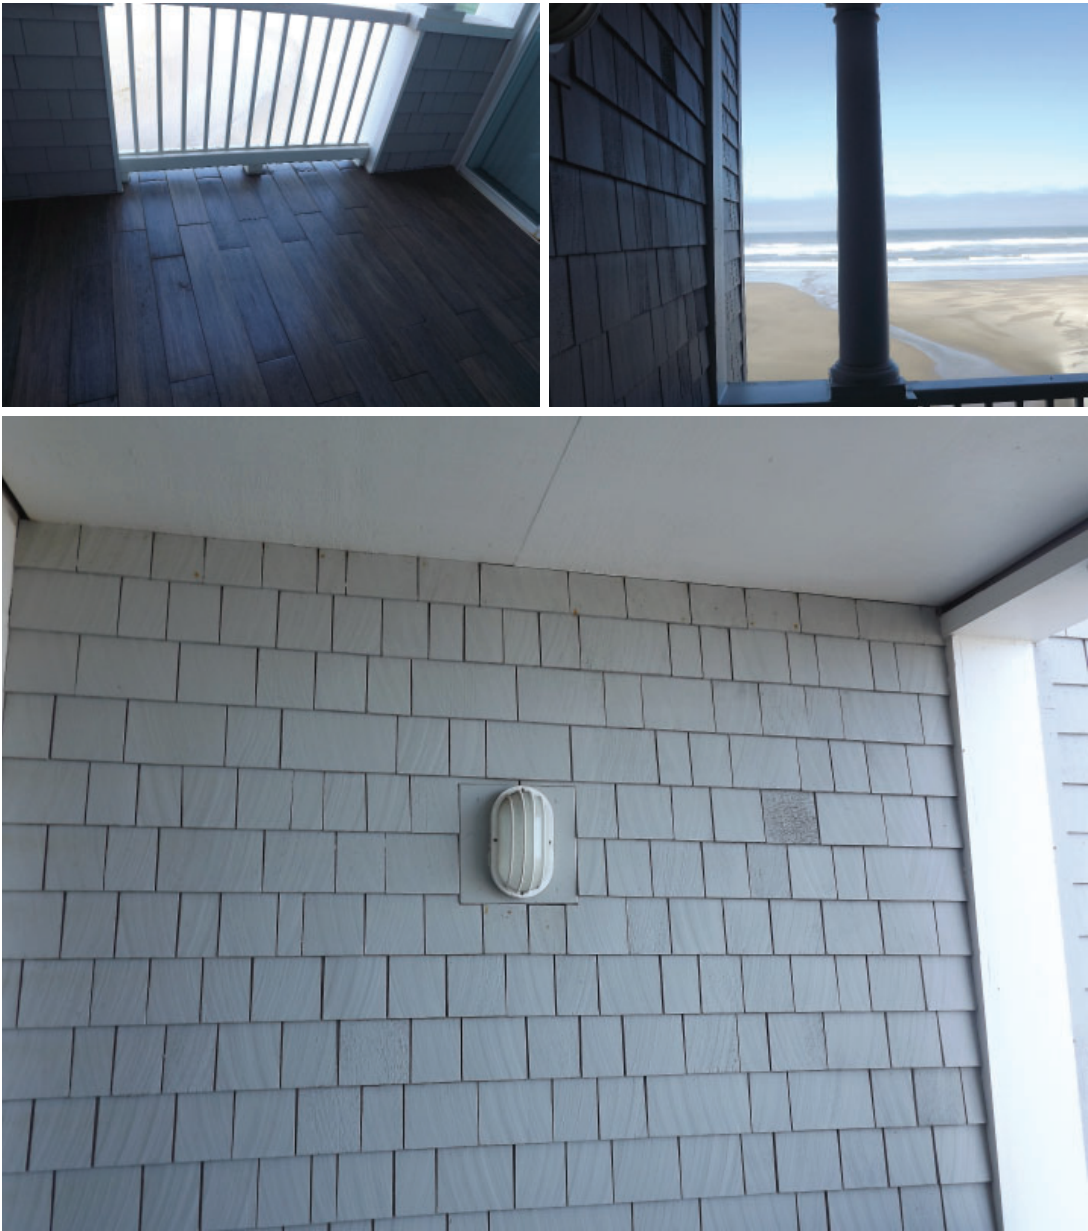
Missing Flashing Over Projecting Surfaces.

Flashing must be installed over projected surfaces to prevent water from re-entering the exterior wall. Flashing was not installed here, leaving this area susceptible to moisture intrusion.

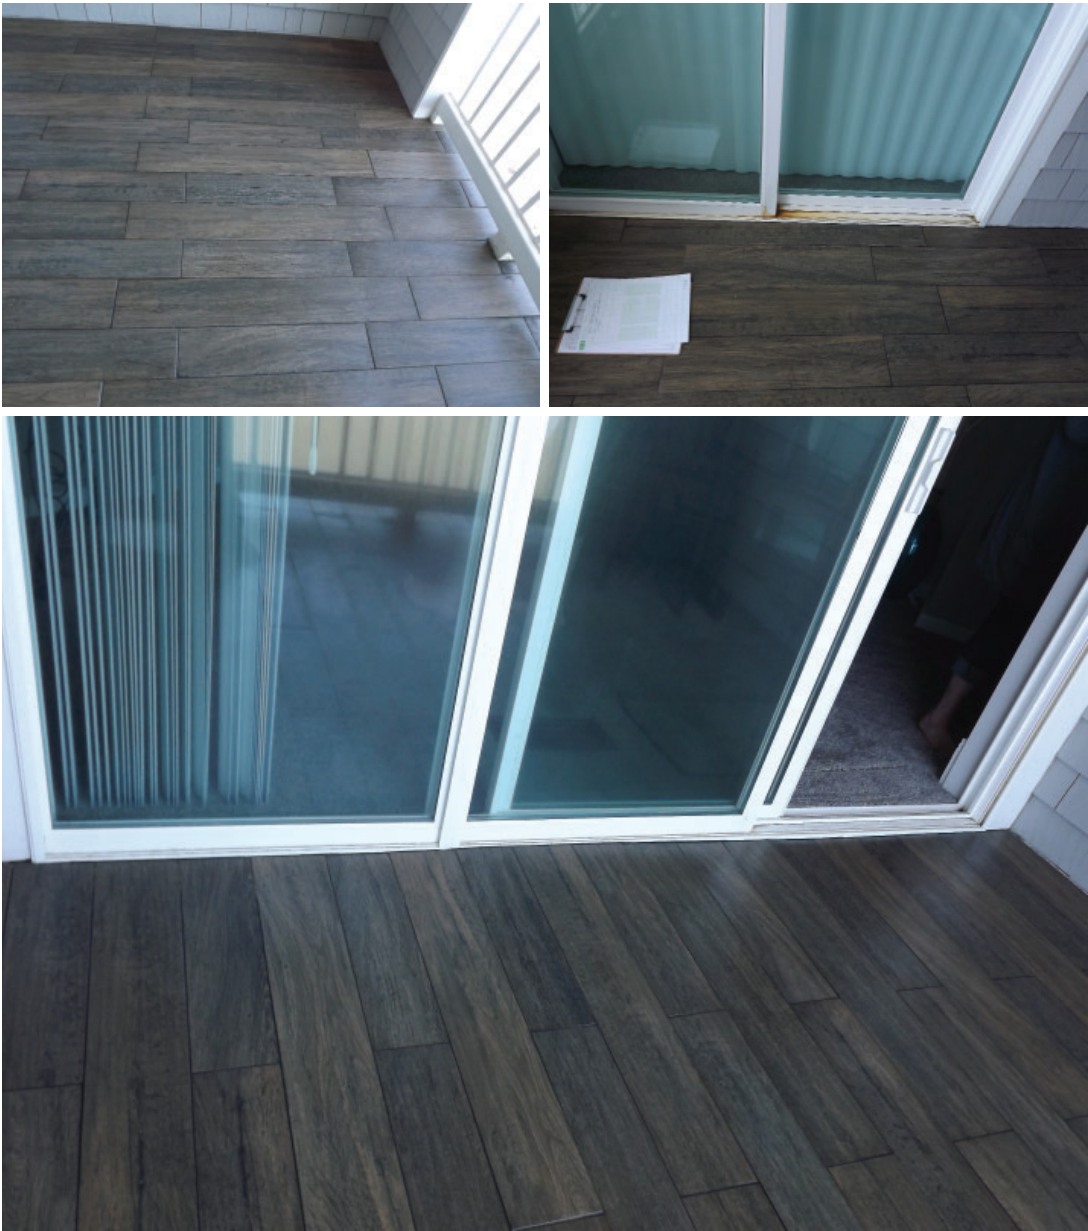
Sill Pan Sealed.

A sill pan is a collection device. This device collects moisture from the item that is set inside of it and directs moisture out to the drainage plane or out to the exterior of the cladding.

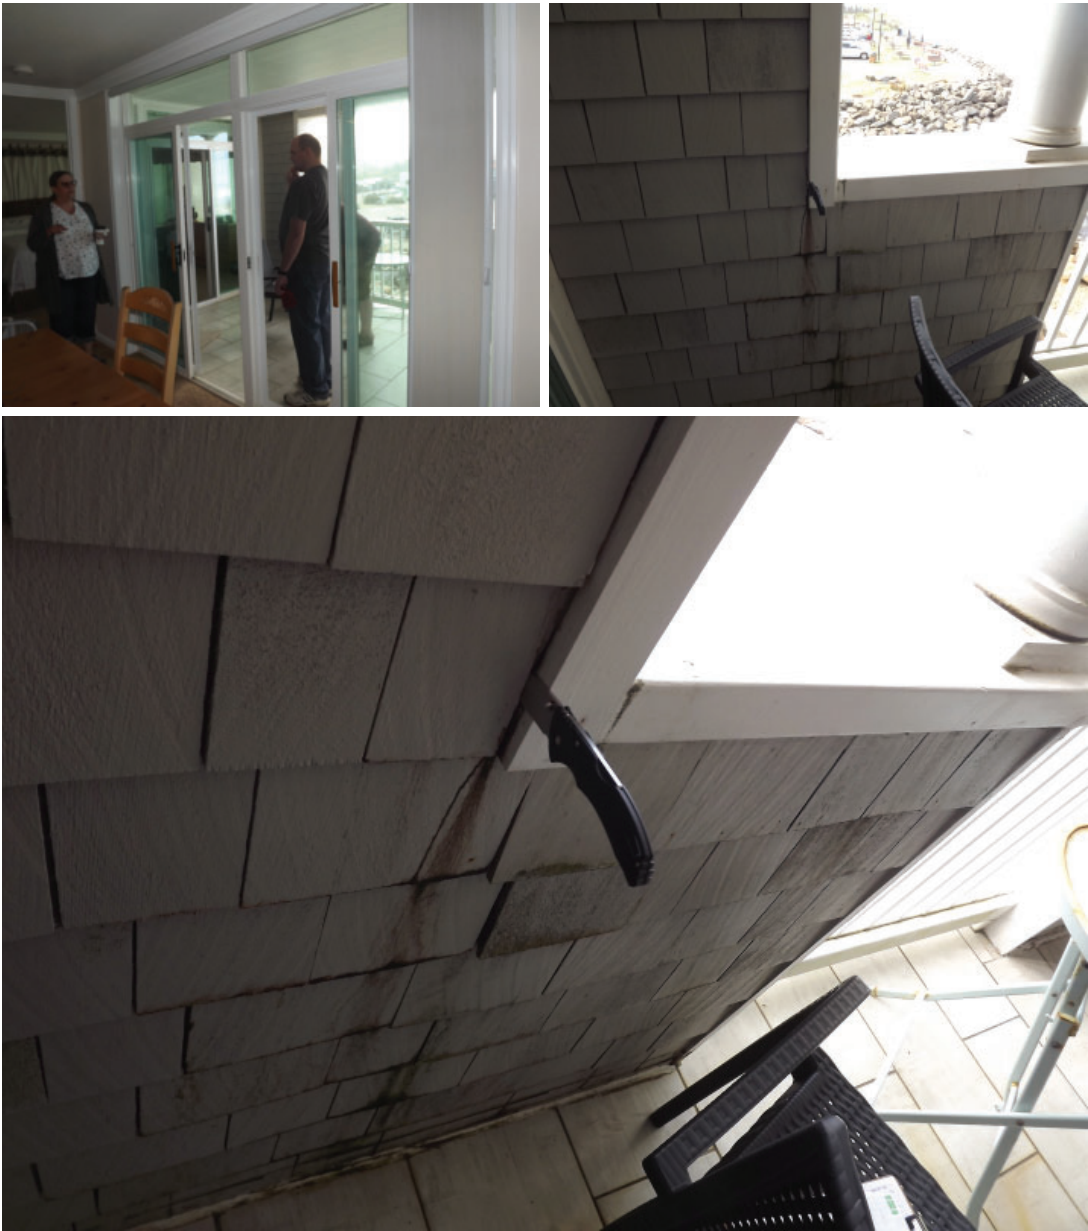
Missing Saddle Flashing.

Saddle flashings are flashings that cover and divert moisture out and away from the vertical wall of the structure in combination with horizontal penetrations of the structure.

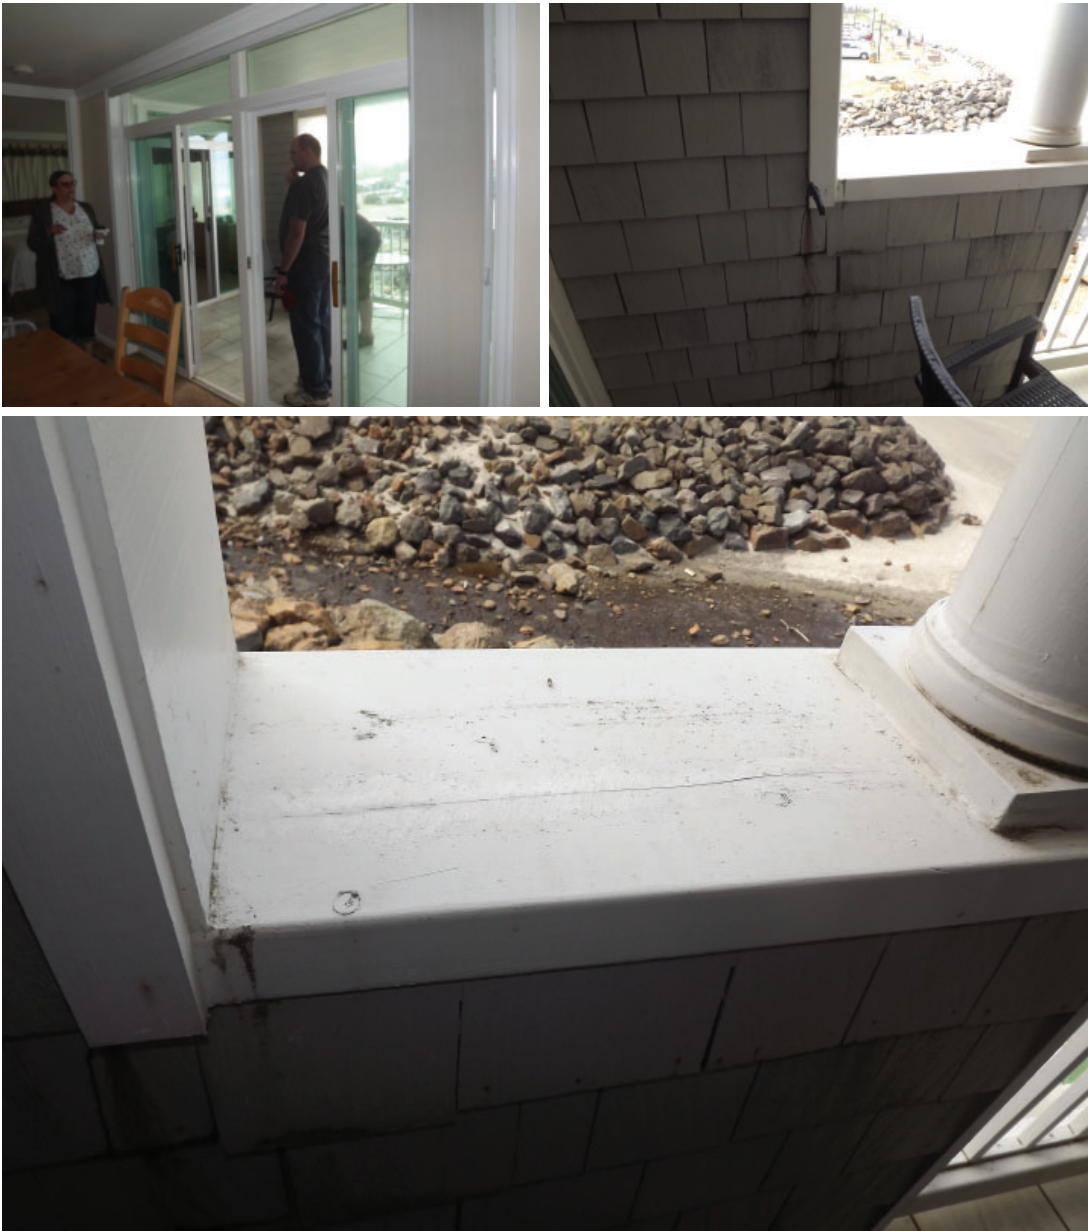
Missing Cap Flashings For Exterior Walls.

Cap flashings are flashings that protect exterior walls. These flashings provide slope and protect from moisture intrusion.

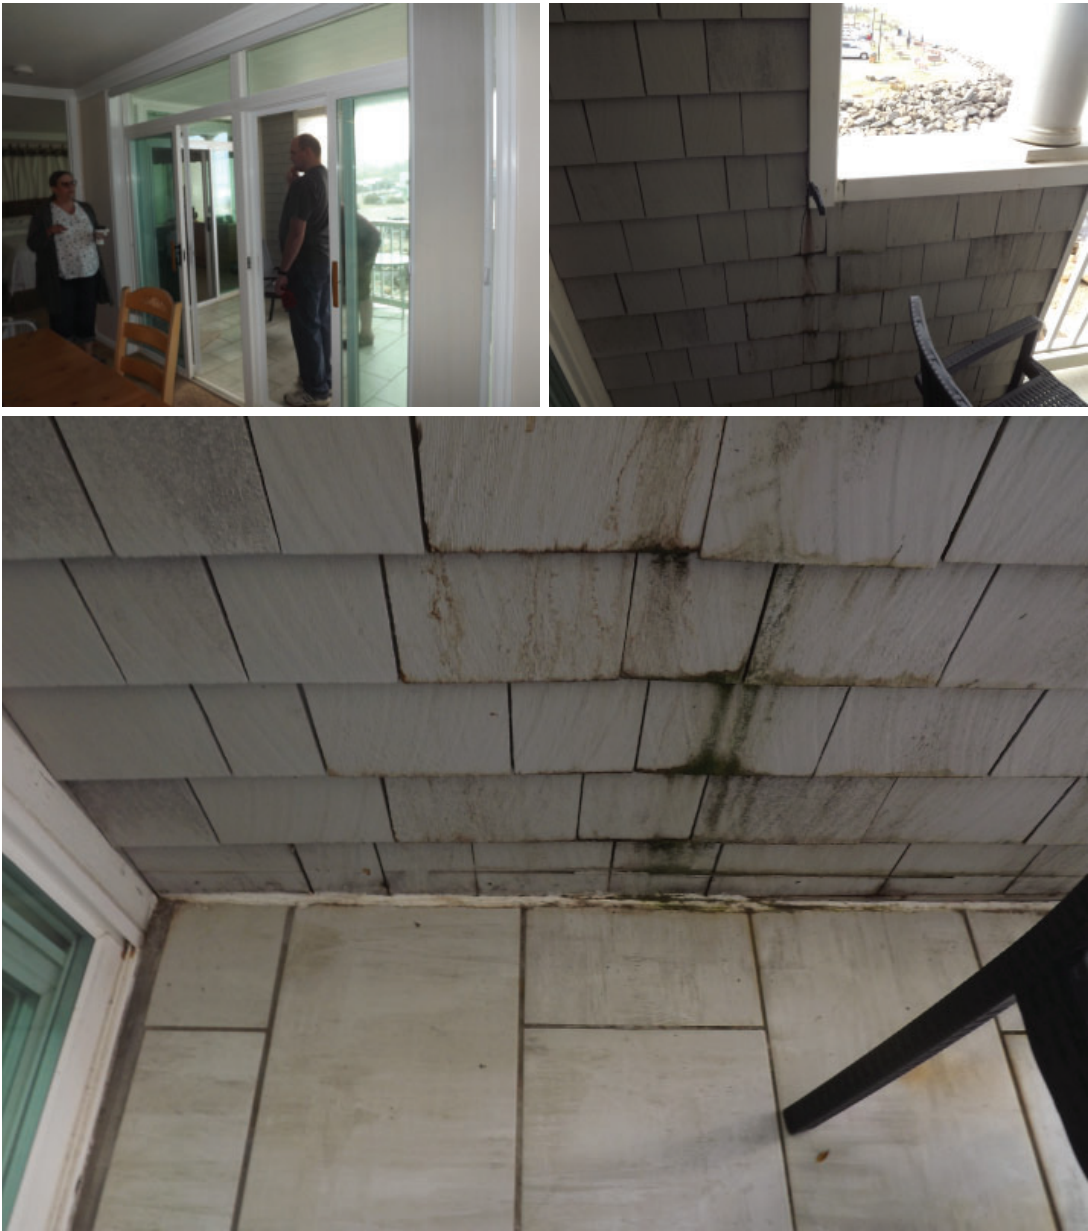
Trapped Moisture.

Moisture was found to be trapped within the wall assembly. The code prohibits moisture to be trapped within the wall assembly.

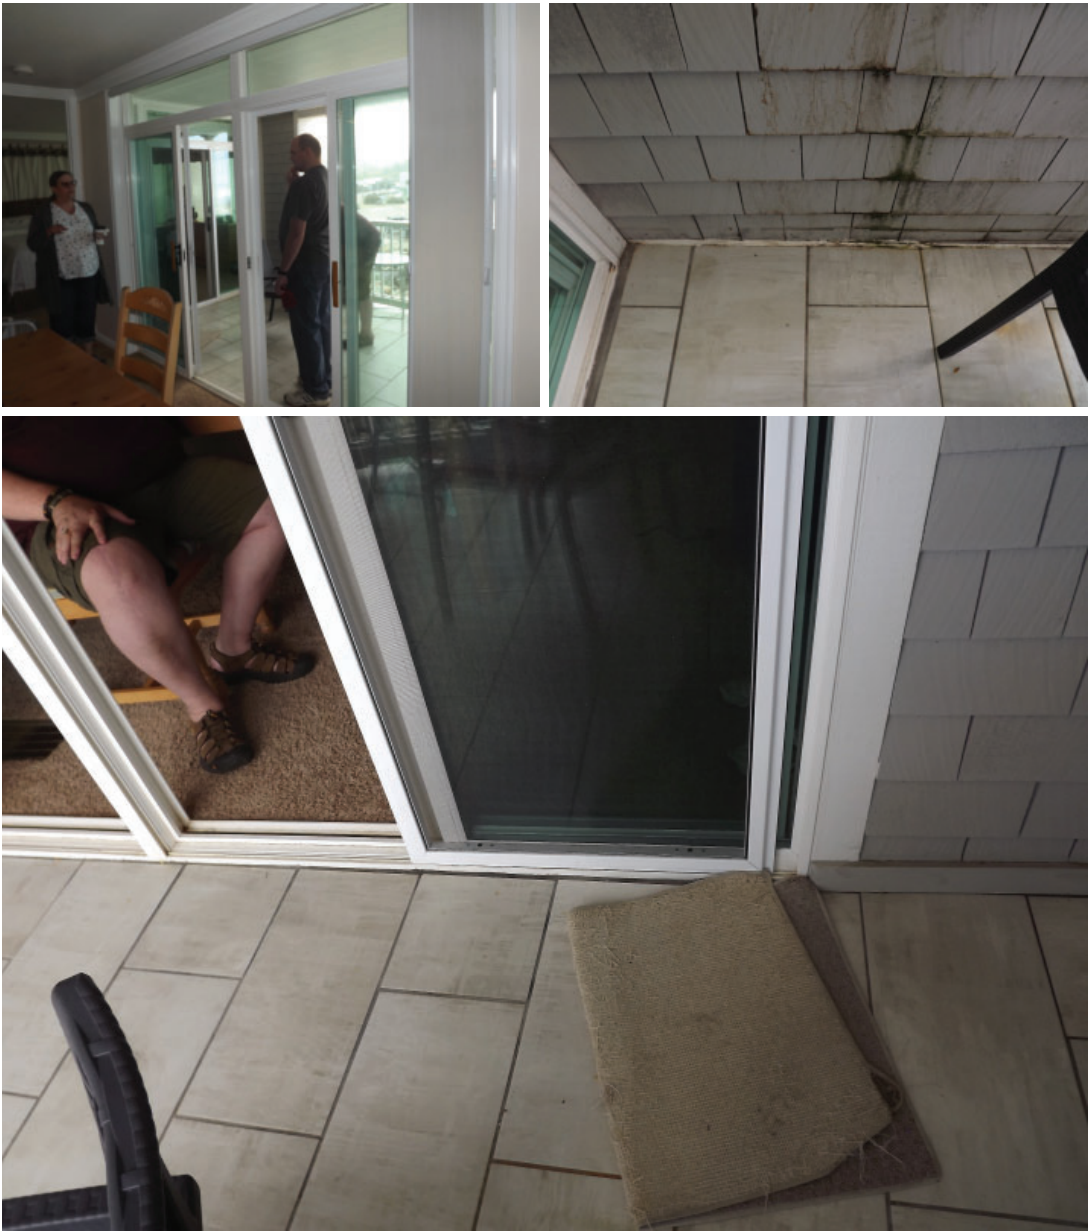
Trapped Moisture.

Deck surface prevents water from draining from the assembly. The code prohibits moisture to be trapped within the wall assembly.

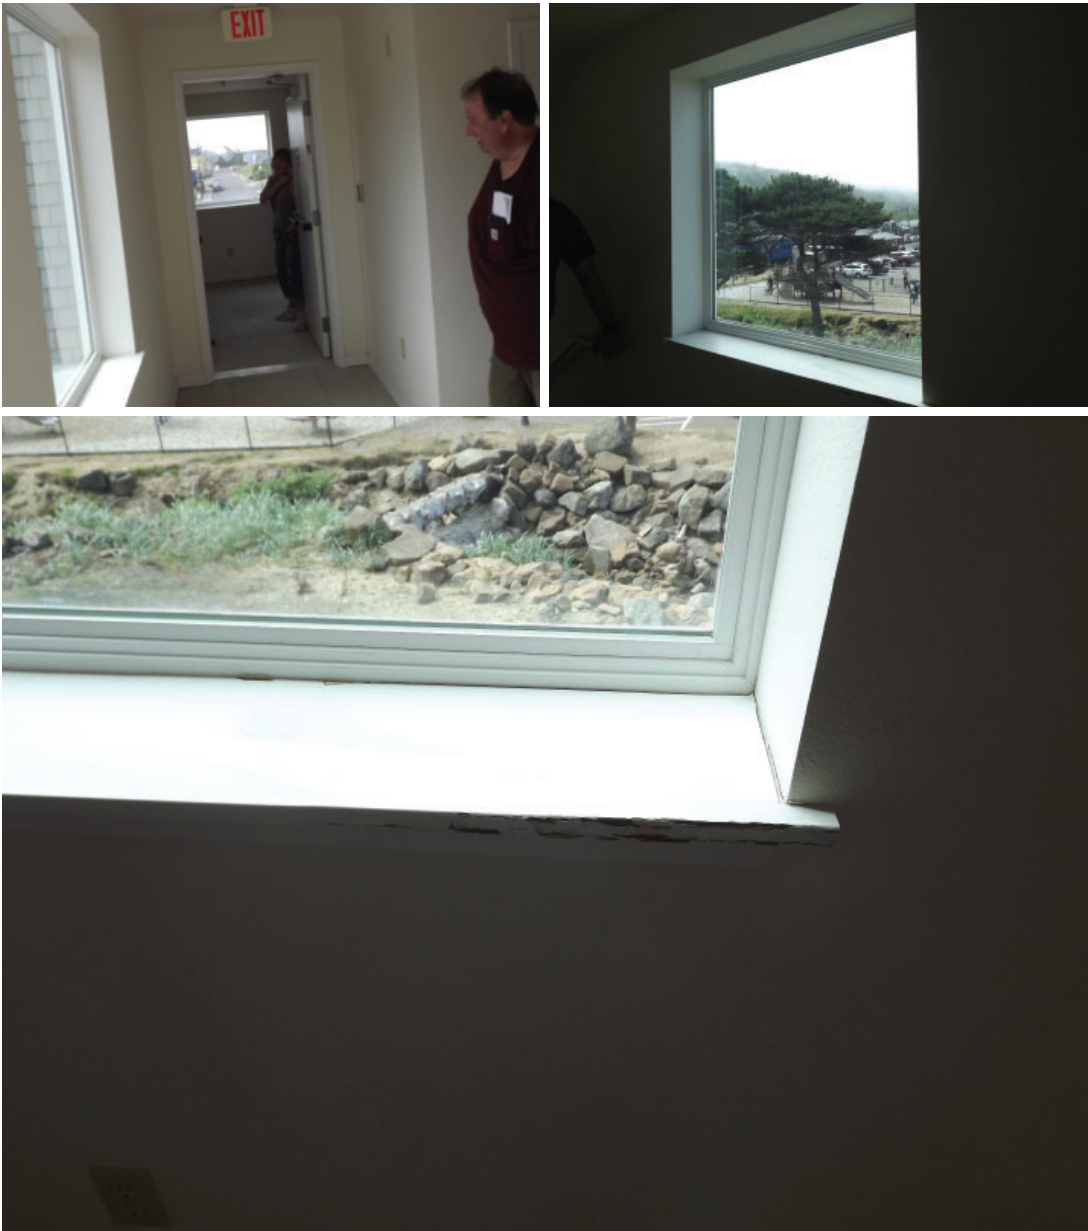
Visible Moisture Intrusion At Window Sill.

Windows may leak from many different reasons. Regardless of the reason, the windows shouldn't be leaking. At this location staining/leaking was visible to the eye.

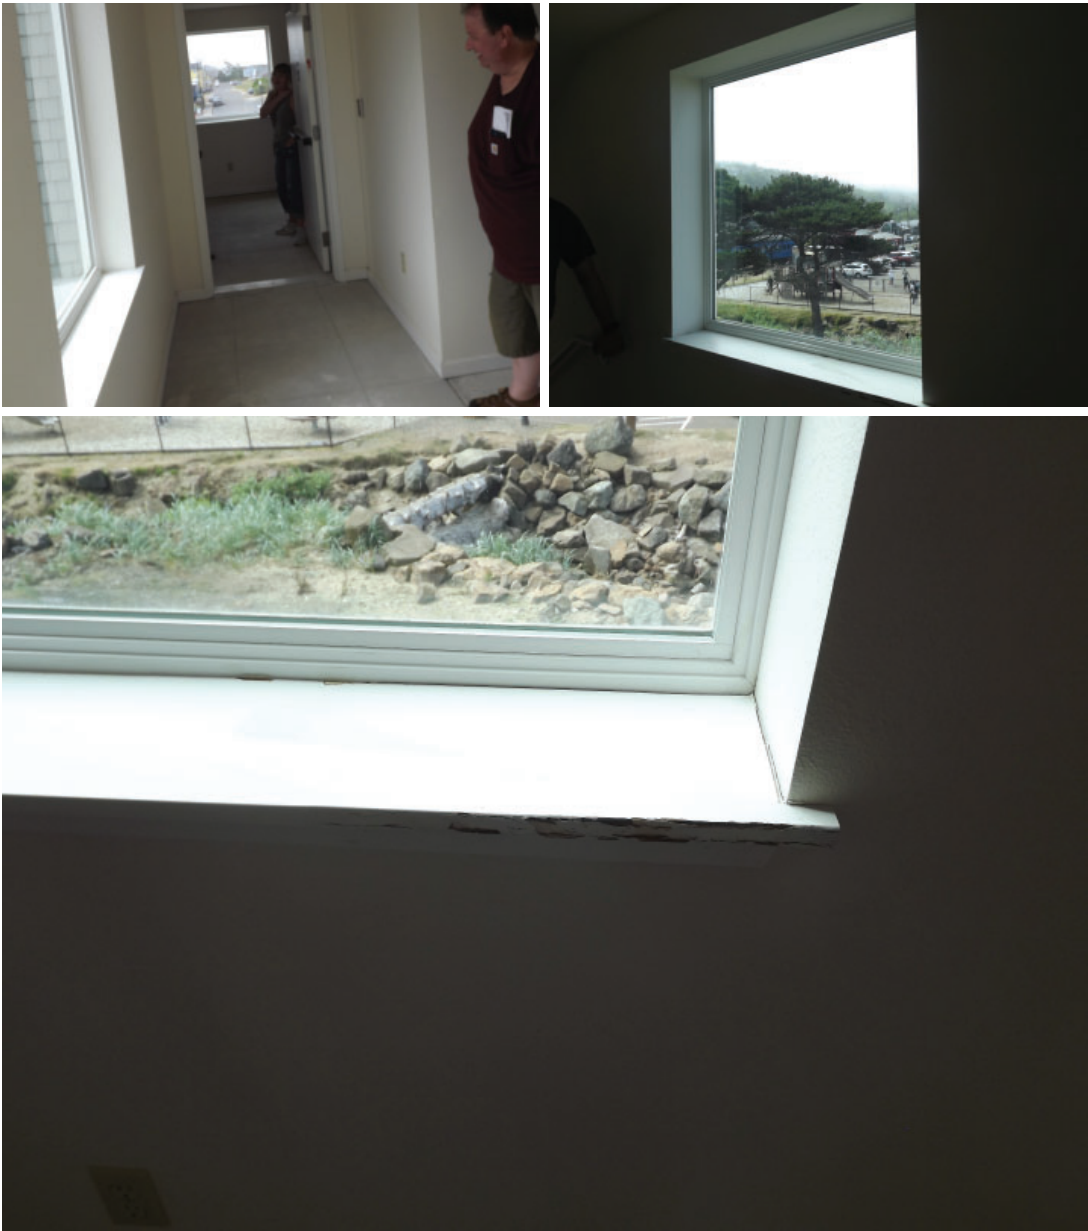
Damage.

The window sill trim is damaged and may not function as intended.

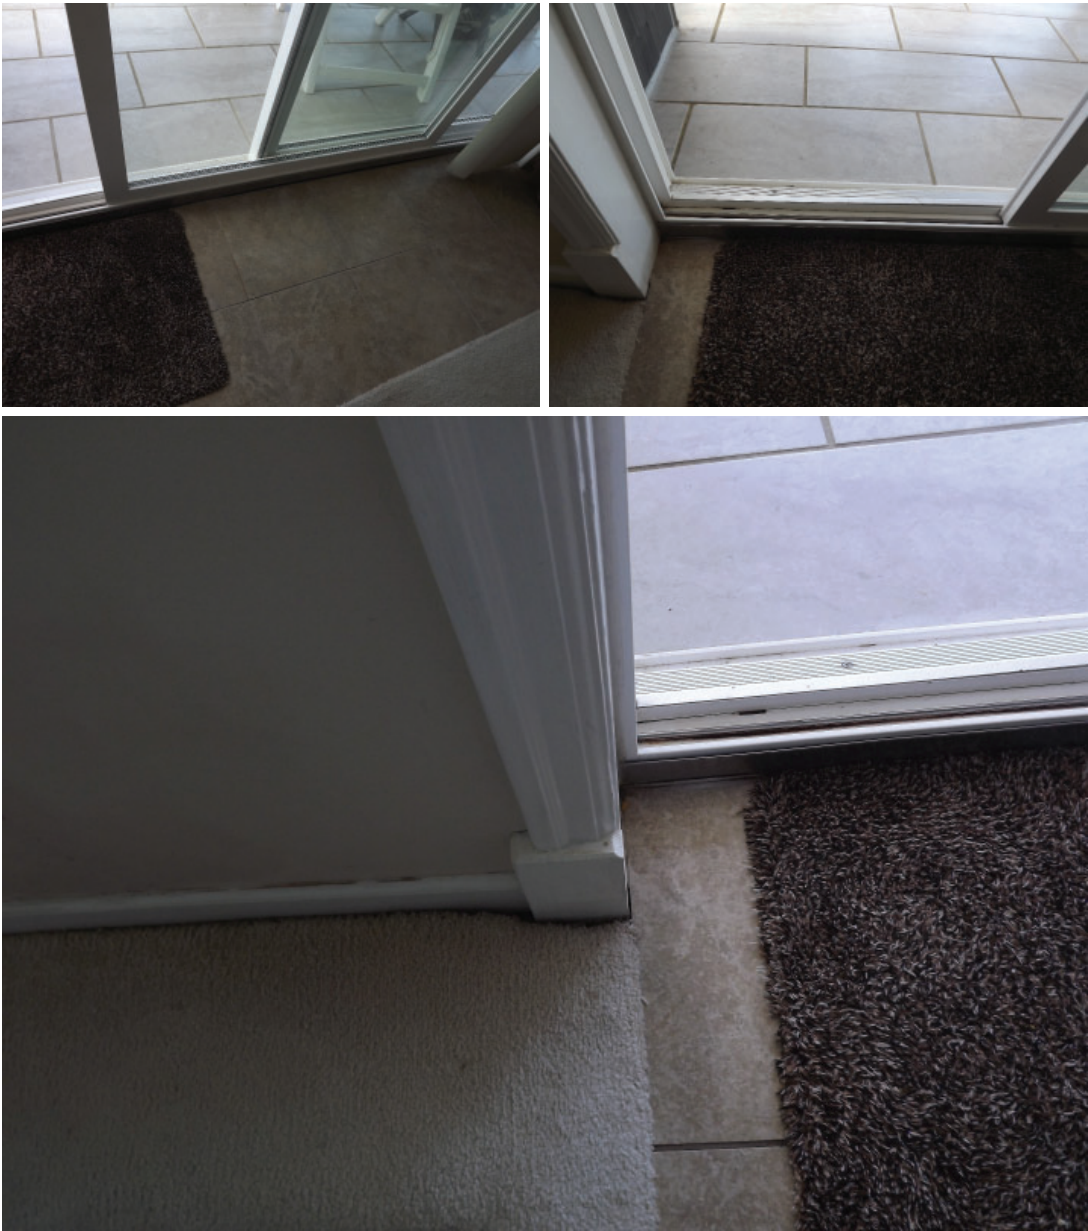
Moisture Damage.

Moisture damage was discovered at this location. Moisture damage is the precursor to dry rot.

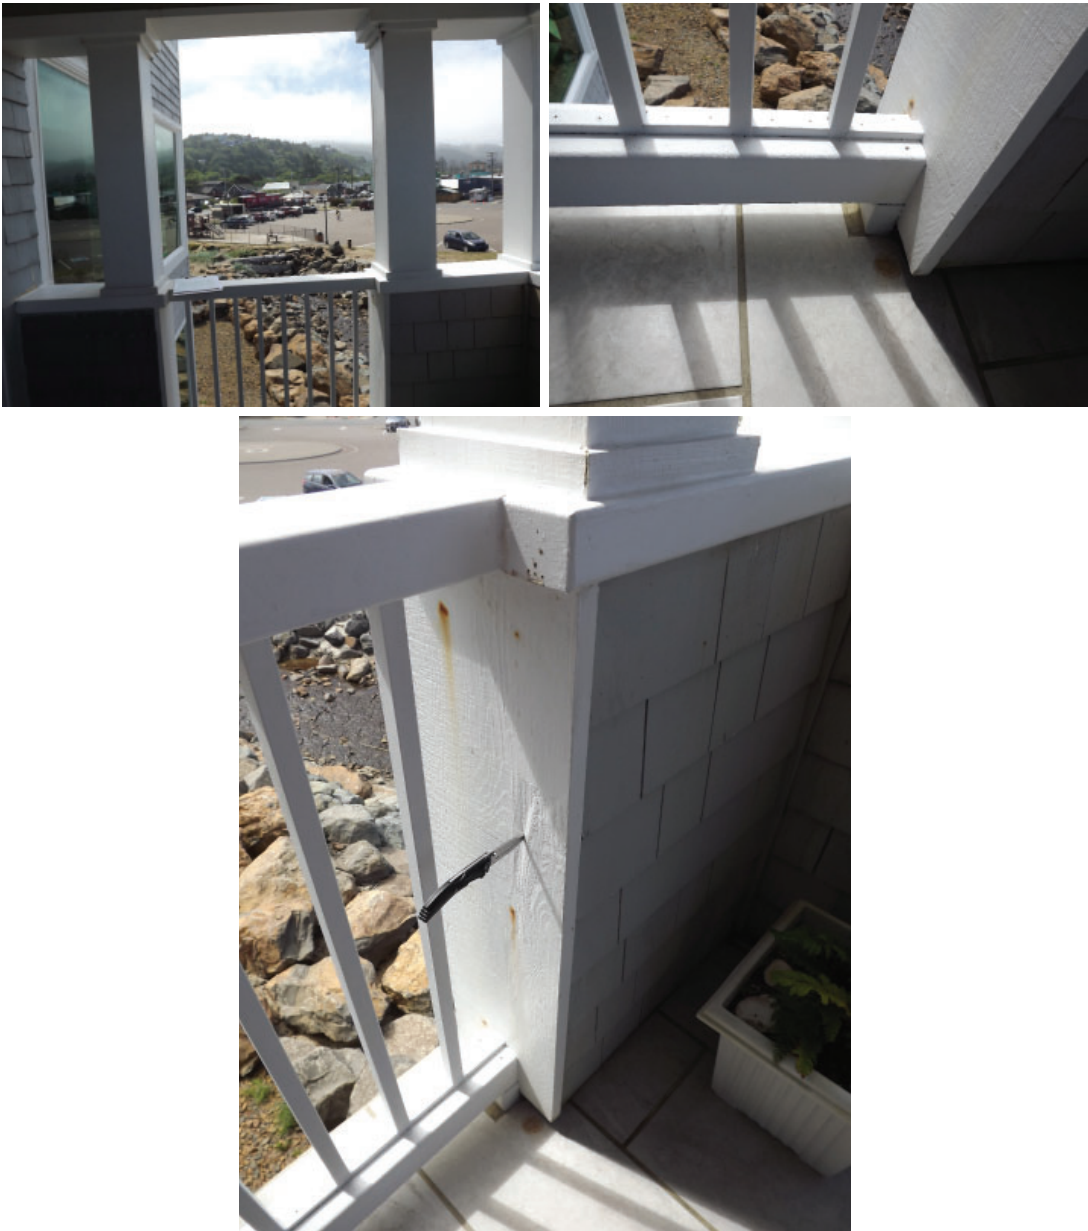
Dry Rot.

Dry rot is the decay of wood products. One main purpose of exterior envelope waterproofing is to deter dry rot because it causes substantial damage to the building and structural members. Dry rot is present at this location.

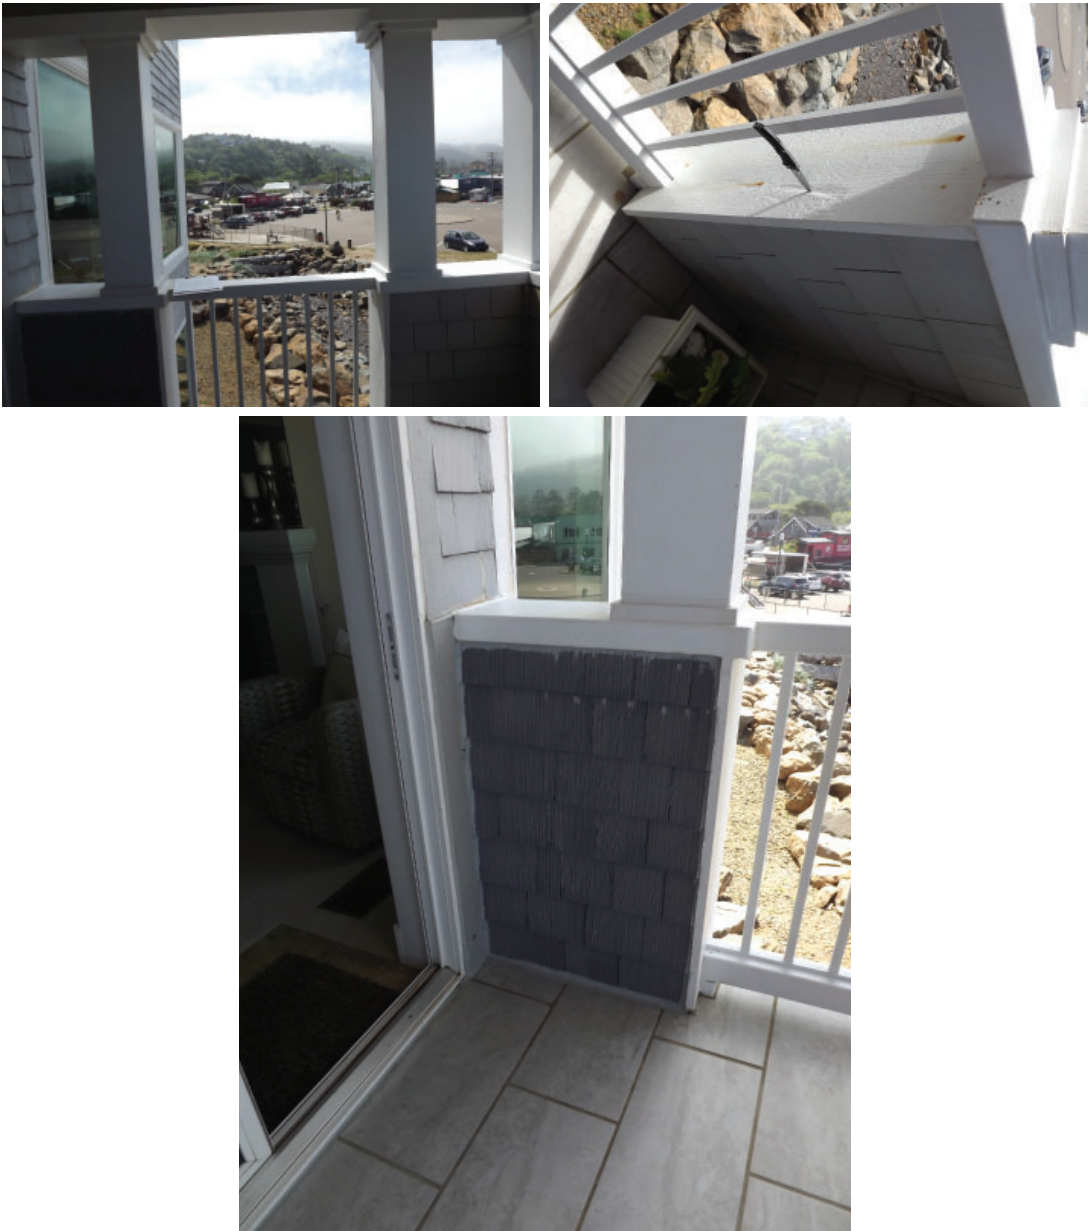
Owner Found Dry Rot, Repaired.

Dry rot is the decay of wood products. One main purpose of exterior envelope waterproofing is to deter dry rot because it causes substantial damage to the building and structural members. Dry rot is present at numerous locations on this deck.

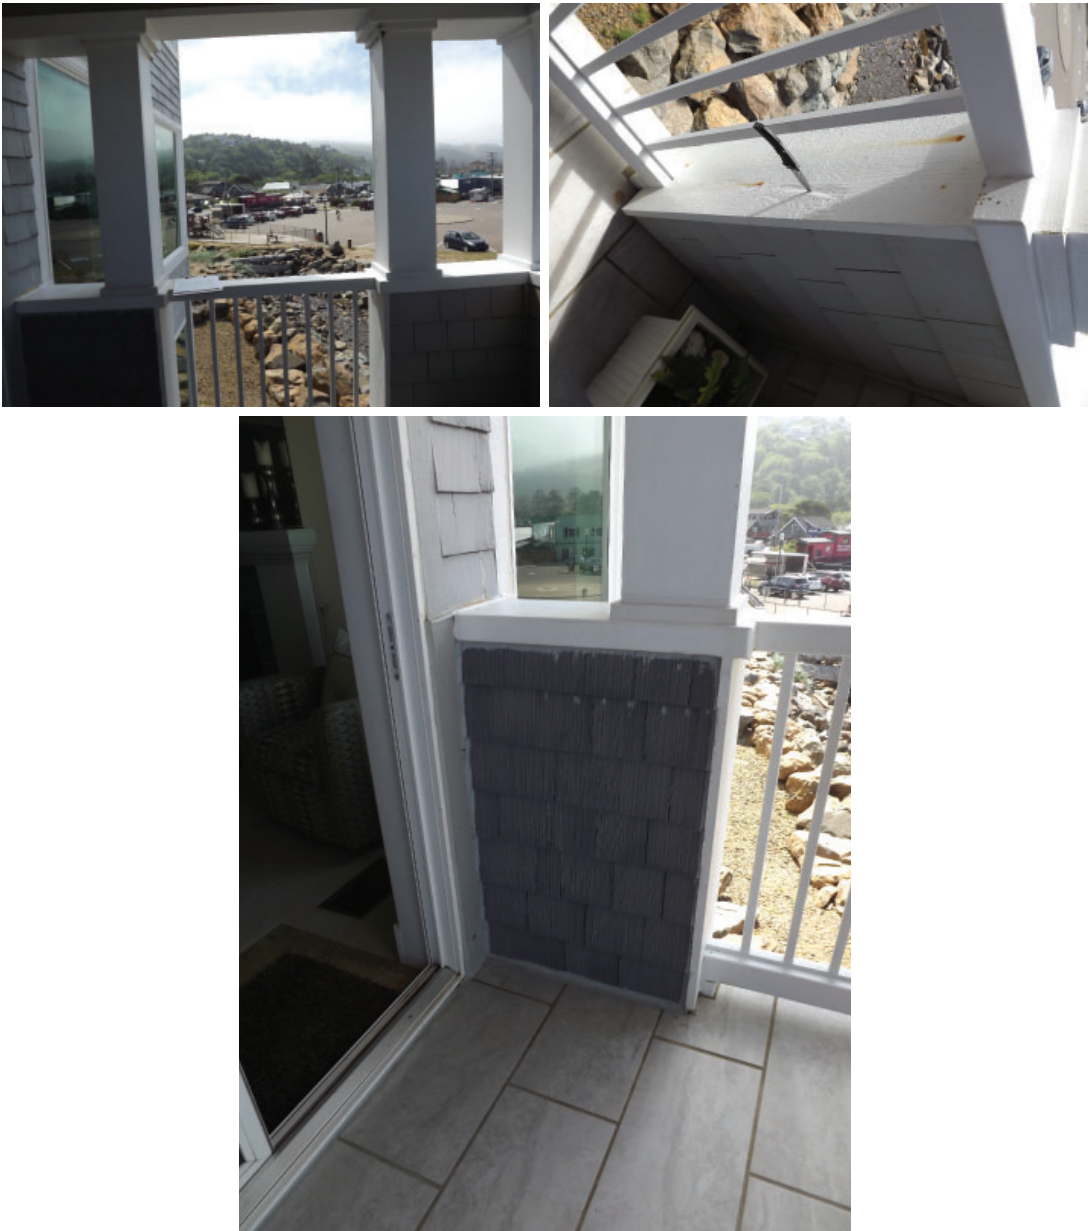
Missing Cap Flashings For Exterior Walls.

Cap flashings are flashings that protect exterior walls. These flashings provide slope and protect from moisture intrusion.

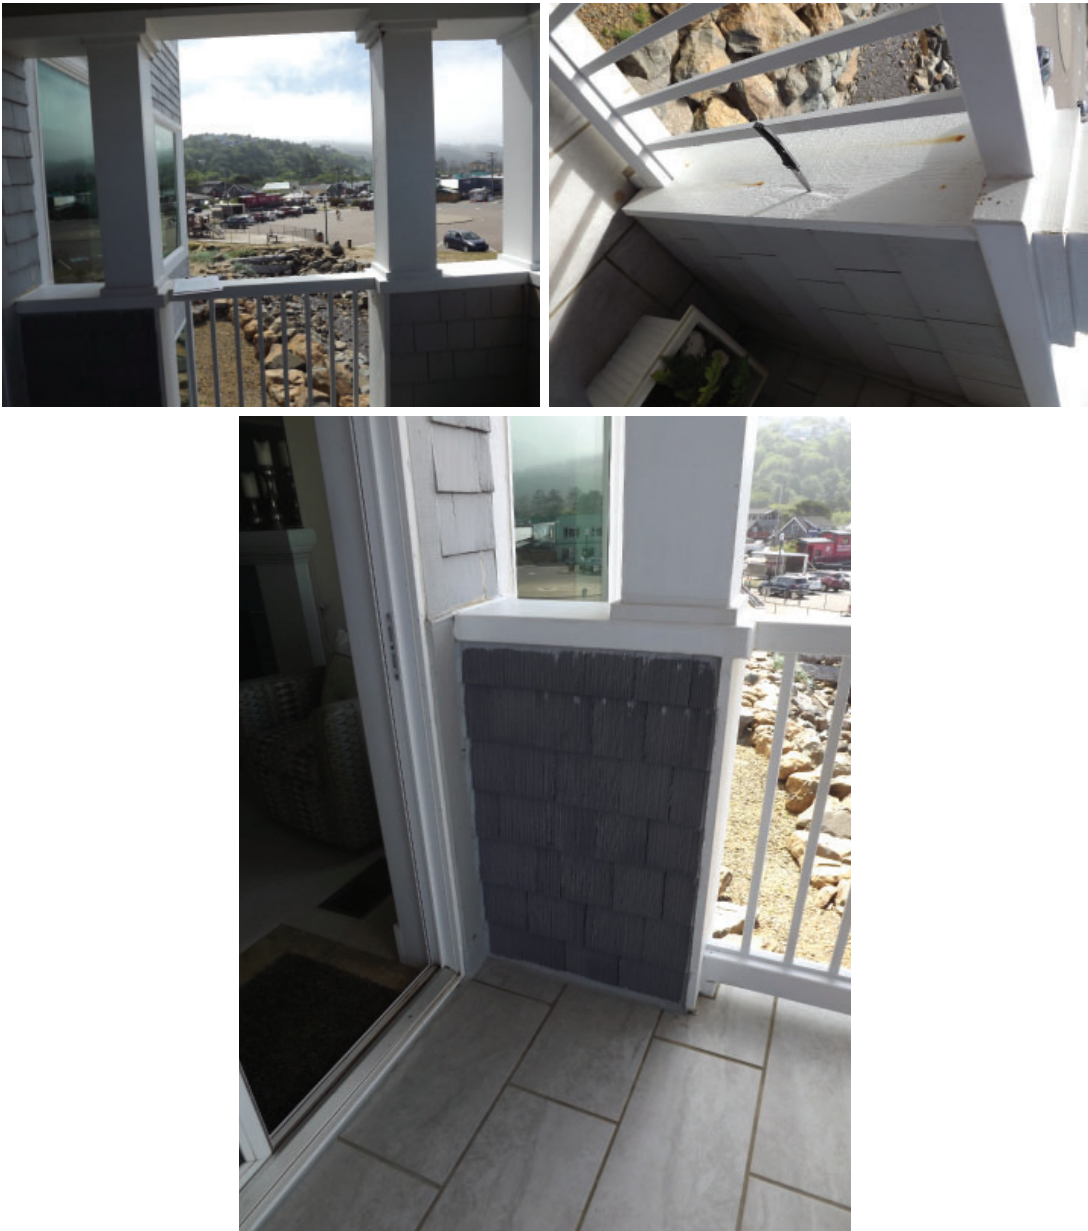
Missing Saddle Flashing.

Saddle flashings are flashings that cover and divert moisture out and away from the vertical wall of the structure in combination with horizontal penetrations of the structure.

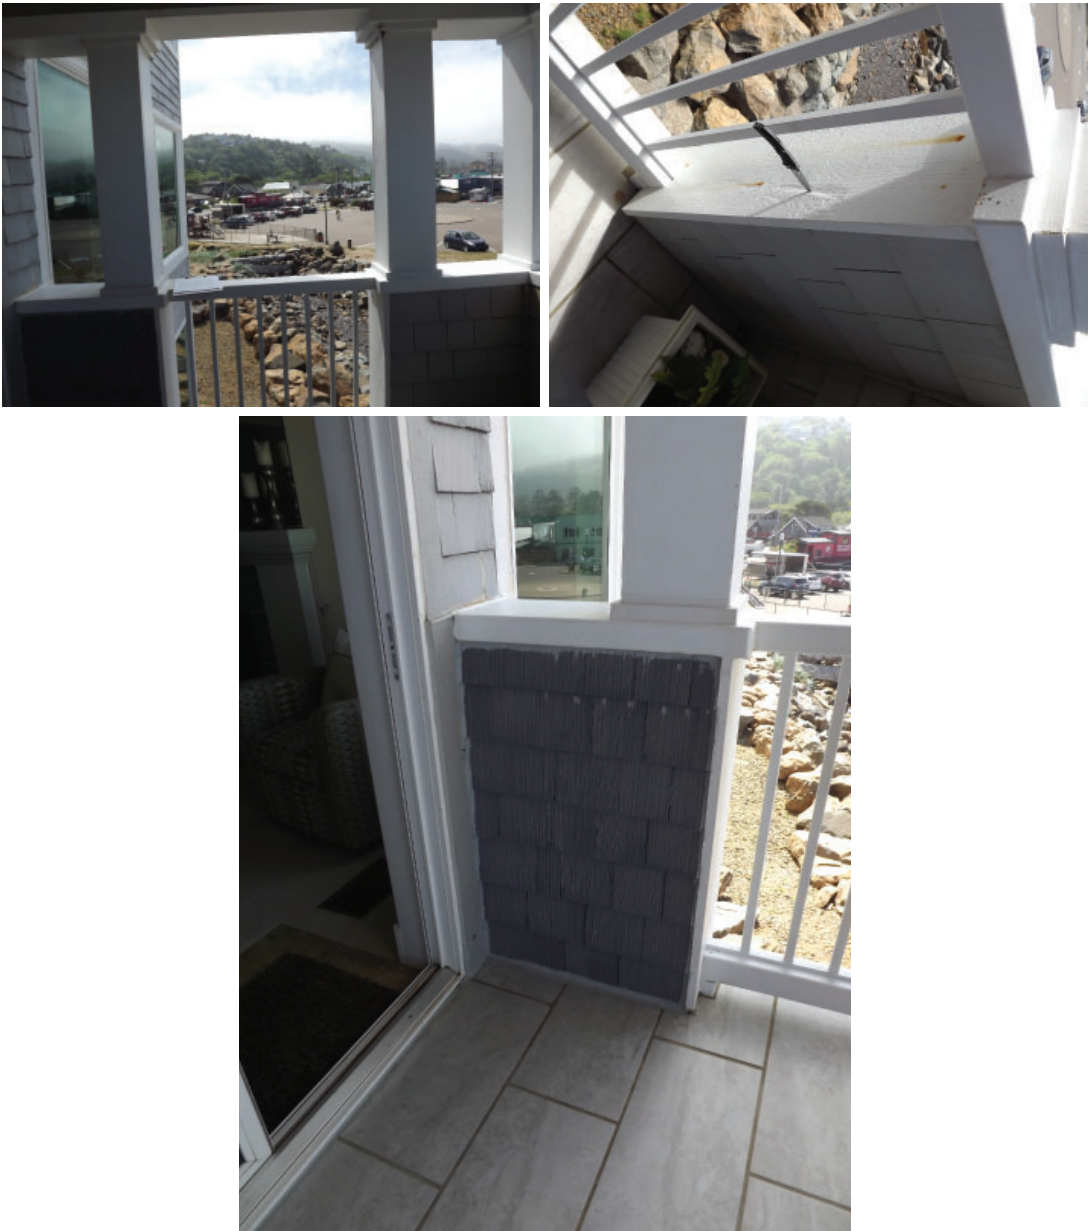
Siding Trminates Too Closely To Deck Surface.

A separation of 1-2” is required between siding and deck surfaces. The gap prevents moisture from wicking into the material and allows moisture to drain effectively. The siding below was installed too close to the deck surface.
