# PRELIMINARY BUILDING ENVELOPE EVALUATION OF SEAVIEW CONDOMINIUMS

LOCATED AT:  
115 N. MILLER STREET  
ROCKAWAY BEACH, OR 97136

August 2nd, 2022

Client # B22265 Seaview Condominiums

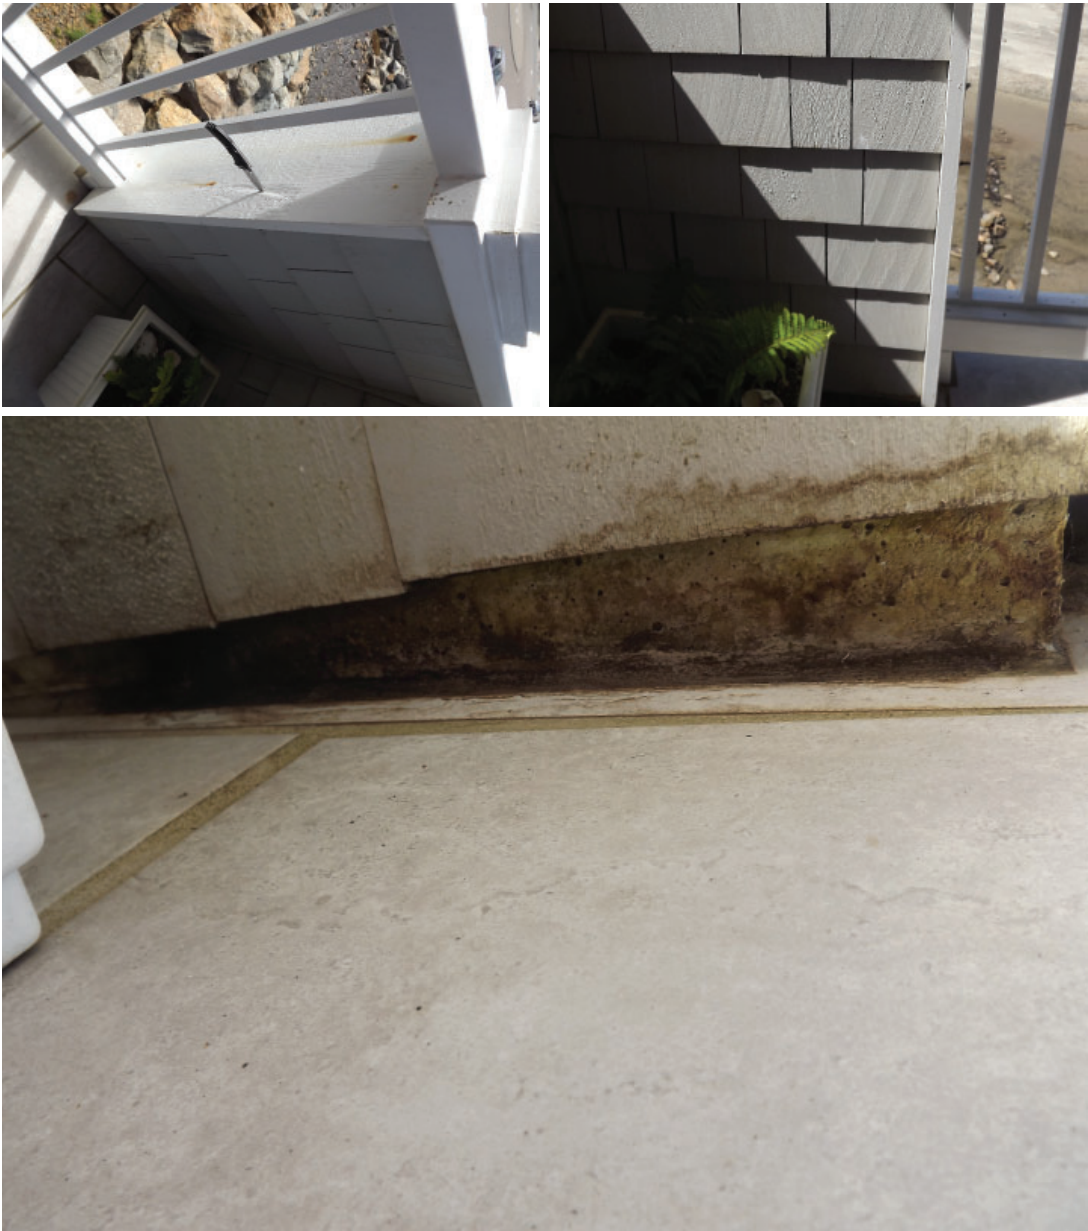
No Evidence Of Waterproof Membrane For Deck.

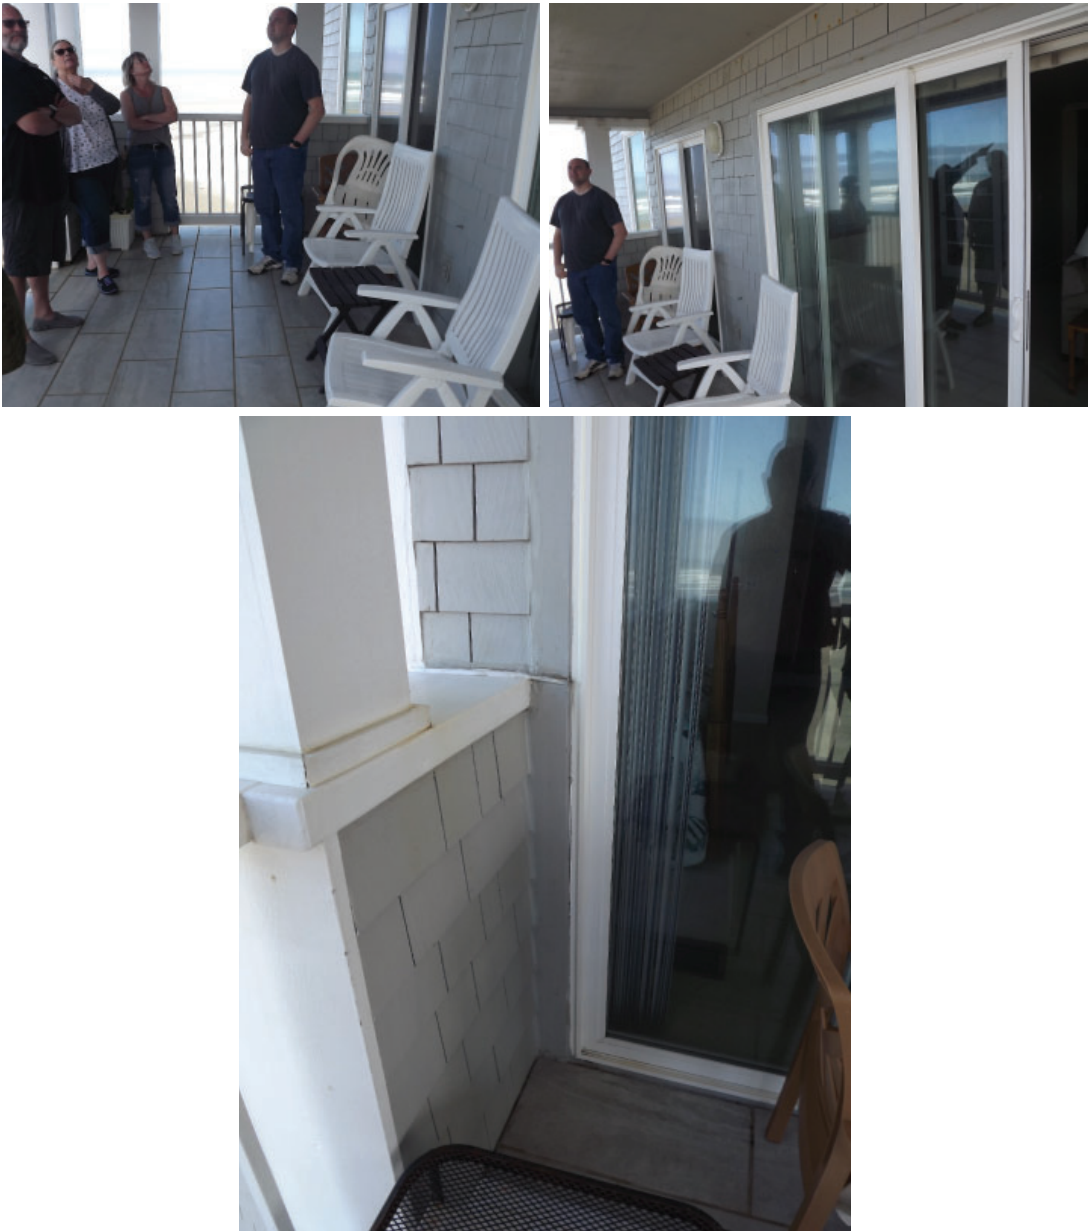
Missing Cap Flashings For Exterior Walls.

Cap flashings are flashings that protect exterior walls. These flashings provide slope and protect from moisture intrusion.

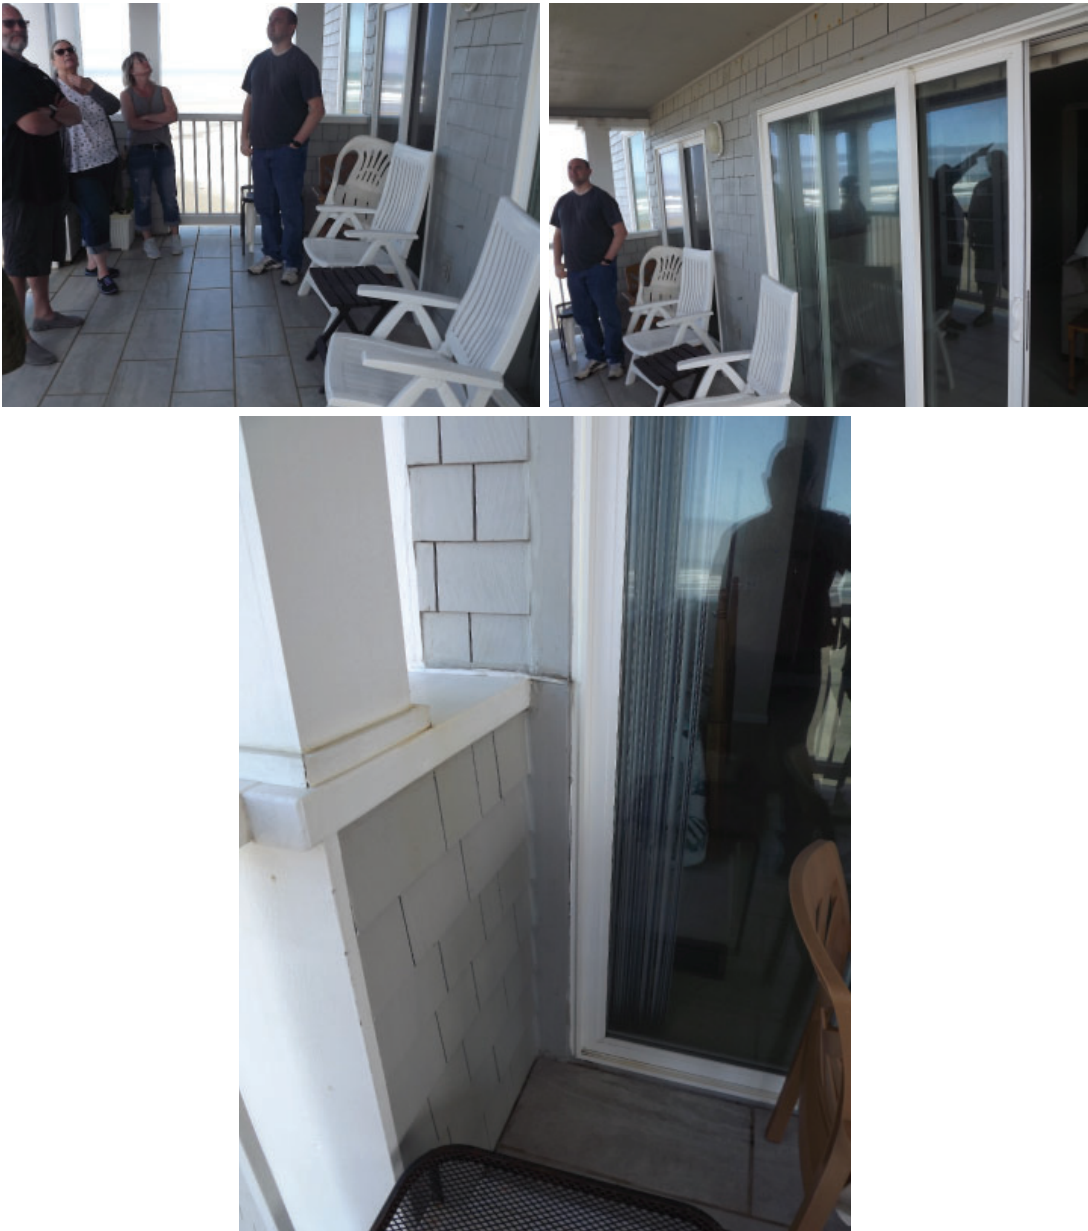
Missing Saddle Flashing.

Saddle flashings are flashings that cover and divert moisture out and away from the vertical wall of the structure in combination with horizontal penetrations of the structure.

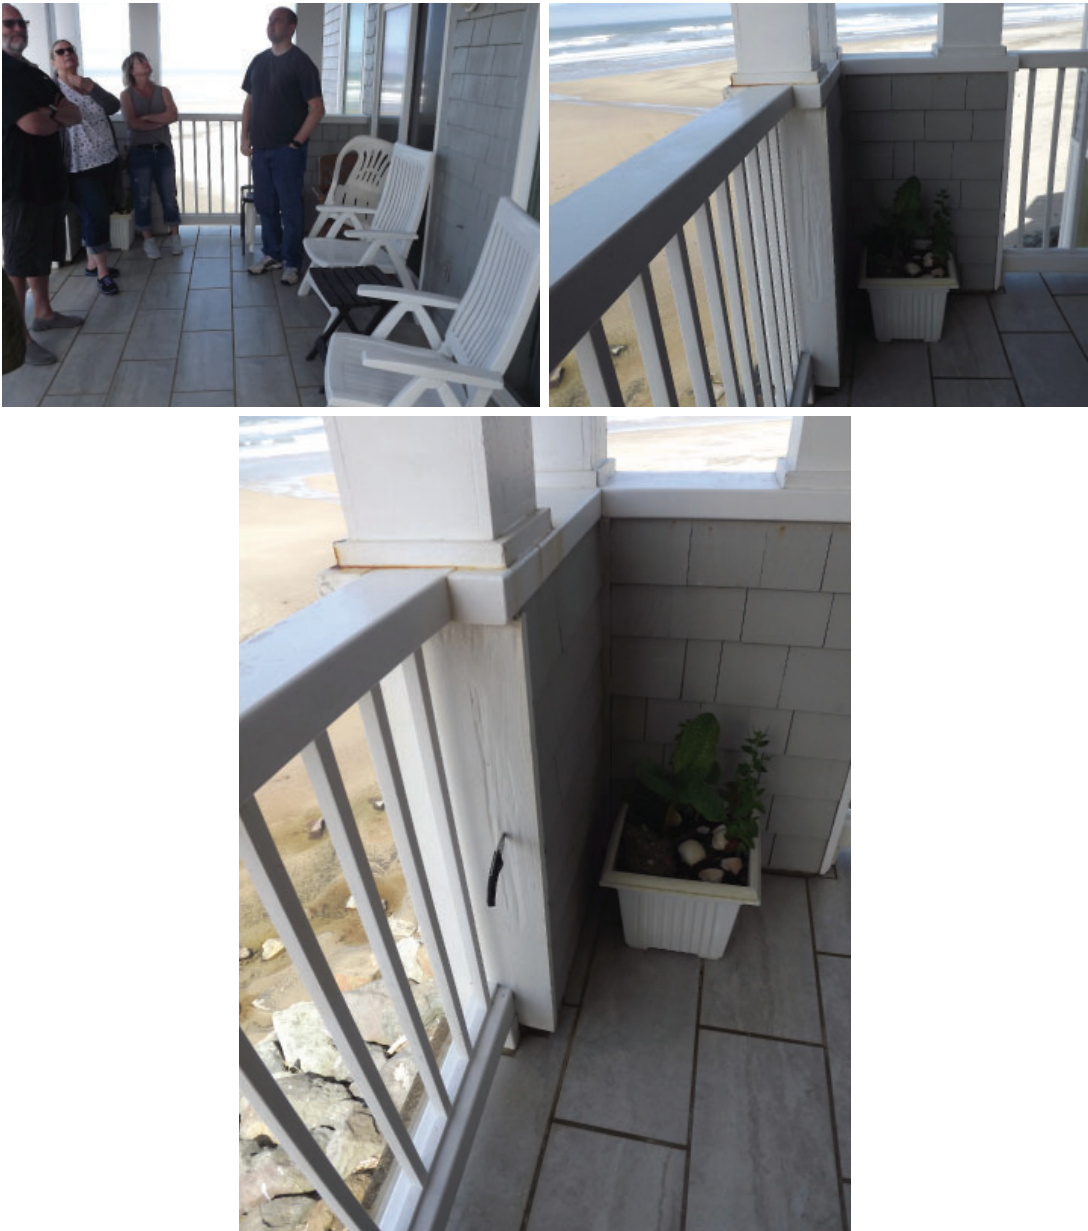
Dry Rot.

Dry rot is the decay of wood products. One main purpose of exterior envelope waterproofing is to deter dry rot because it causes substantial damage to the building and structural members. Dry rot is present at this location.

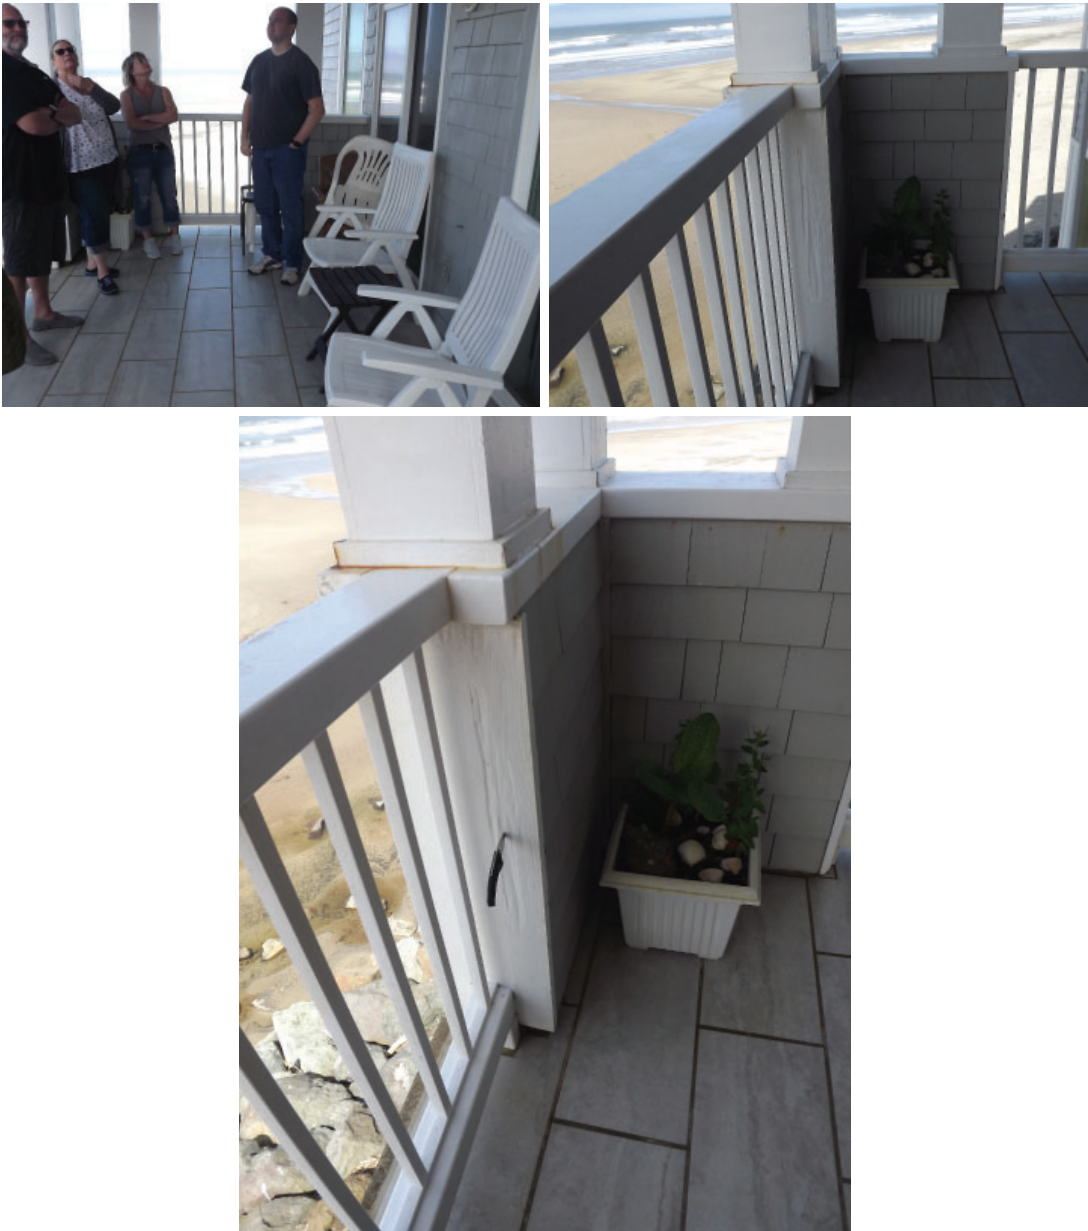
Missing Cap Flashings For Exterior Walls.

Cap flashings are flashings that protect exterior walls. These flashings provide slope and protect from moisture intrusion.

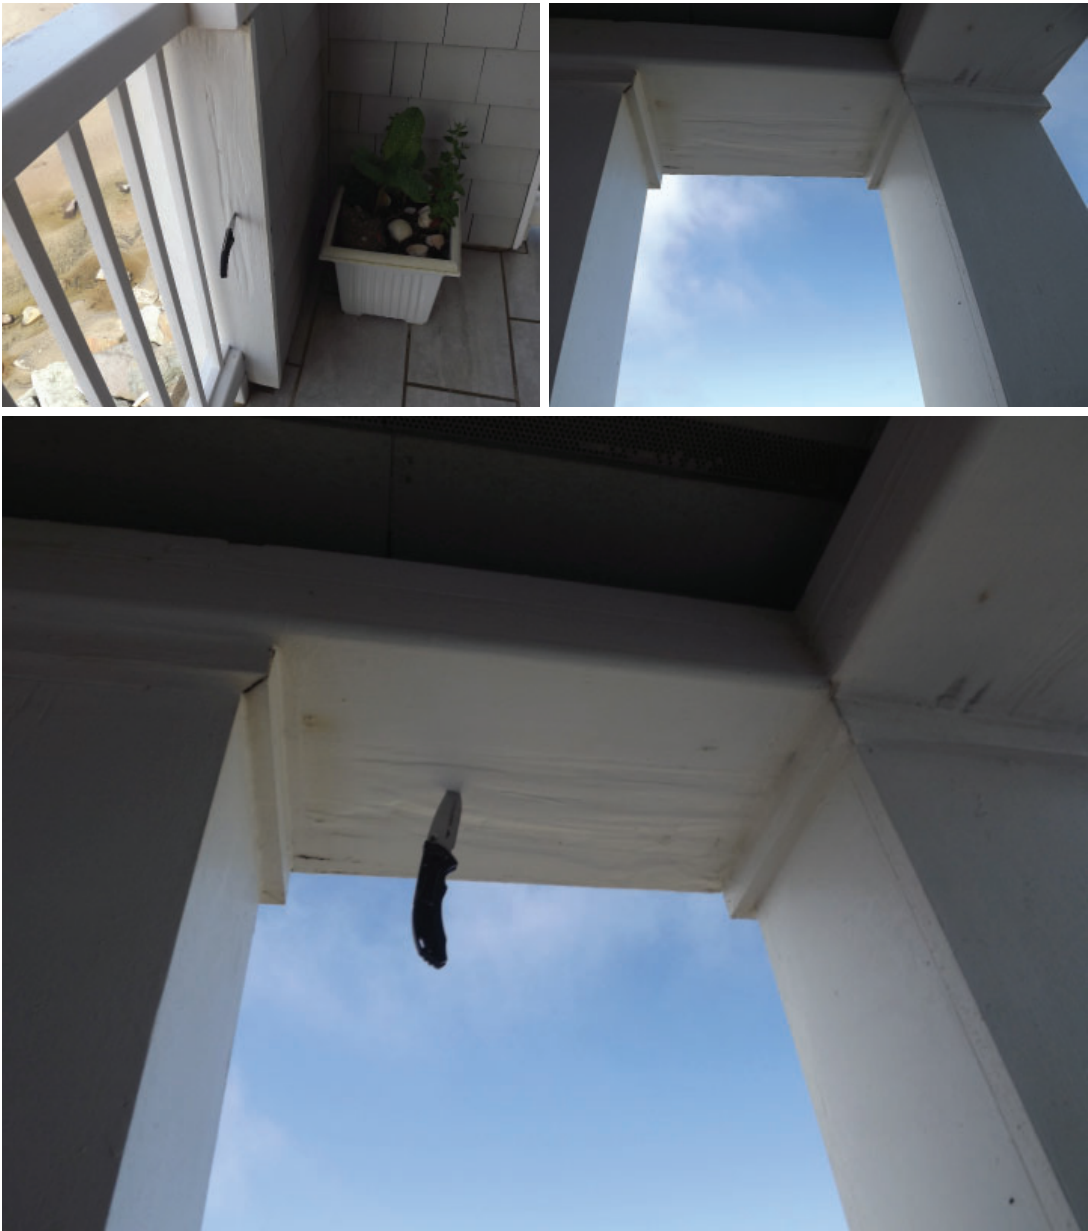
Dry Rot.

Dry rot is the decay of wood products. One main purpose of exterior envelope waterproofing is to deter dry rot because it causes substantial damage to the building and structural members. Dry rot is present at this location.

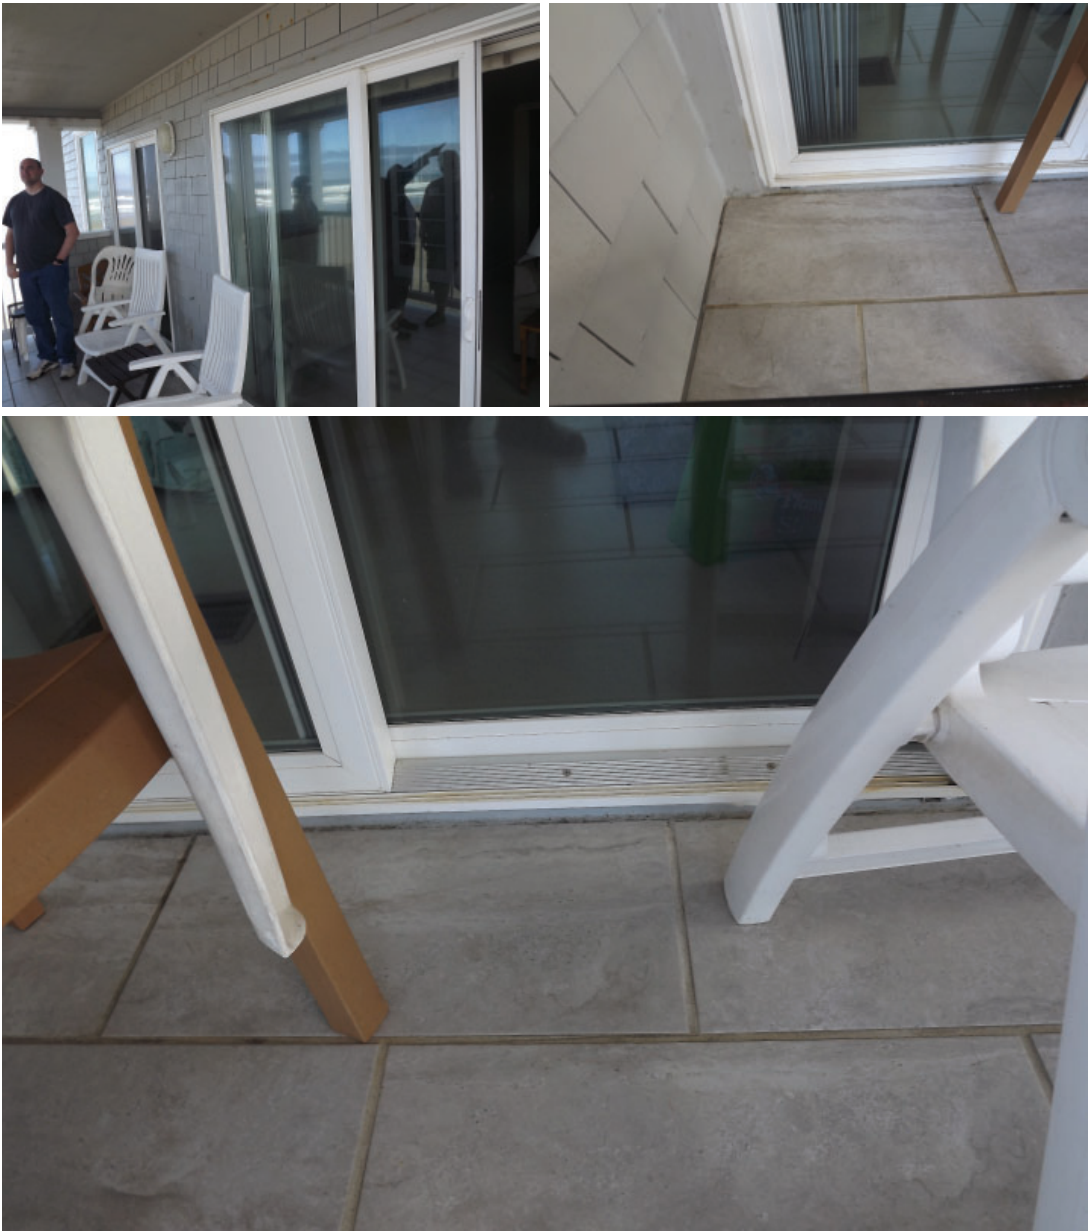
Sealed Drainage Path.

The intersection between the soffit and the vertical wall below has been sealed, thereby preventing moisture drainage from behind the vertical wall and trapping moisture at the intersection.

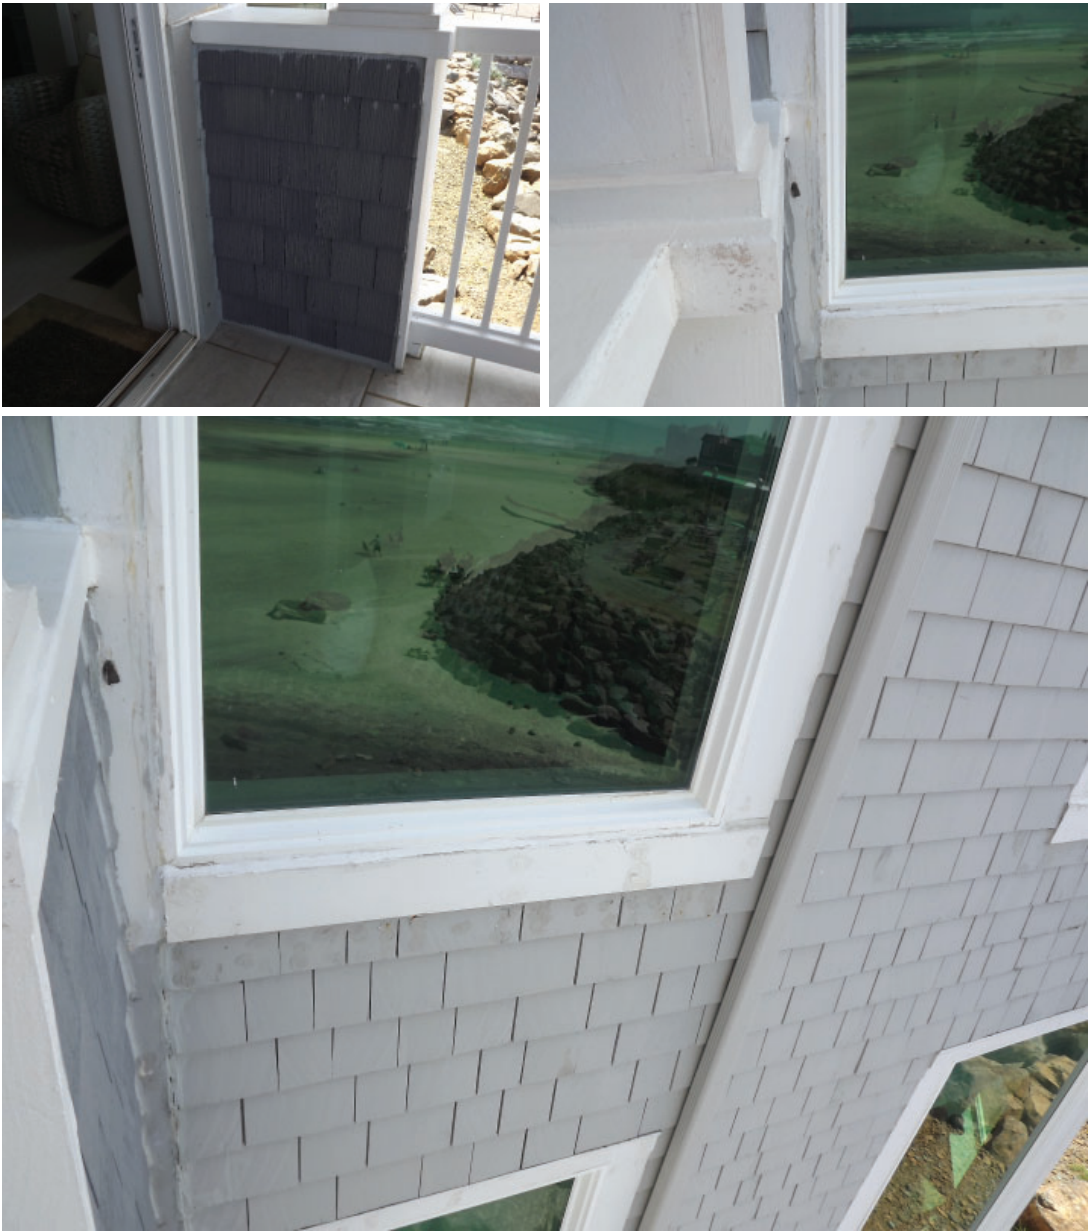
Trim Missing Weather Cut Joints.

The application of trim requires weather cut to allow for moisture to drain outside of the structure. This is typical in the industry but has not occurred here or in other locations on the structure.

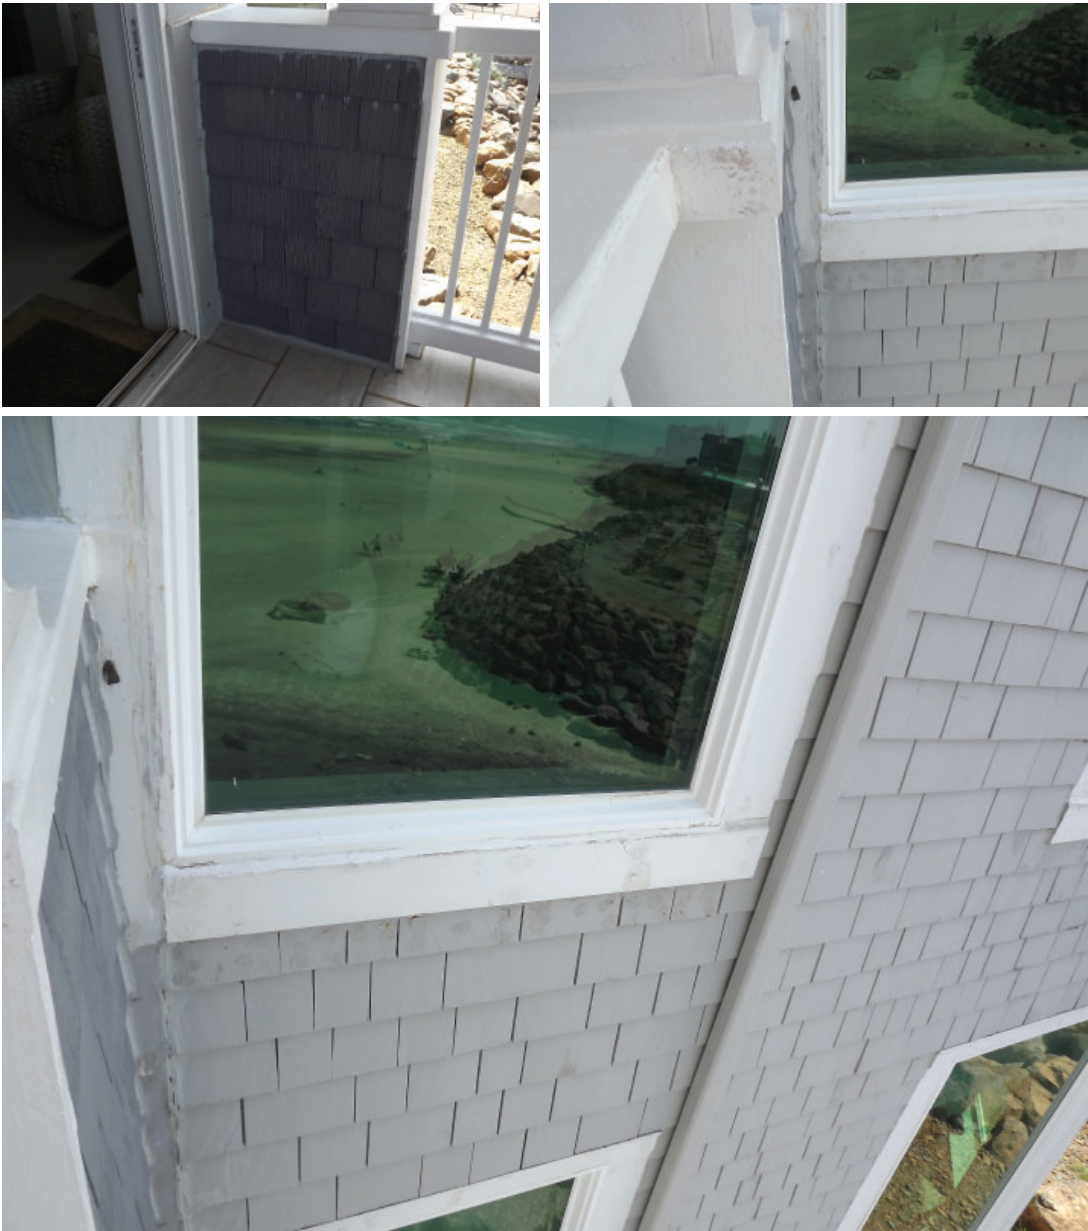
Missing Sealant Between Dissimilar Material.

Dynamic sealant joint was not installed between the cultured stone and the wood trim at this location. Without the ability to flex, these two dissimilar materials can crack and allow for moisture intrusion.

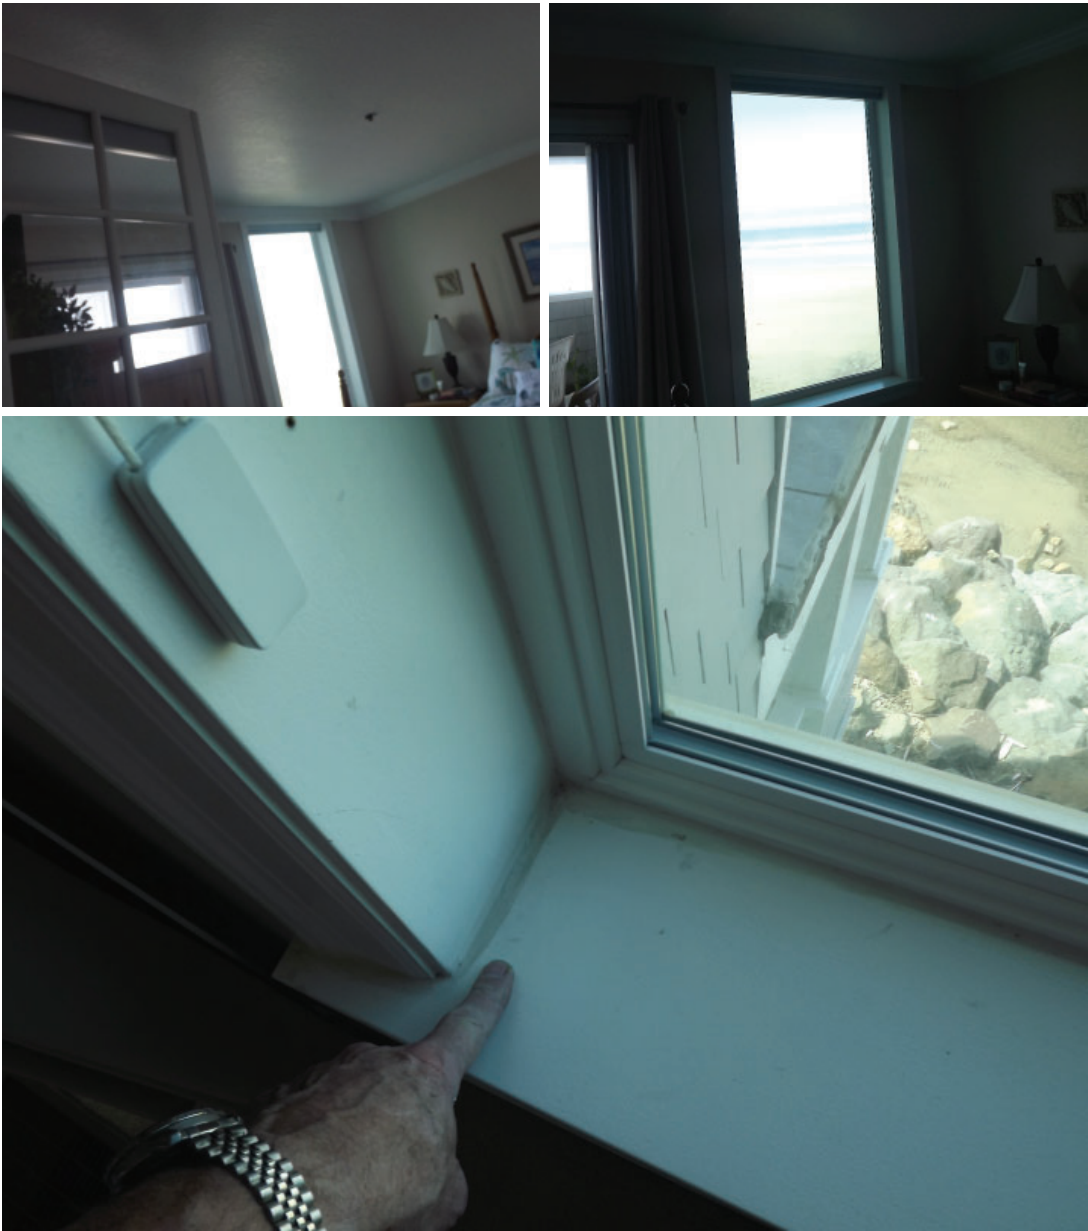
Visible Moisture Intrusion At Window Sill.

Windows may leak from many different reasons. Regardless of the reason, the windows shouldn't be leaking. At this location staining/leaking was visible to the eye.

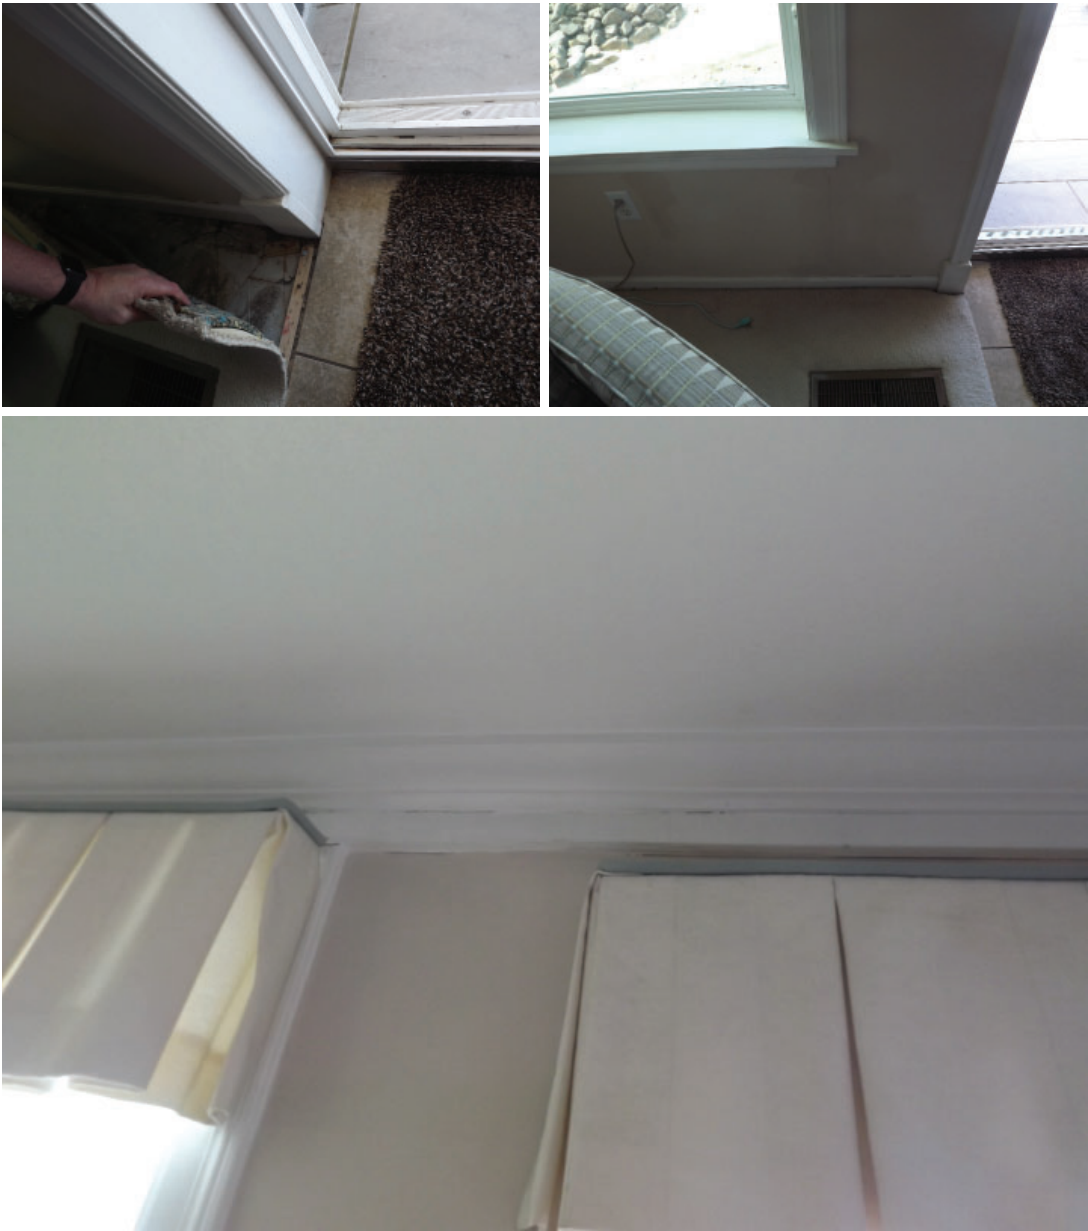
Moisture Damage.

Moisture damage was discovered at this location. Moisture damage is the precursor to dry rot.

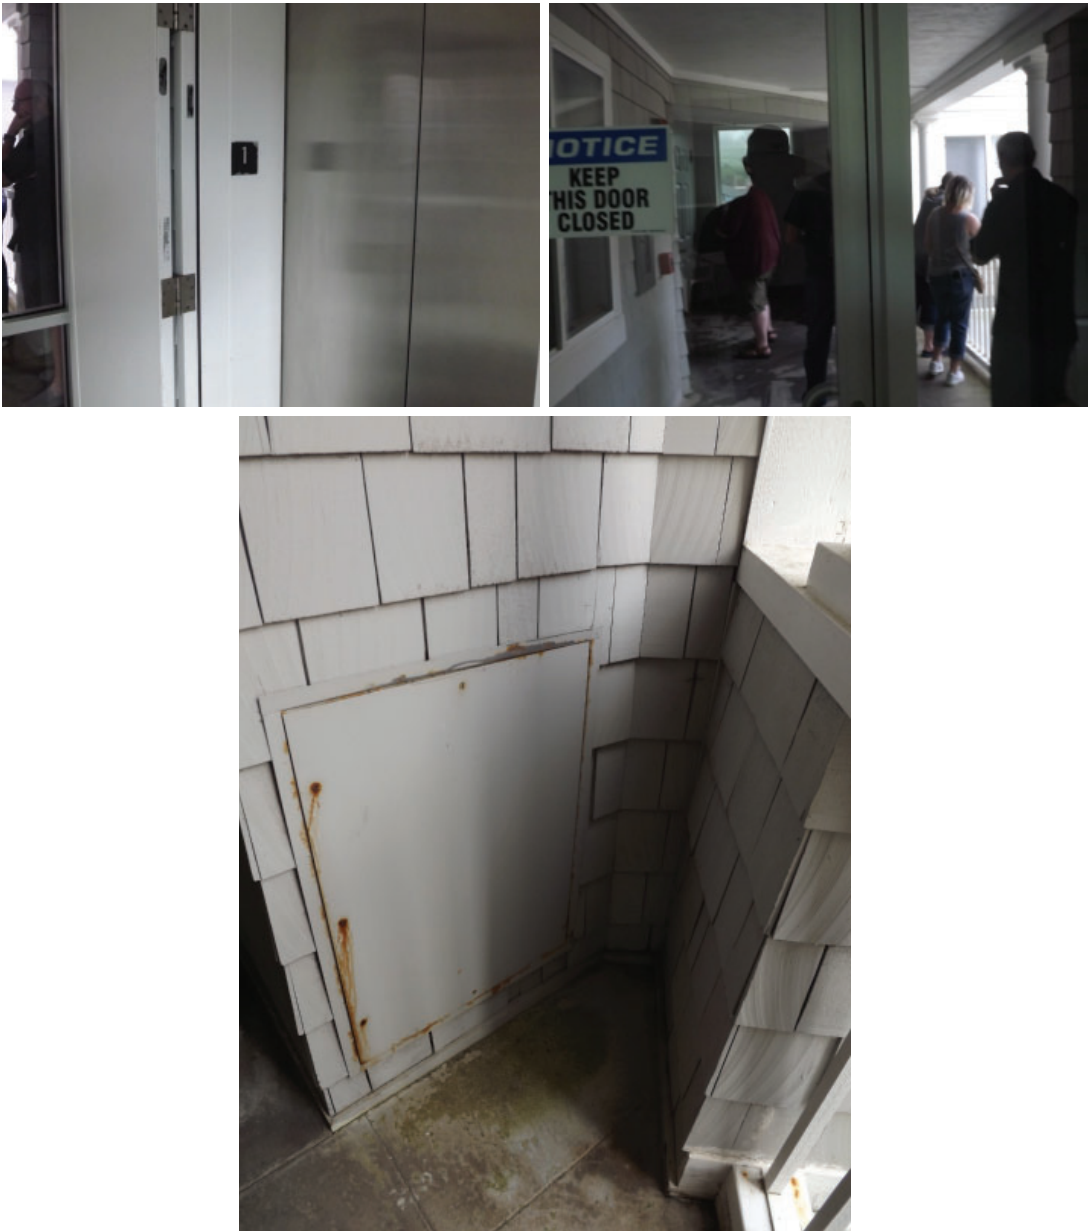
A separation of 1-2” is required between trim or siding and hard surfaces. The gap prevents moisture from wicking into the material and allows moisture to drain effectively. The siding and trim shown below were installed too close to the hard surface.

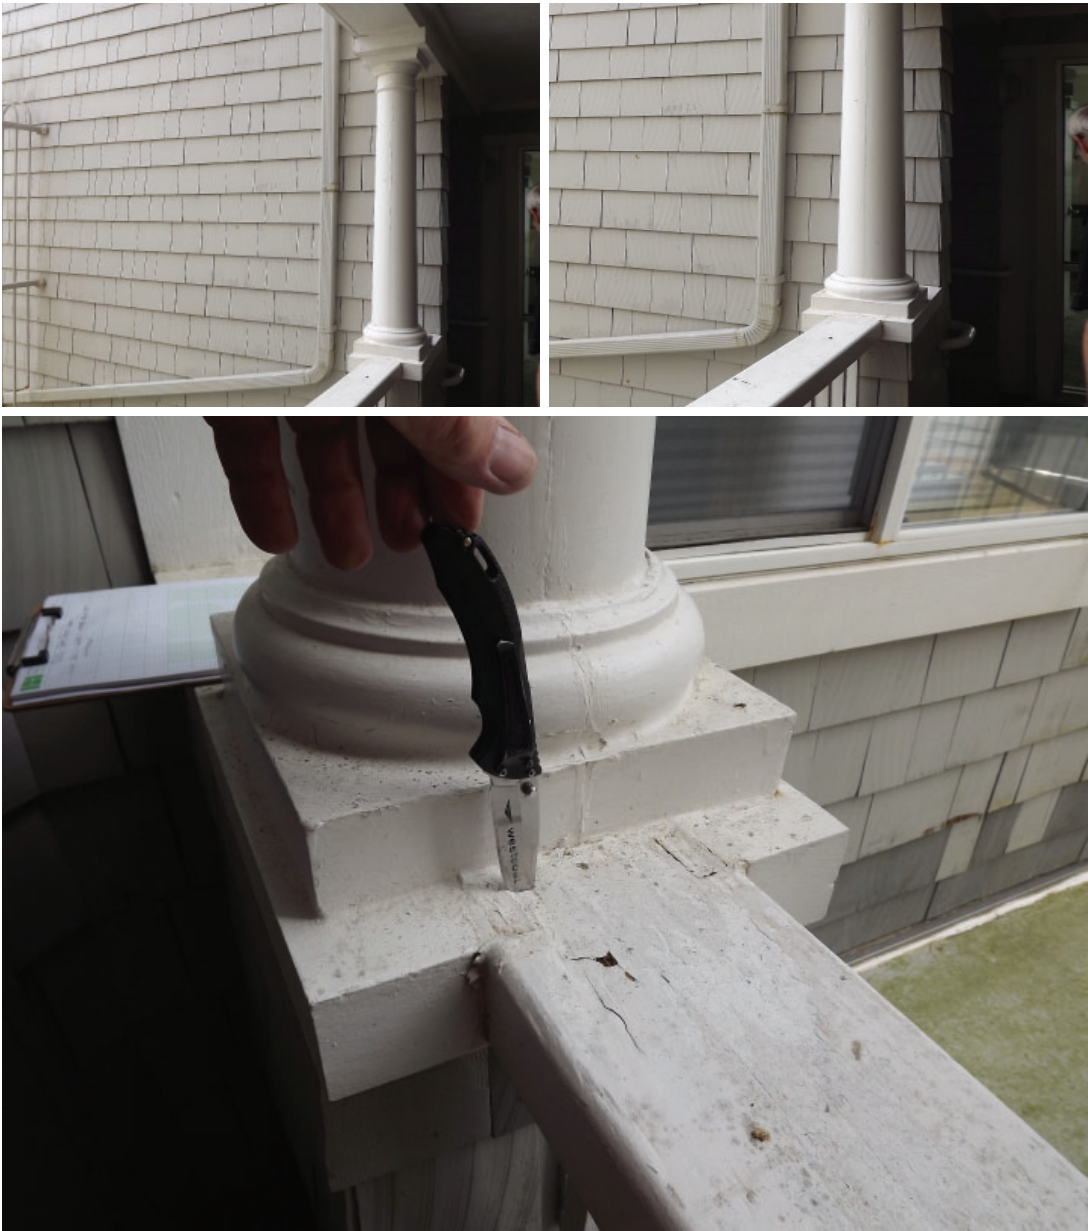
Missing Cap Flashings For Exterior Walls.

Cap flashings are flashings that protect exterior walls. These flashings provide slope and protect from moisture intrusion.

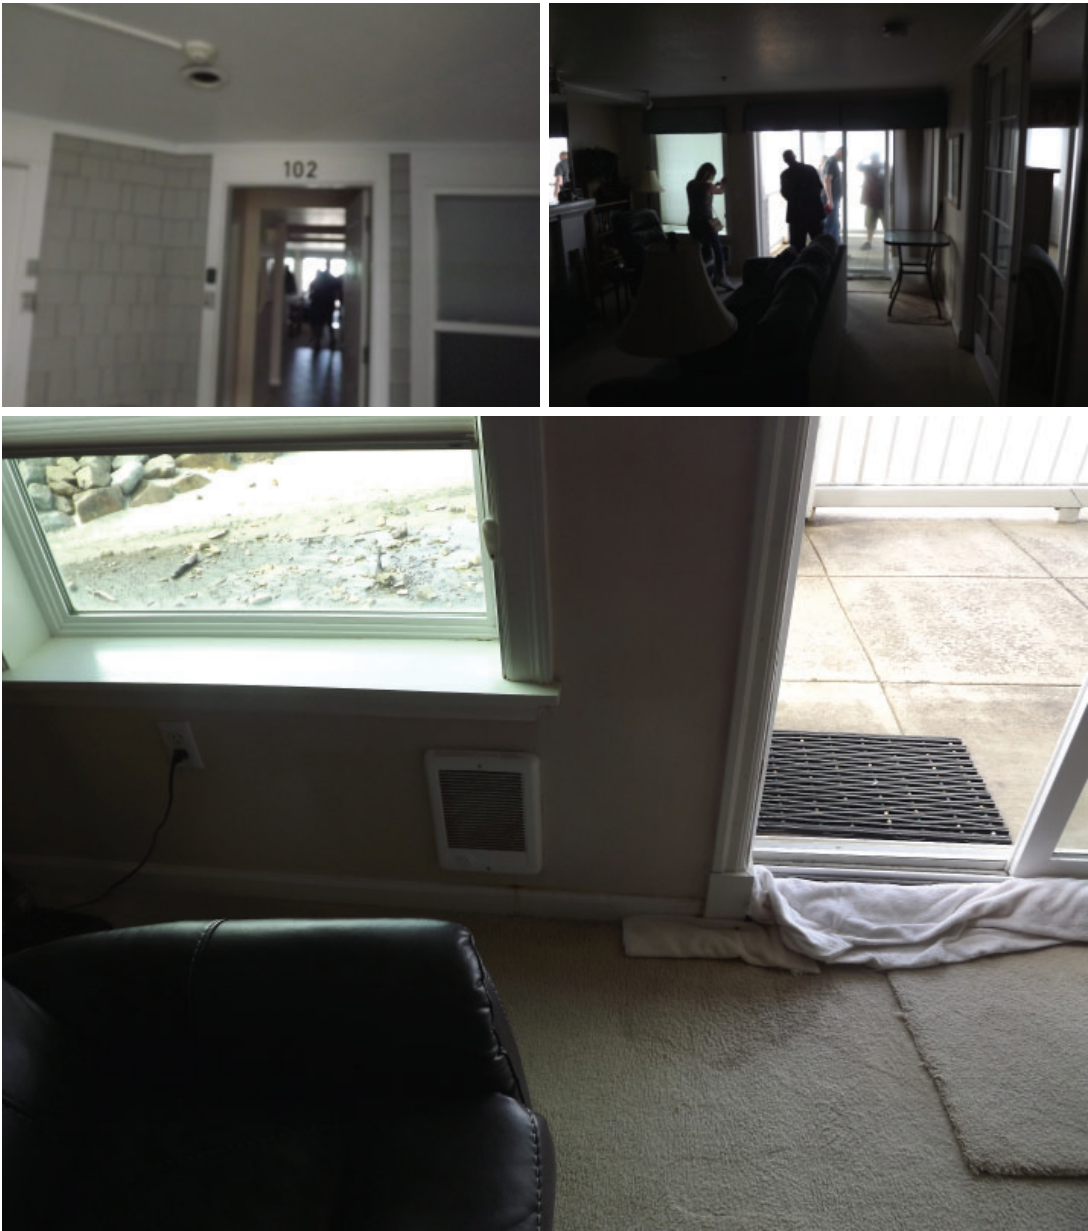
Moisture Damage.

Moisture damage was discovered at this location. Moisture damage is the precursor to dry rot.

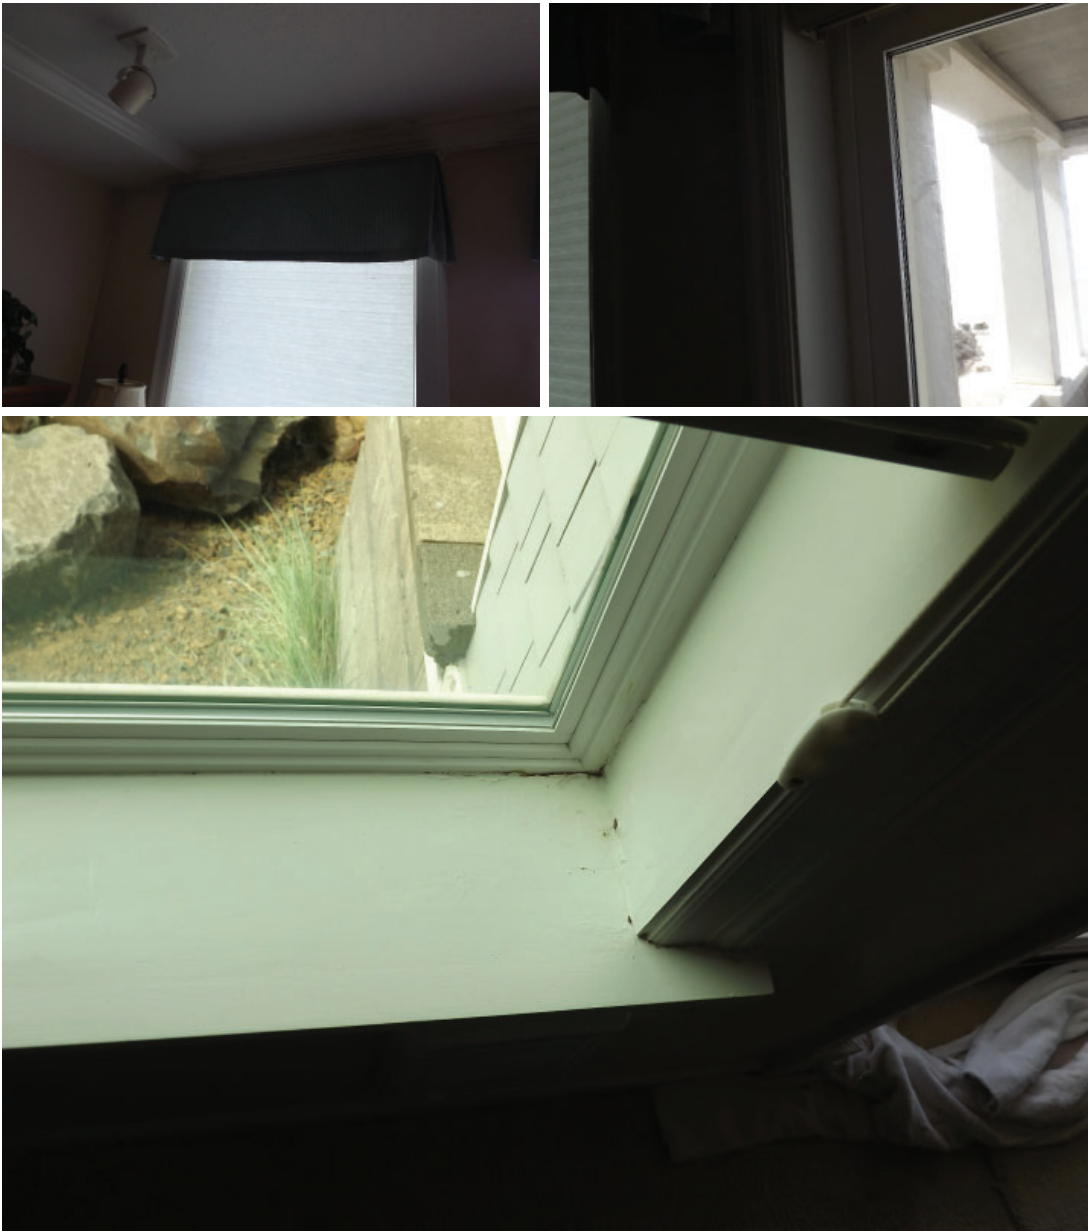
Visible Moisture Intrusion At Window Sill.

Windows may leak from many different reasons. Regardless of the reason, the windows shouldn't be leaking. At this location staining/leaking was visible to the eye.

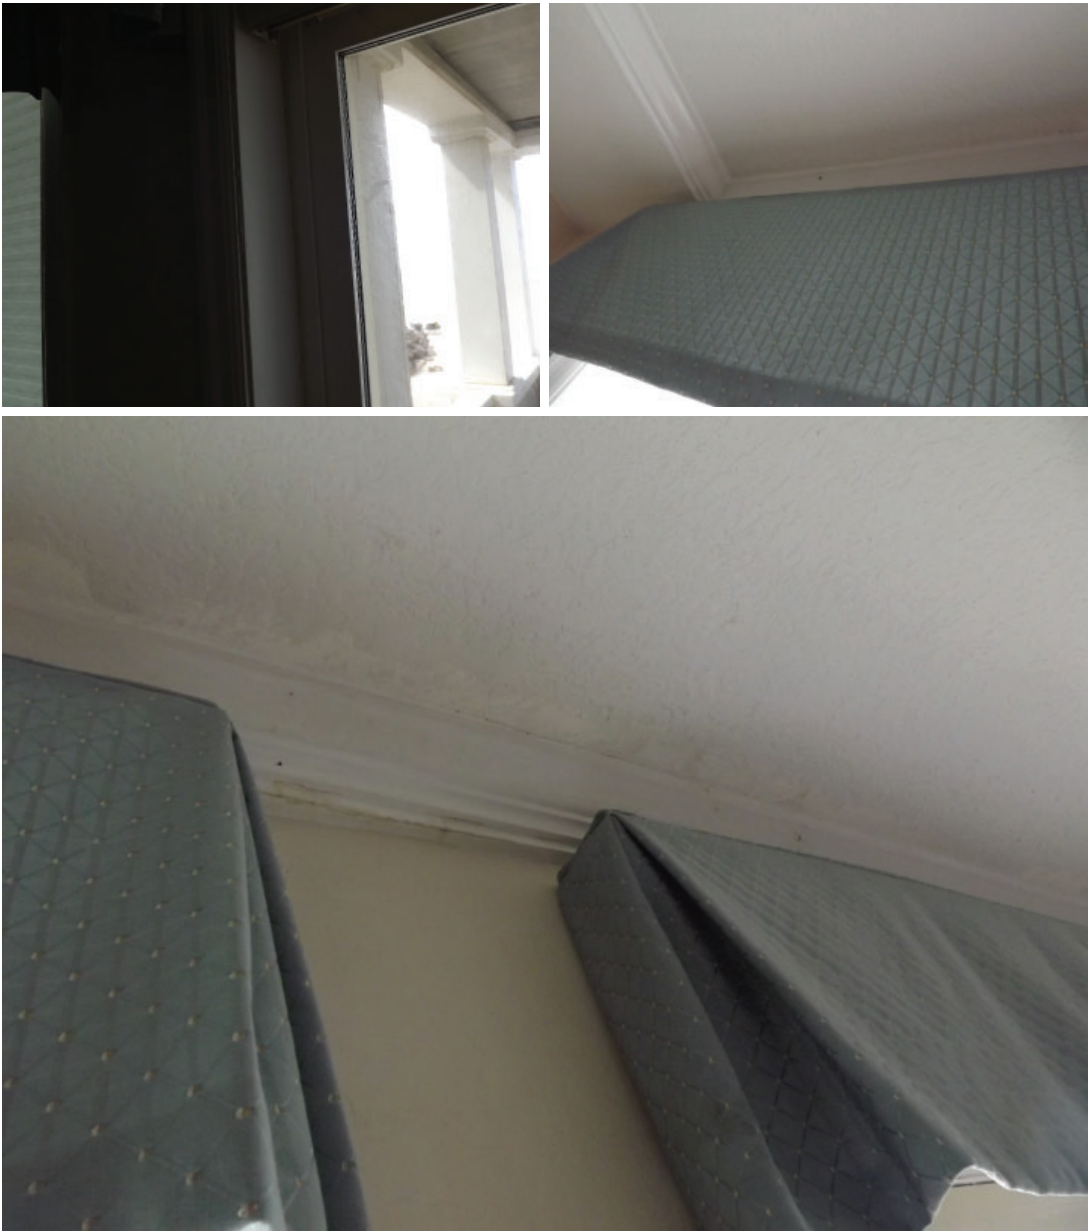
Moisture Damage.

Moisture damage was discovered at this location. Moisture damage is the precursor to dry rot.
