# PRELIMINARY BUILDING ENVELOPE EVALUATION OF SEAVIEW CONDOMINIUMS

LOCATED AT:  
115 N. MILLER STREET  
ROCKAWAY BEACH, OR 97136

August 2nd, 2022

Client # B22265 Seaview Condominiums

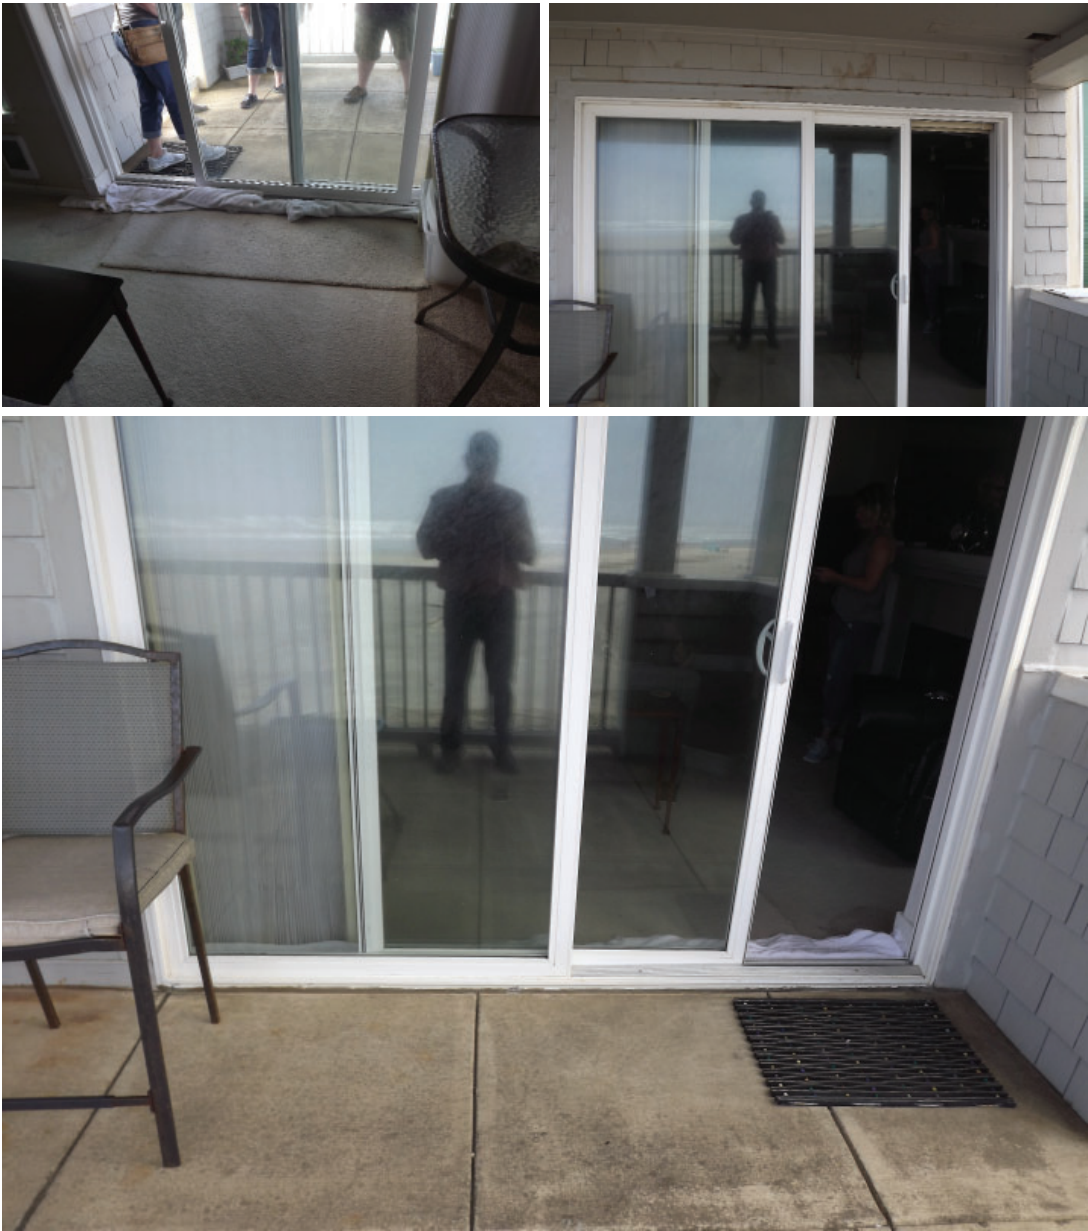
Sealed Drainage Path.

The intersection between the soffit and the vertical wall below has been sealed, thereby preventing moisture drainage from behind the vertical wall and trapping moisture at the intersection.

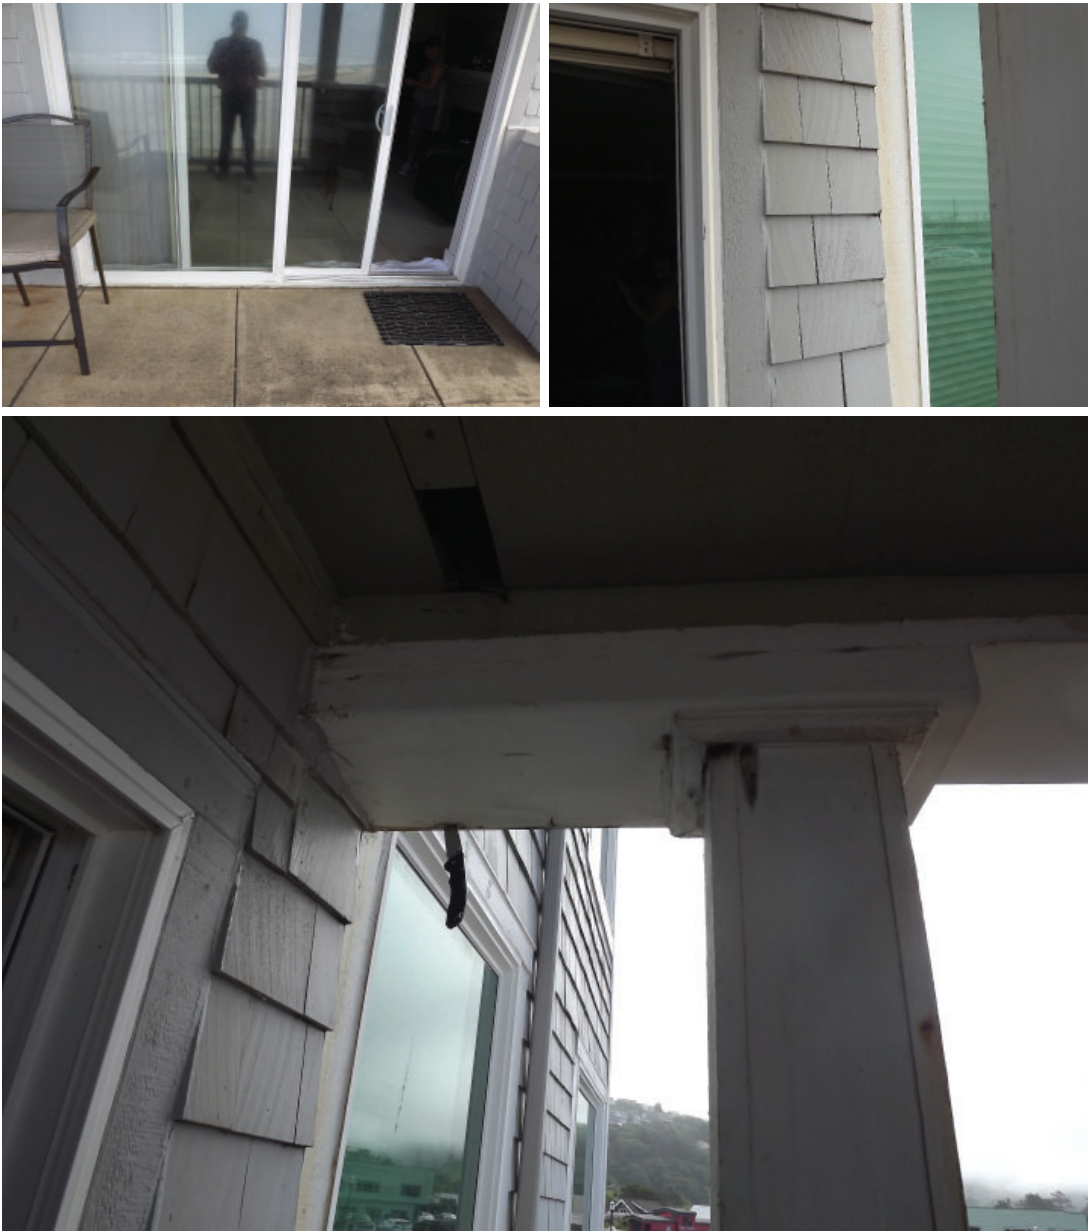
Dry Rot.

Dry rot is the decay of wood products. One main purpose of exterior envelope waterproofing is to deter dry rot because it causes substantial damage to the building and structural members. Dry rot is present at this location.

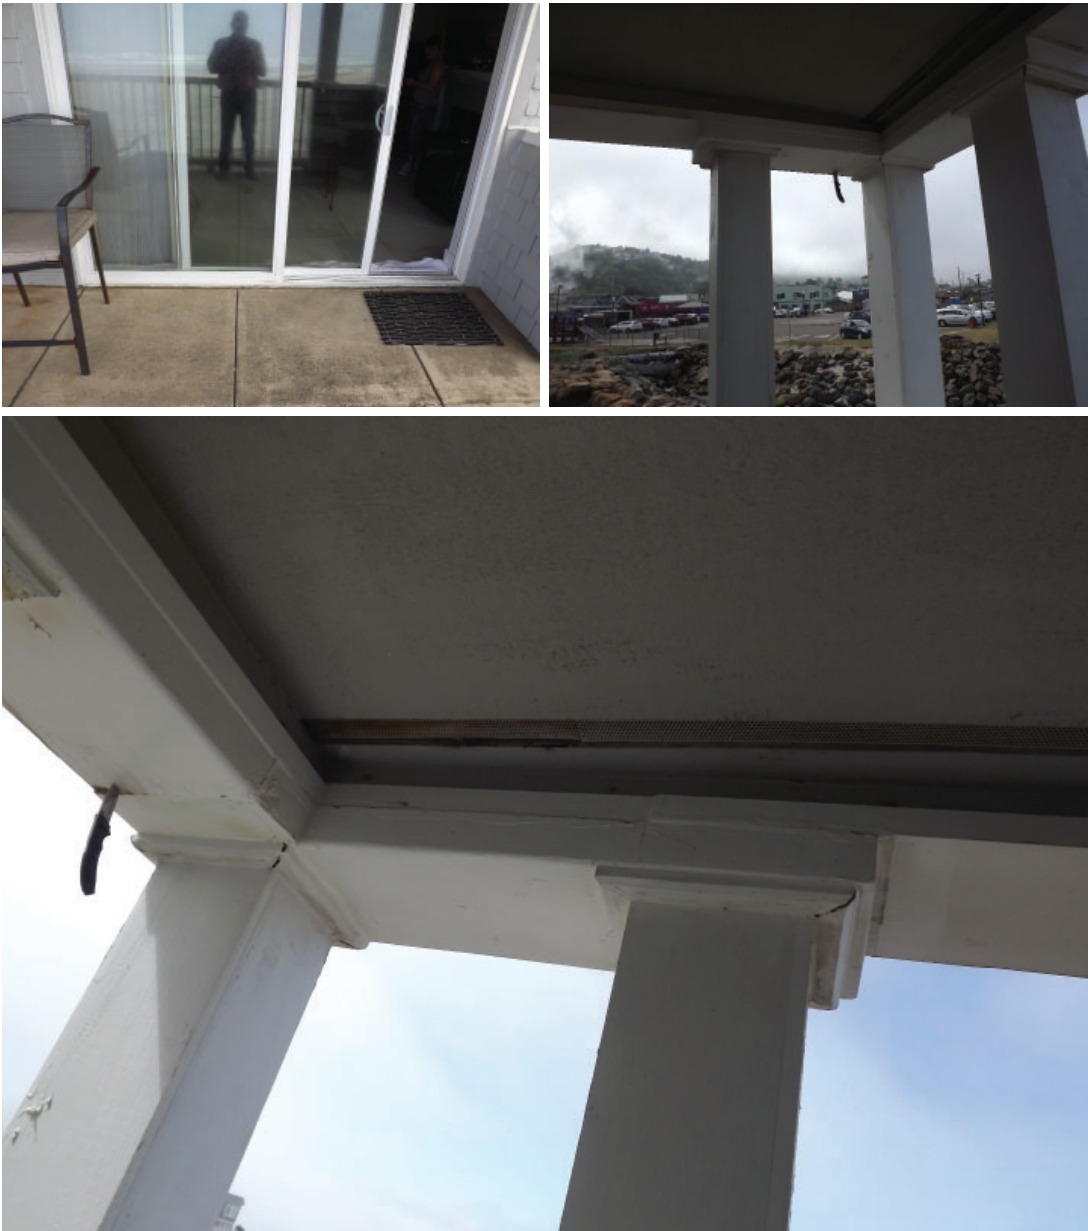
Dry Rot.

Dry rot is the decay of wood products. One main purpose of exterior envelope waterproofing is to deter dry rot because it causes substantial damage to the building and structural members. Dry rot is present at this location.

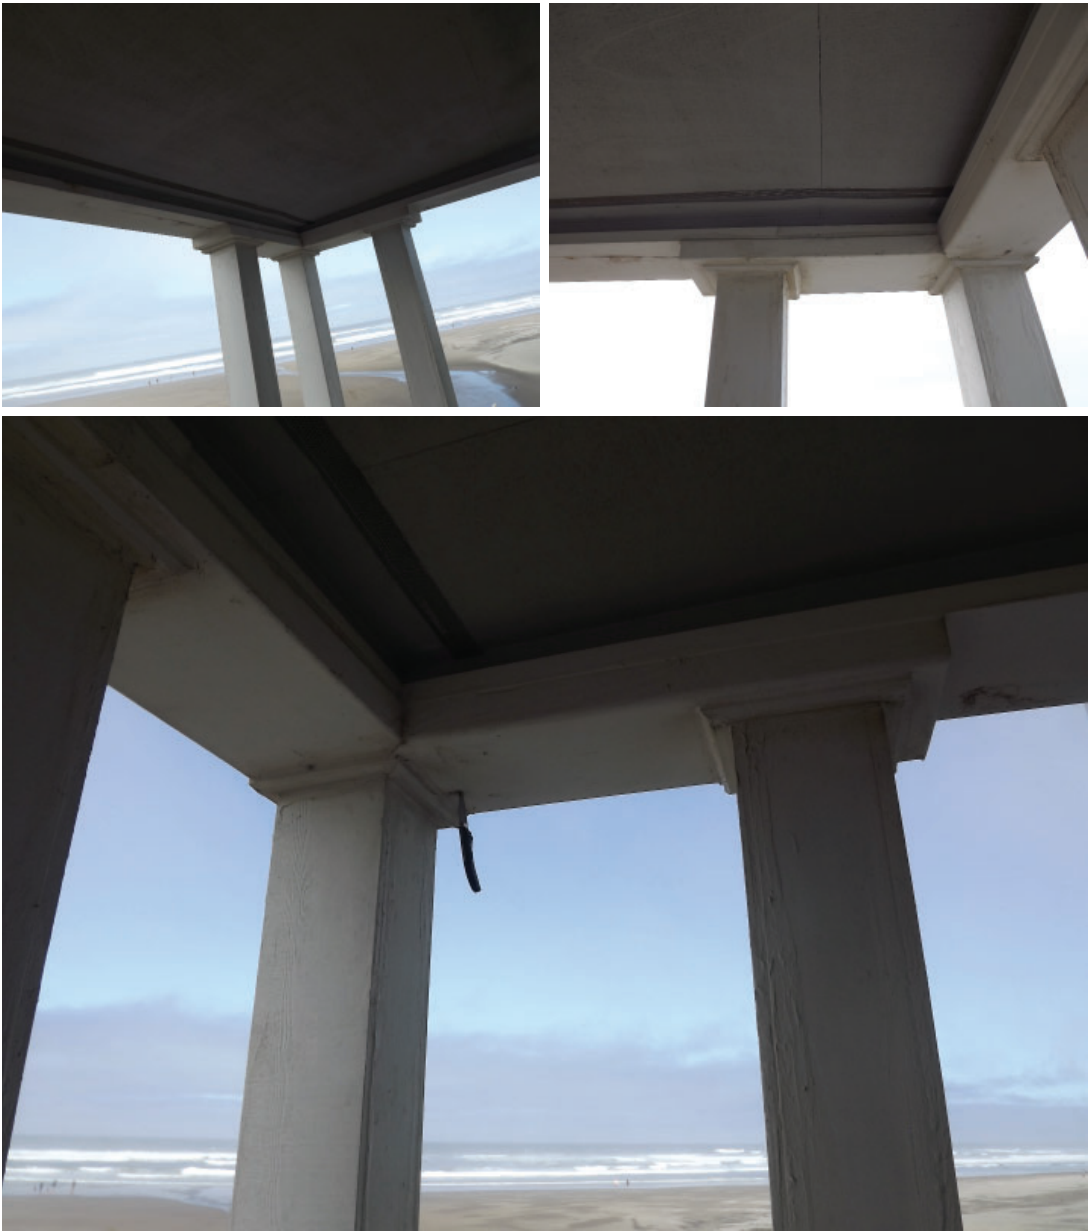
Dry Rot.

Dry rot is the decay of wood products. One main purpose of exterior envelope waterproofing is to deter dry rot because it causes substantial damage to the building and structural members. Dry rot is present at this location.

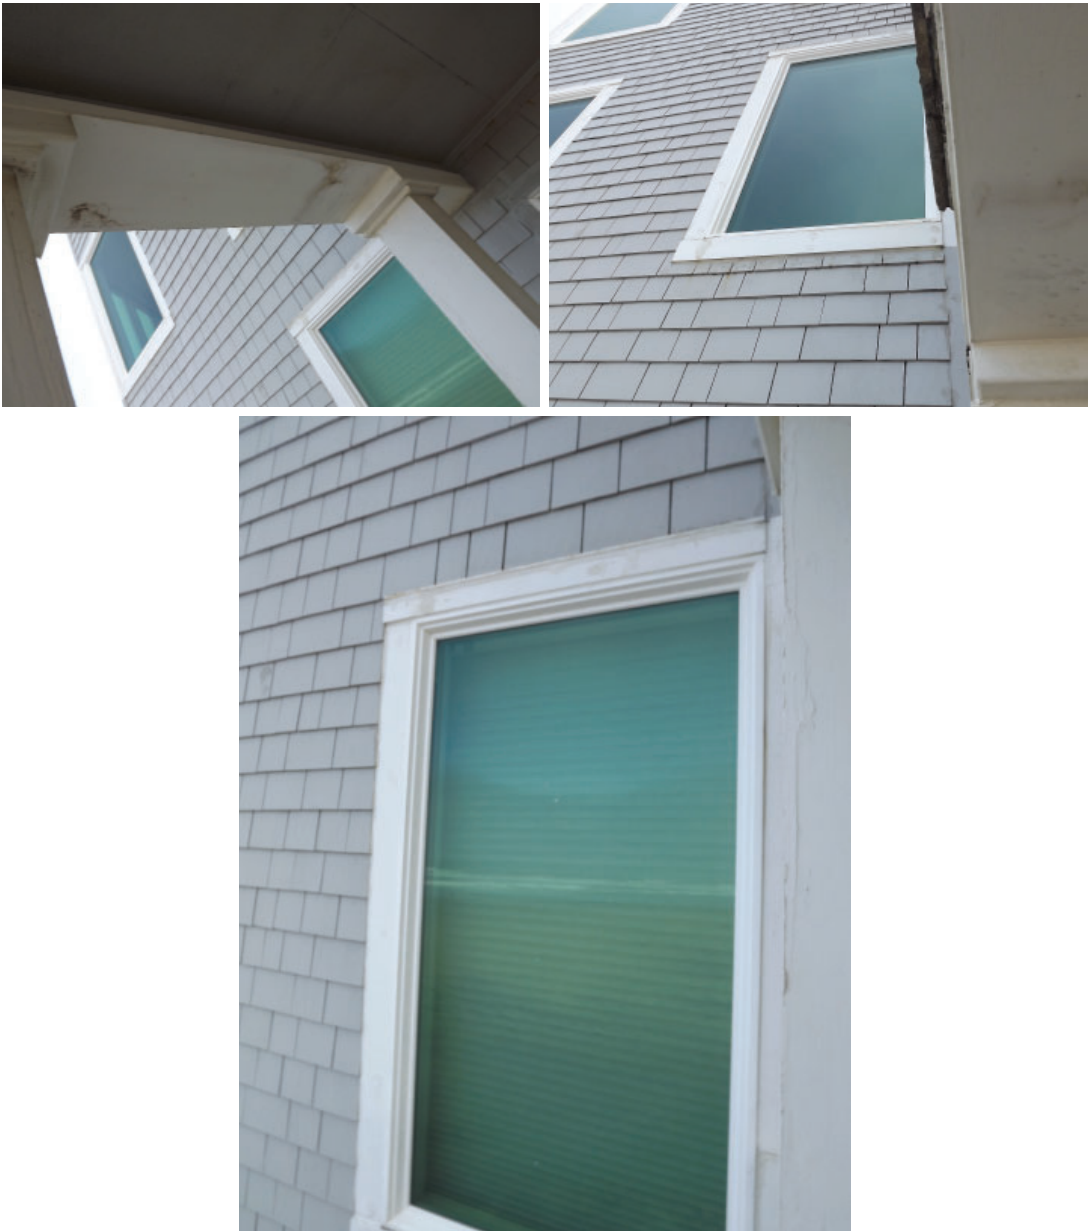
Trim Missing Weather Cut Joints.

The application of trim requires weather cut to allow for moisture to drain outside of the structure. This is typical in the industry but has not occurred here or in other locations on the structure.

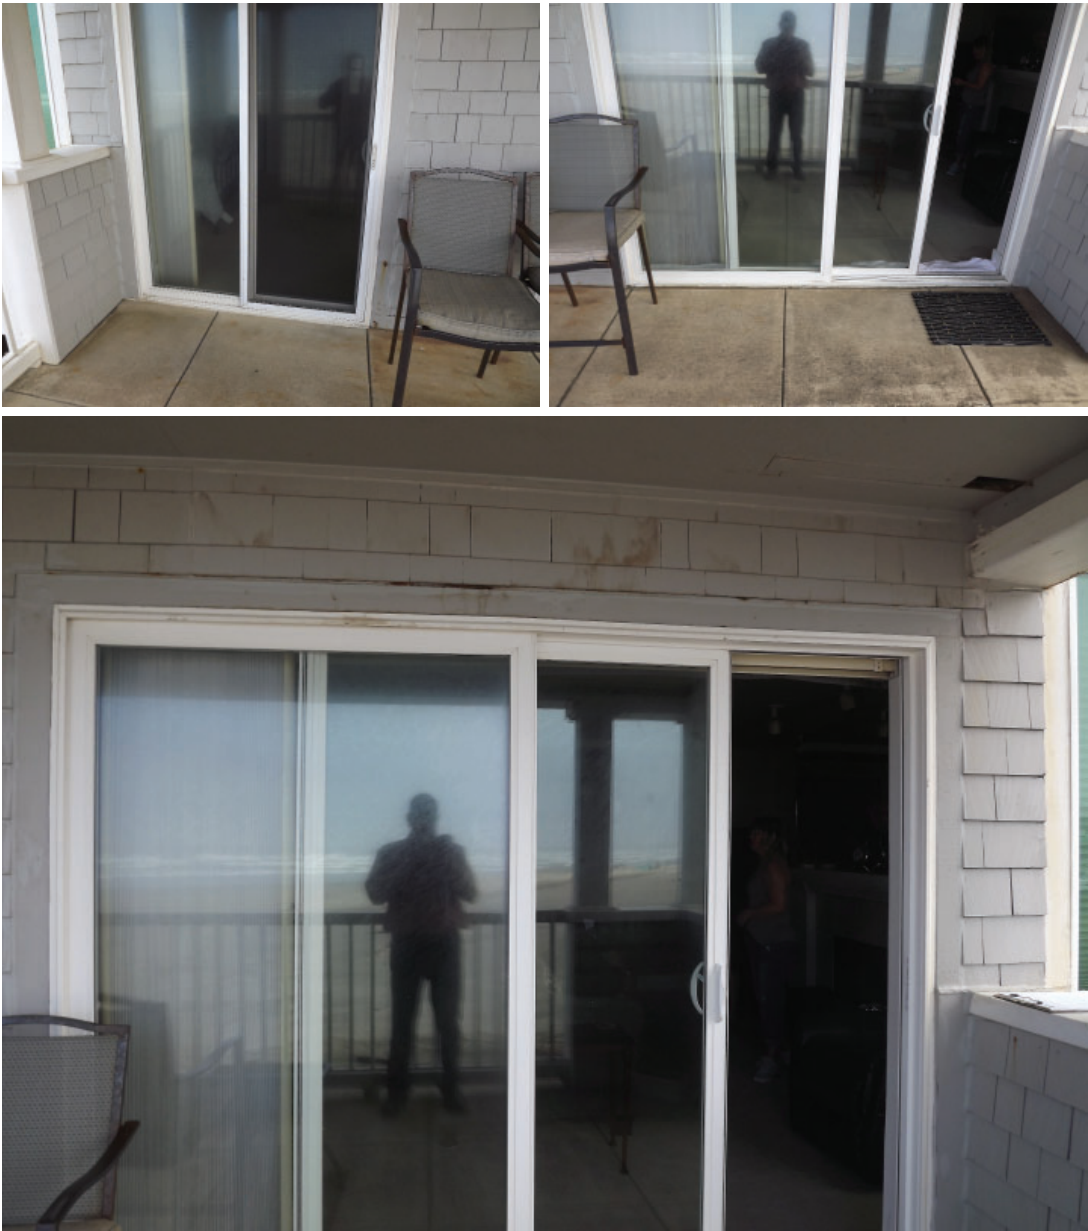
Missing End Dam.

All horizontally protruding surfaces require flashings to prevent moisture accumulation and intrusion. To work effectively, the flashings must be installed correctly. Correct installation includes sealing the flashing sides (though not the length) to the component or bending the flashing to fit into the component. This type of installation, called an end dam, creates a channel to prevent moisture from entering below the flashing. End dams were missing at this location.

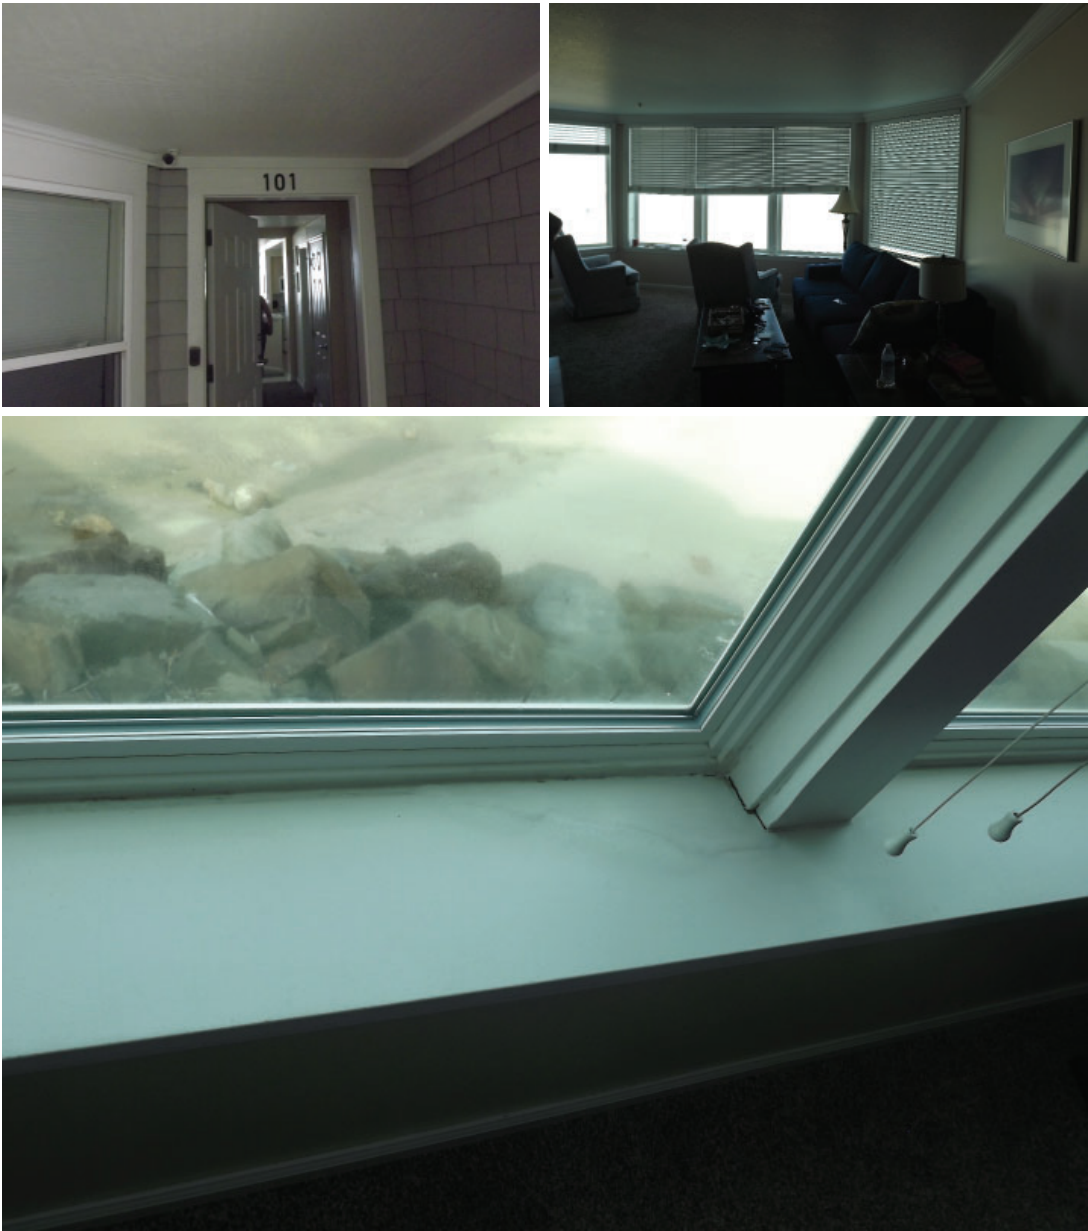
Visible Moisture Intrusion At Window Sill.

Windows may leak from many different reasons. Regardless of the reason, the windows shouldn't be leaking. At this location staining/leaking was visible to the eye.

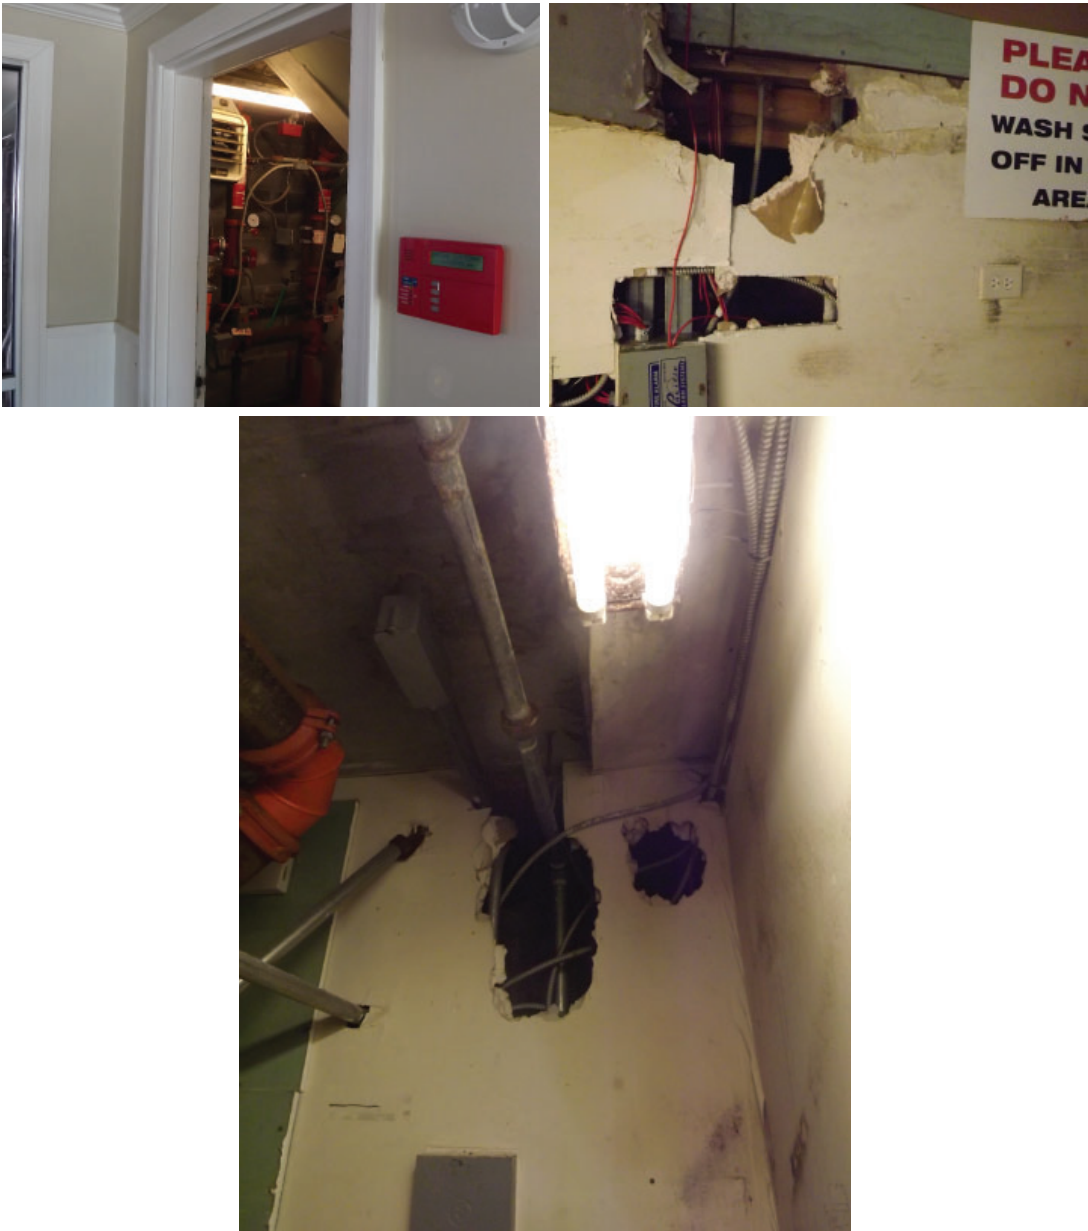
Drywall Is Missing At This Location.

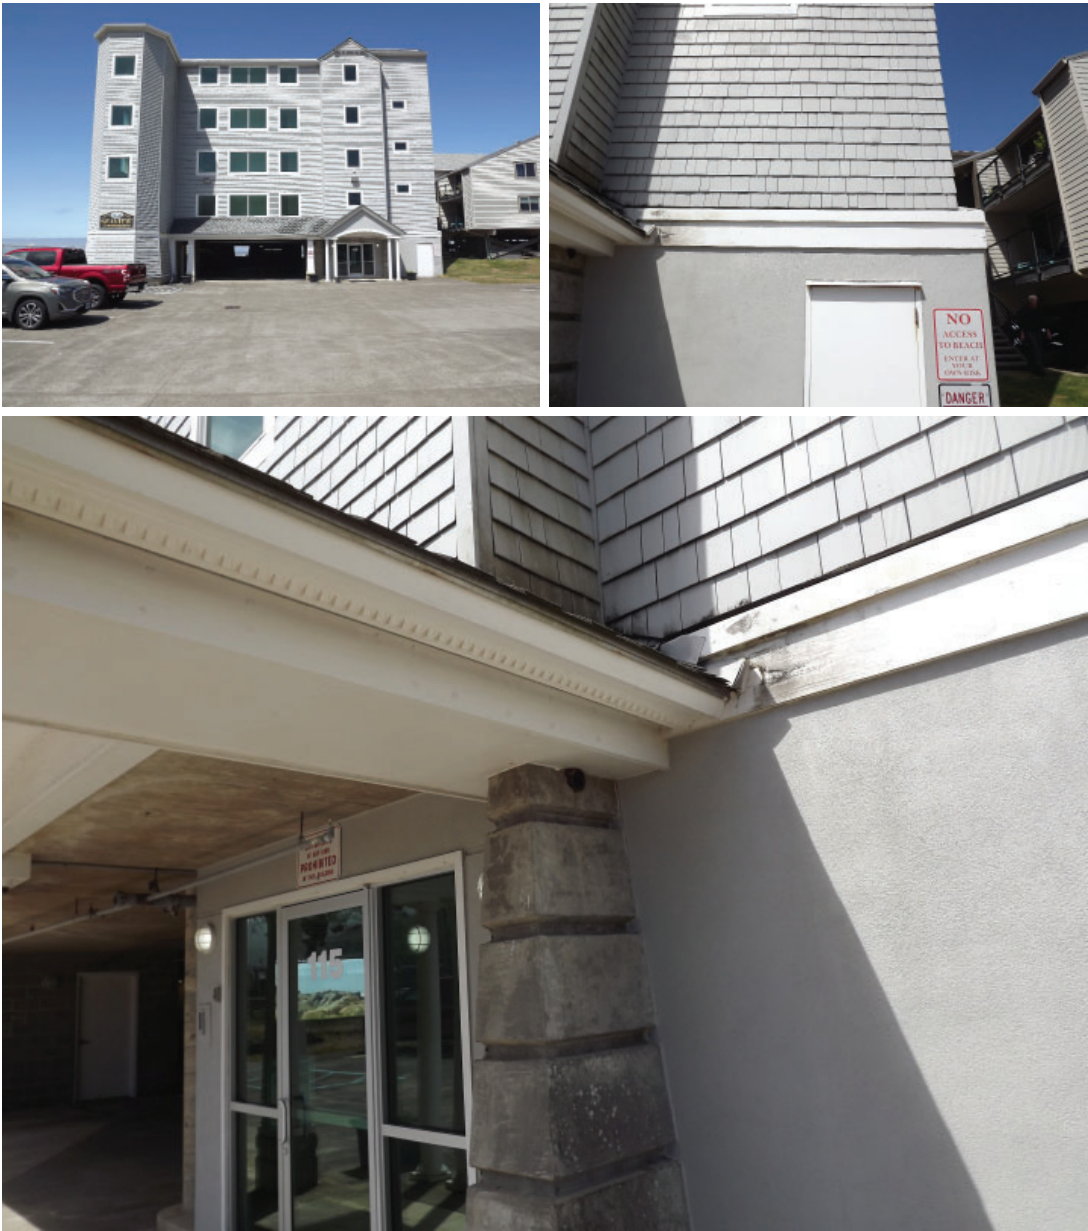
The single lap flashings require application in a specific manner, as they are one of the most threatened structure locations for moisture entry. This application requires a minimum of 4 inches of lapping, which has not occurred here.

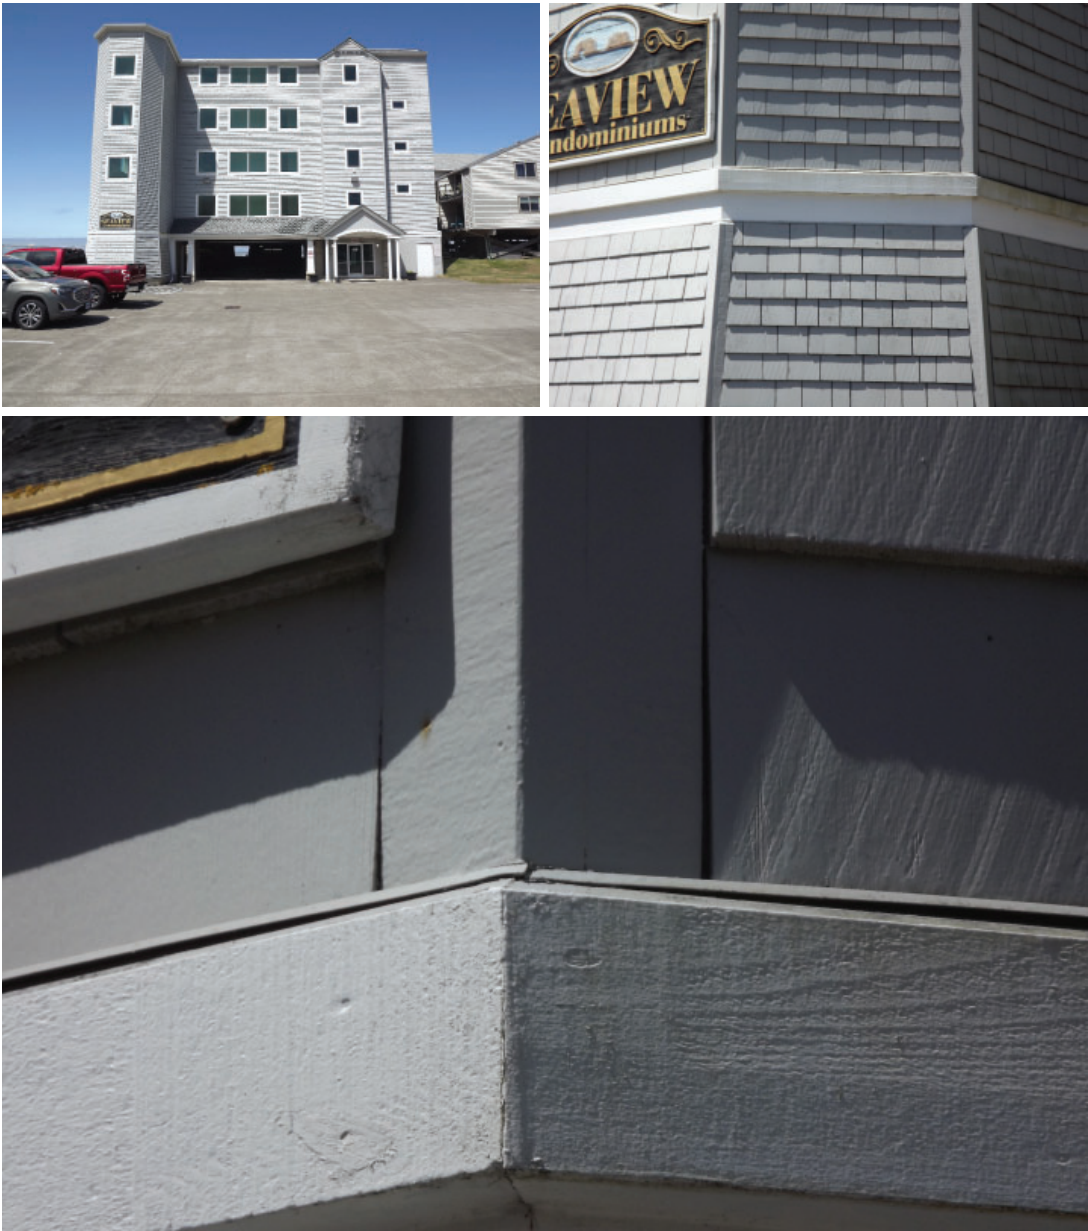
The single lap flashings require application in a specific manner, as they are one of the most threatened structure locations for moisture entry. This application requires a minimum of 4 inches of lapping, which has not occurred here.

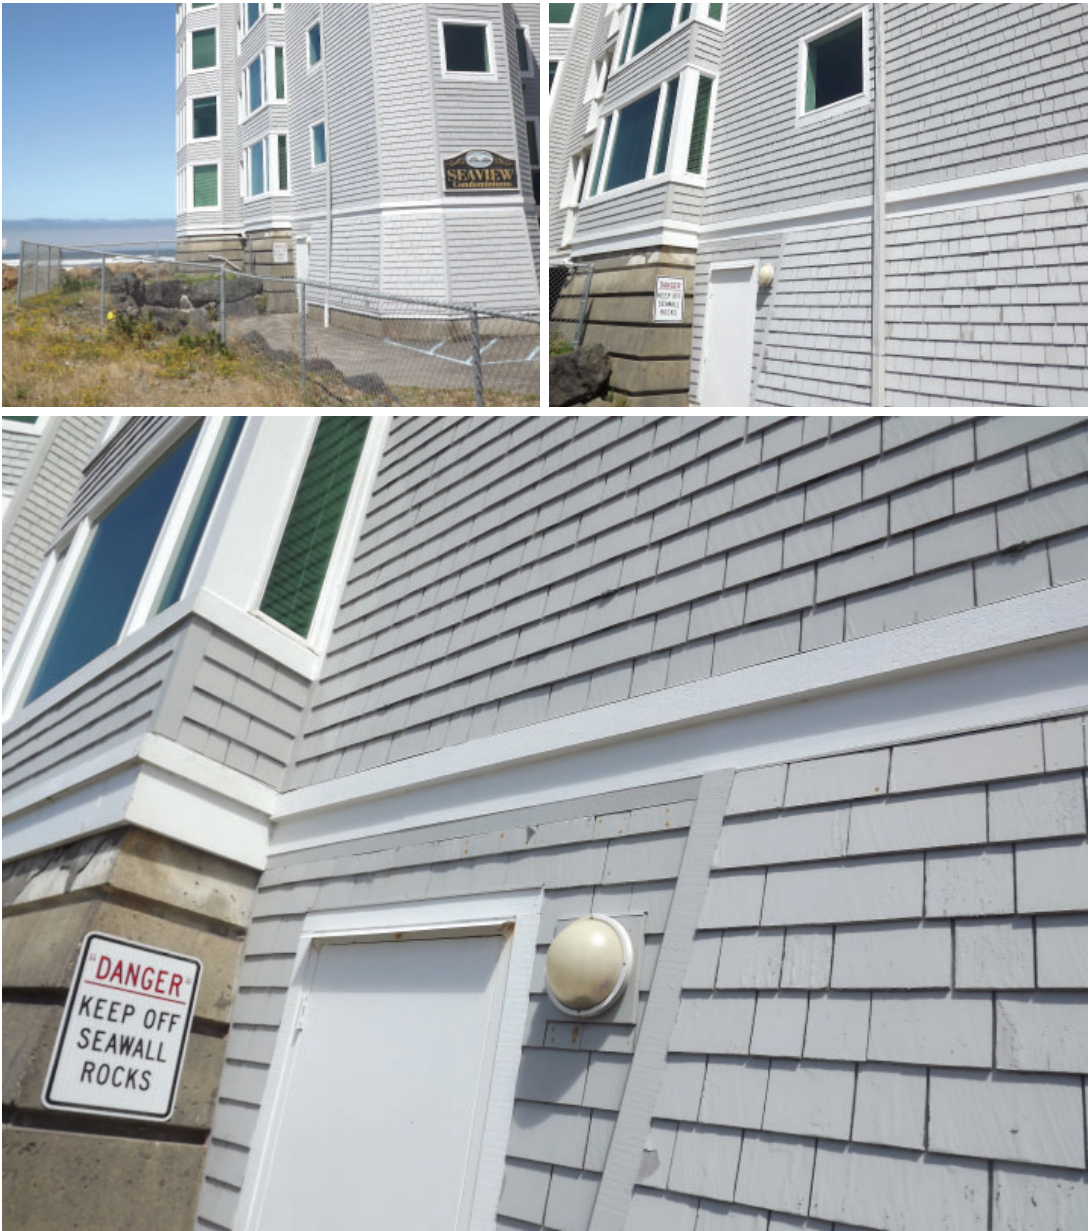
Missing End Dam Flashing At Door And Light.

All horizontally protruding surfaces require flashings to prevent moisture accumulation and intrusion. To work effectively, the flashings must be installed correctly. Correct installation includes sealing the flashing sides (though not the length) to the component or bending the flashing to fit into the component. This type of installation, called an end dam, creates a channel to prevent moisture from entering below the flashing. End dams were missing at this location.

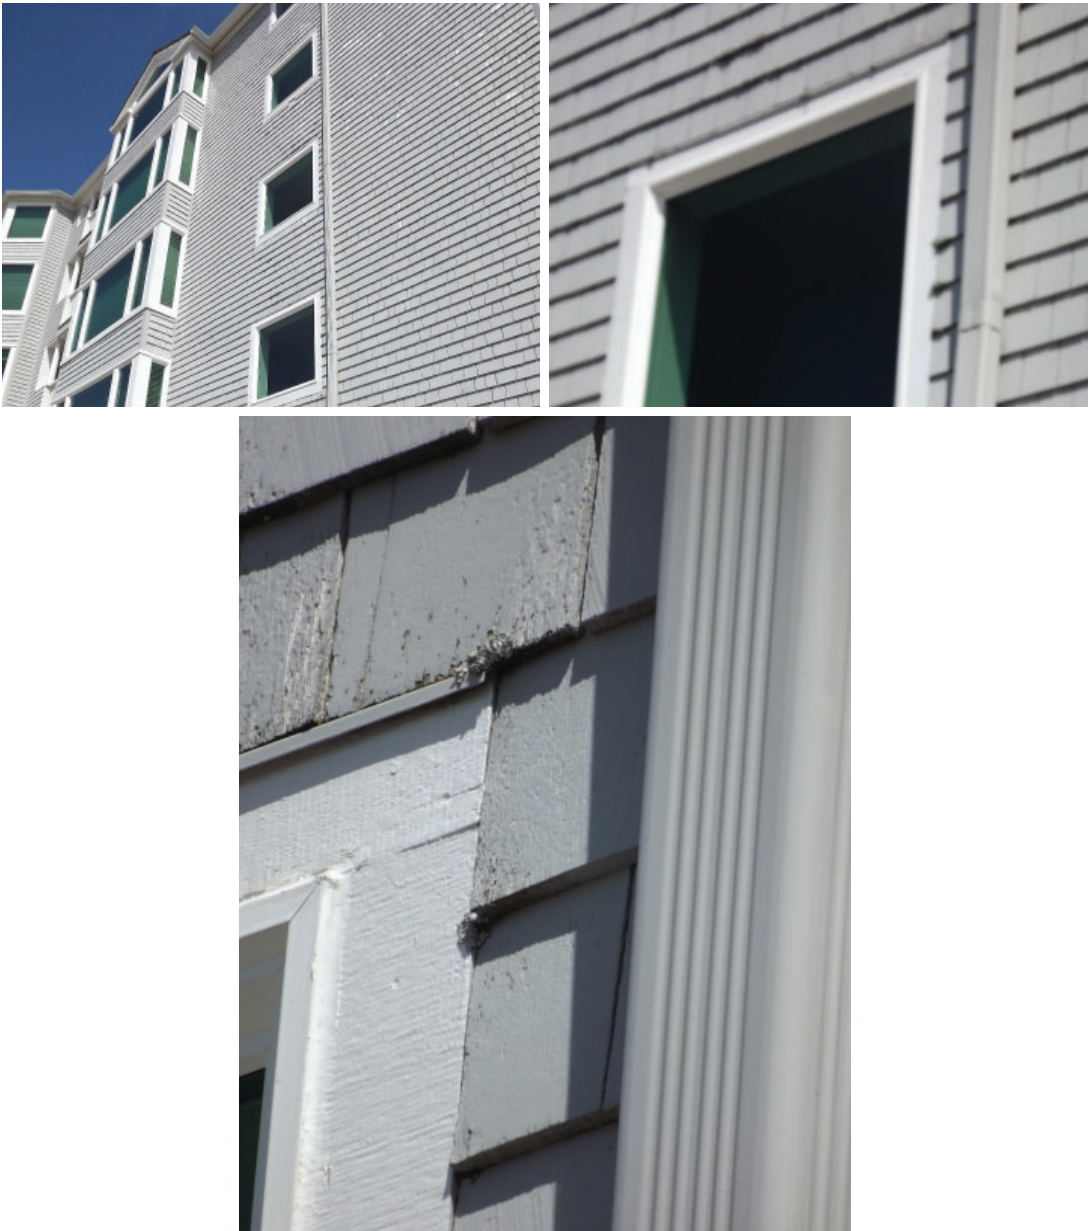
Missing End Dam.

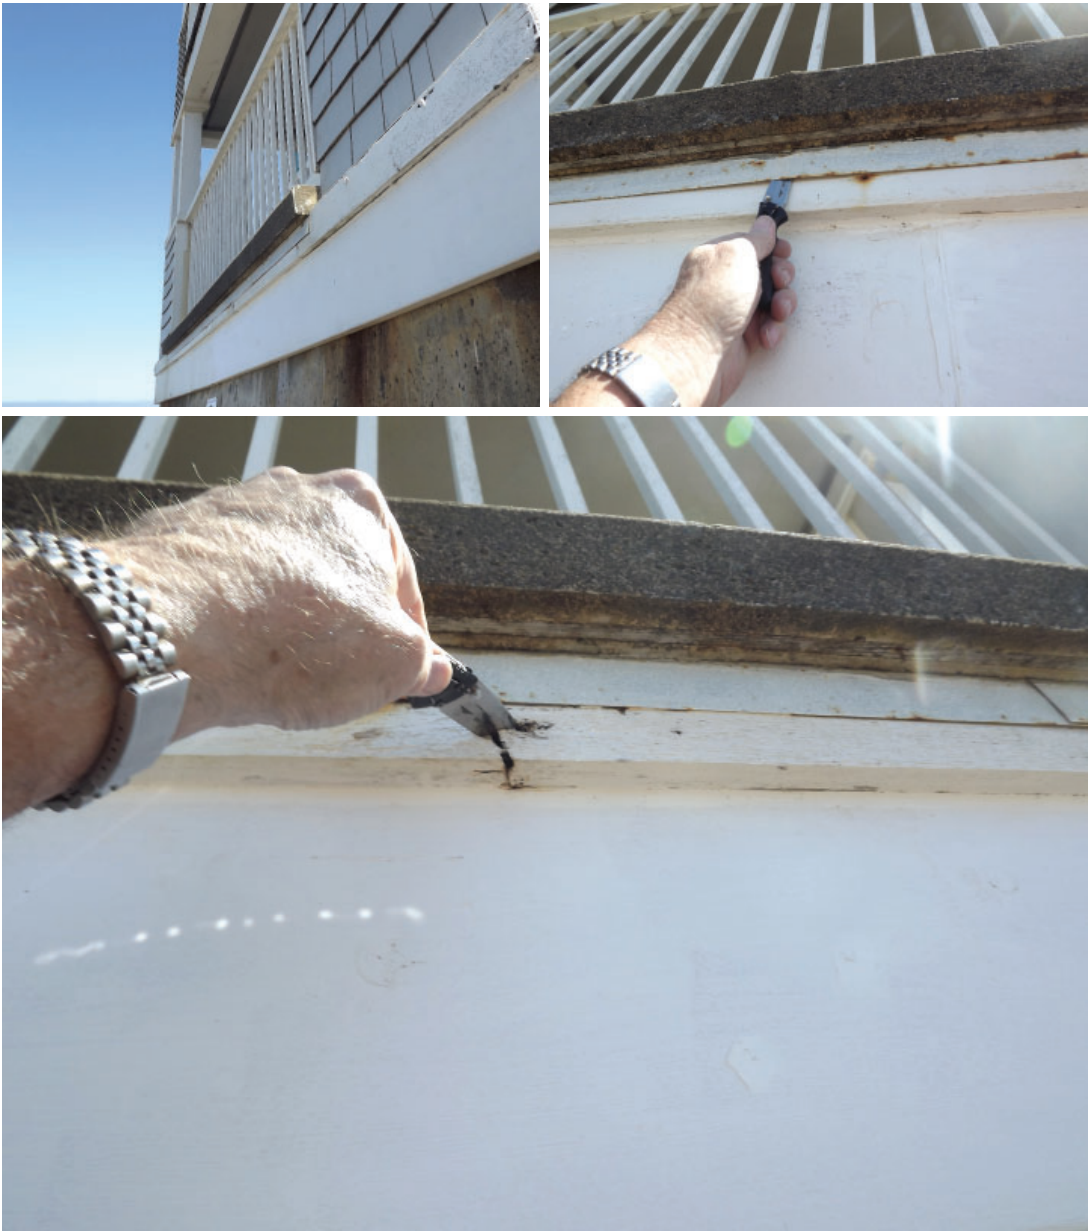
Dry Rot.

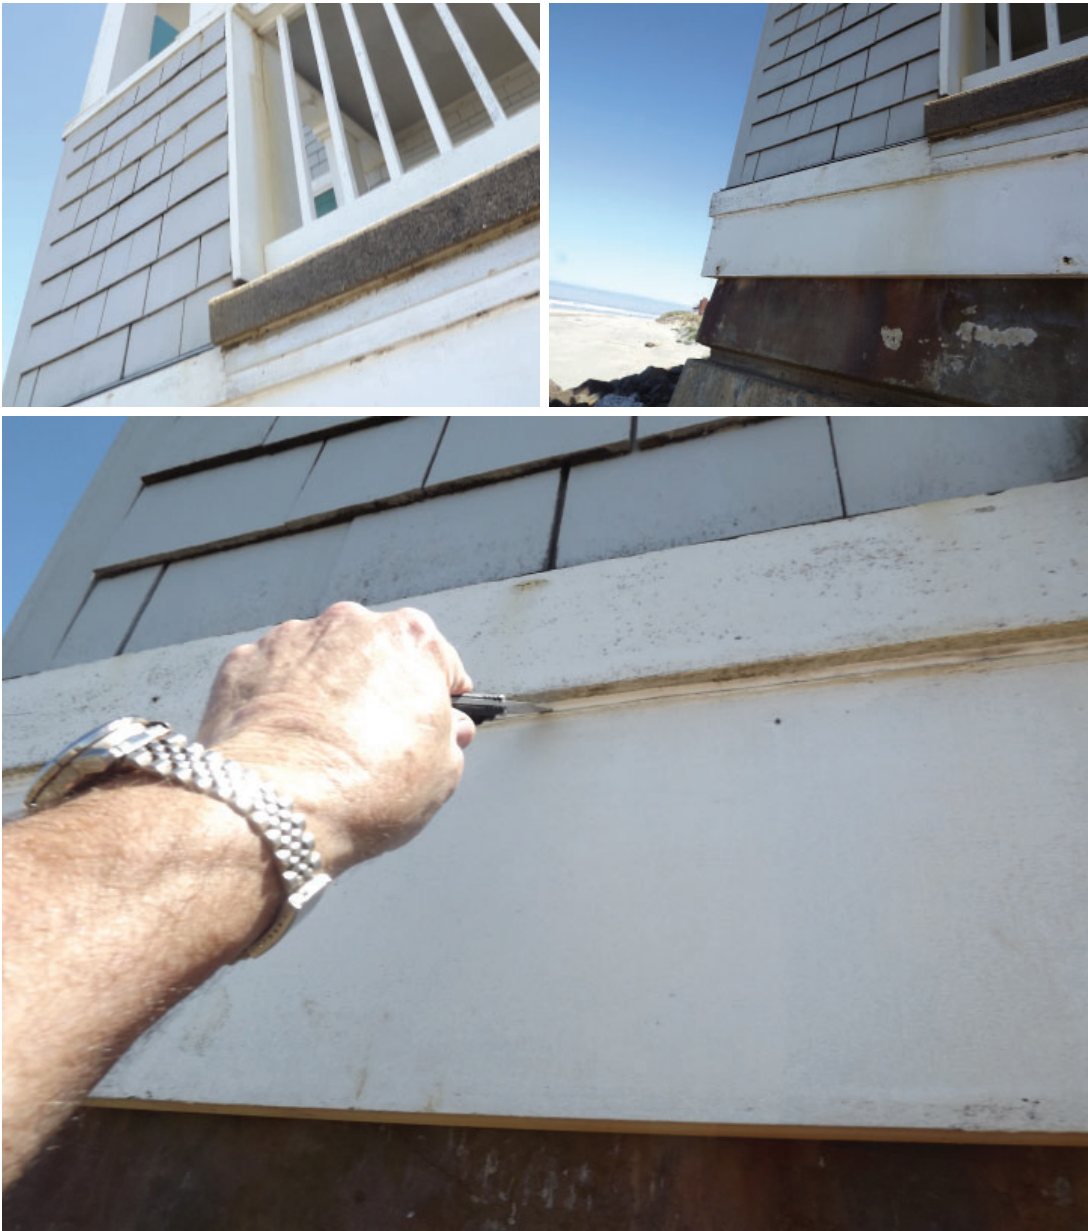
Missing Flashing.

Flashing is a critical aspect of exterior waterproofing; it directs moisture into appropriate drainage planes. However, flashing was missing from this location.

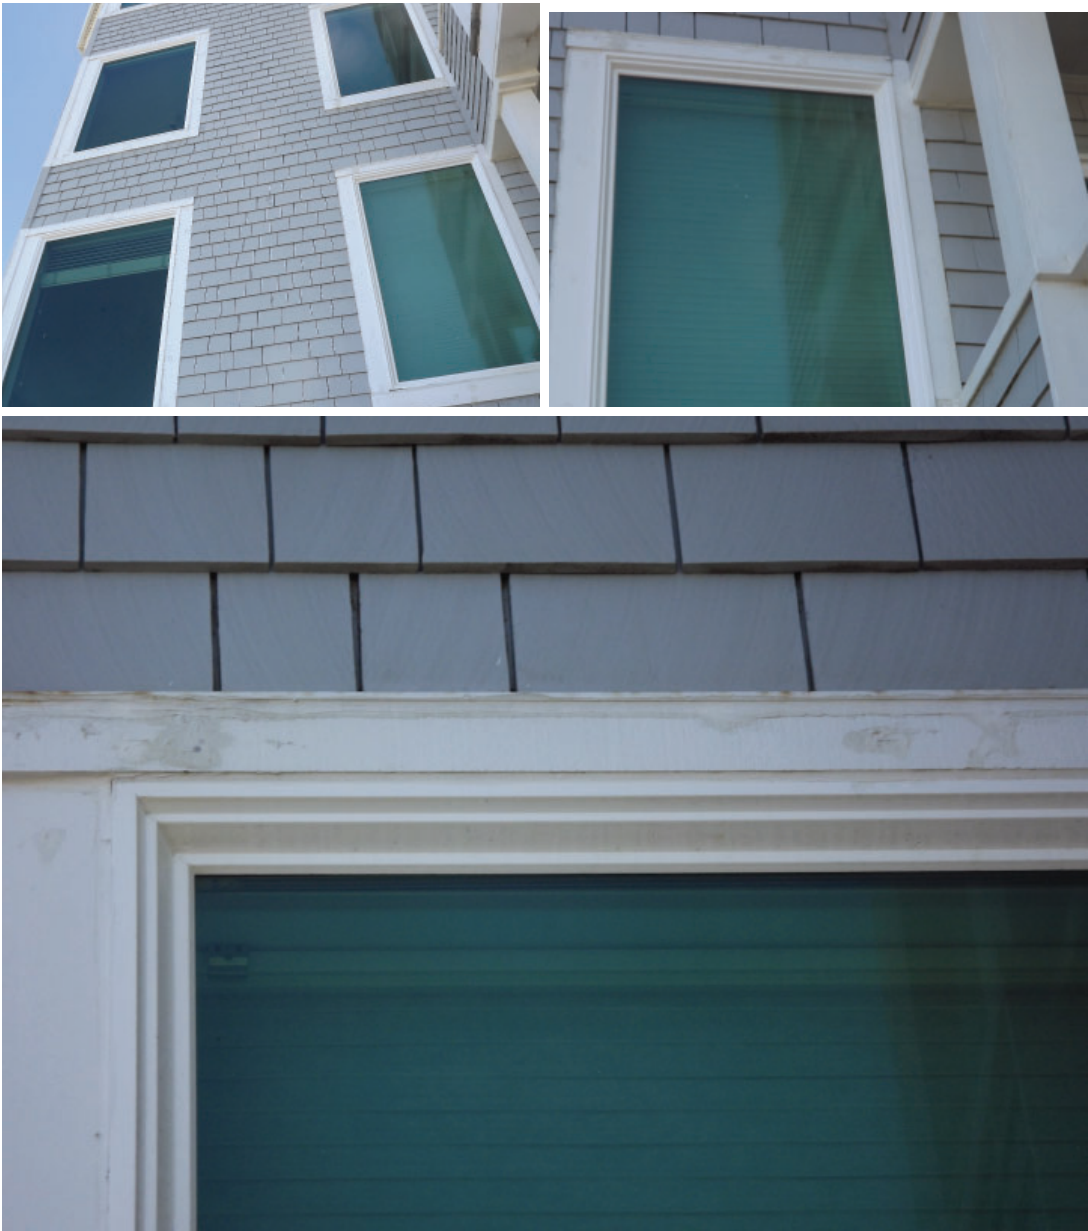
Sealed Flashing.

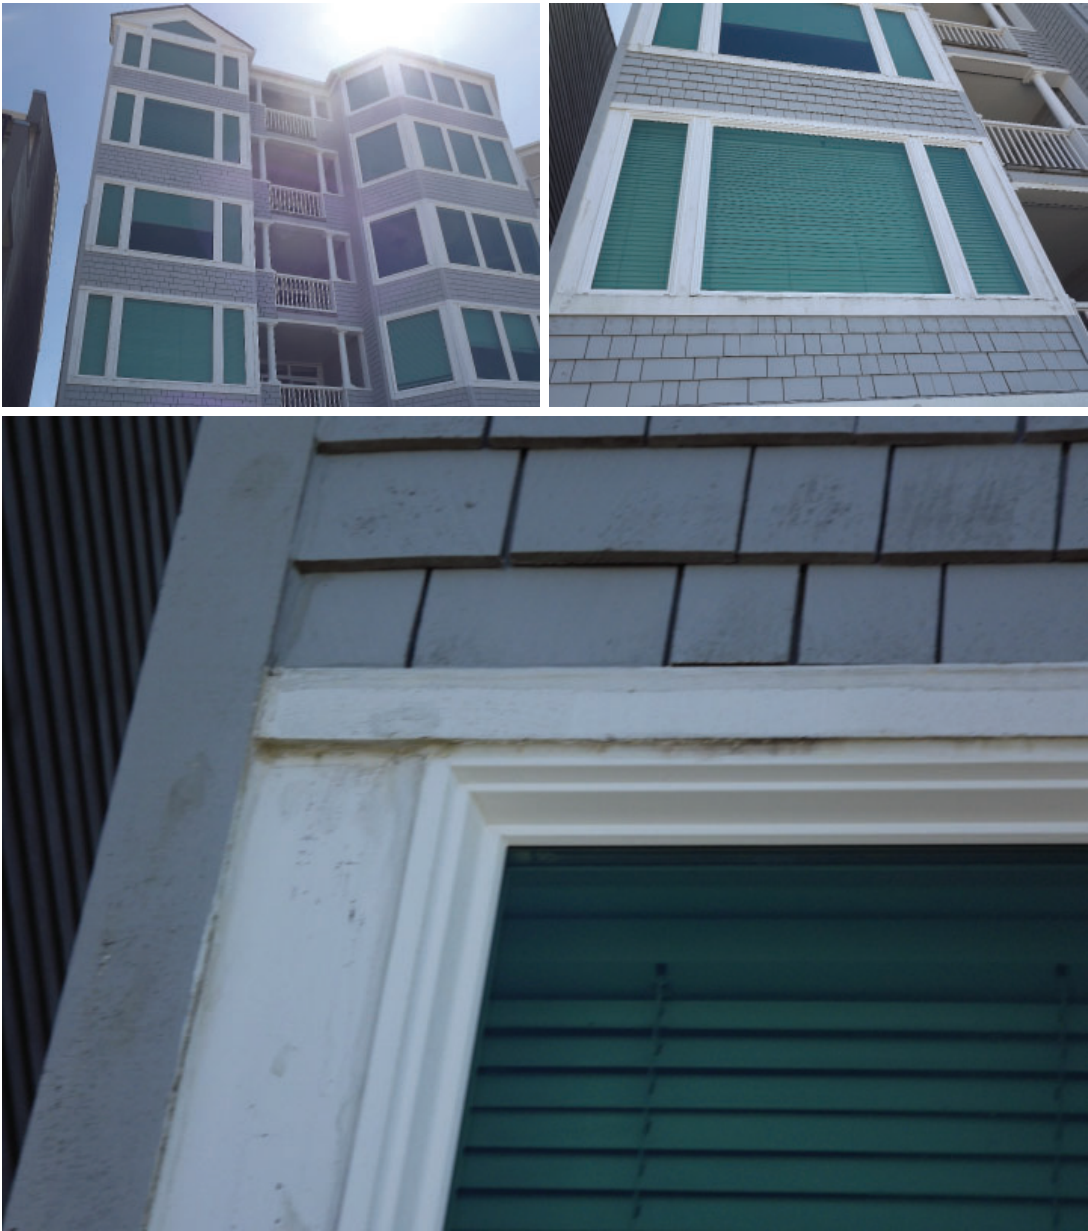
Missing End Dam At West Elevation.
