# PRELIMINARY BUILDING ENVELOPE EVALUATION OF SEAVIEW CONDOMINIUMS

LOCATED AT:  
115 N. MILLER STREET  
ROCKAWAY BEACH, OR 97136

August 2nd, 2022

Client # B22265 Seaview Condominiums

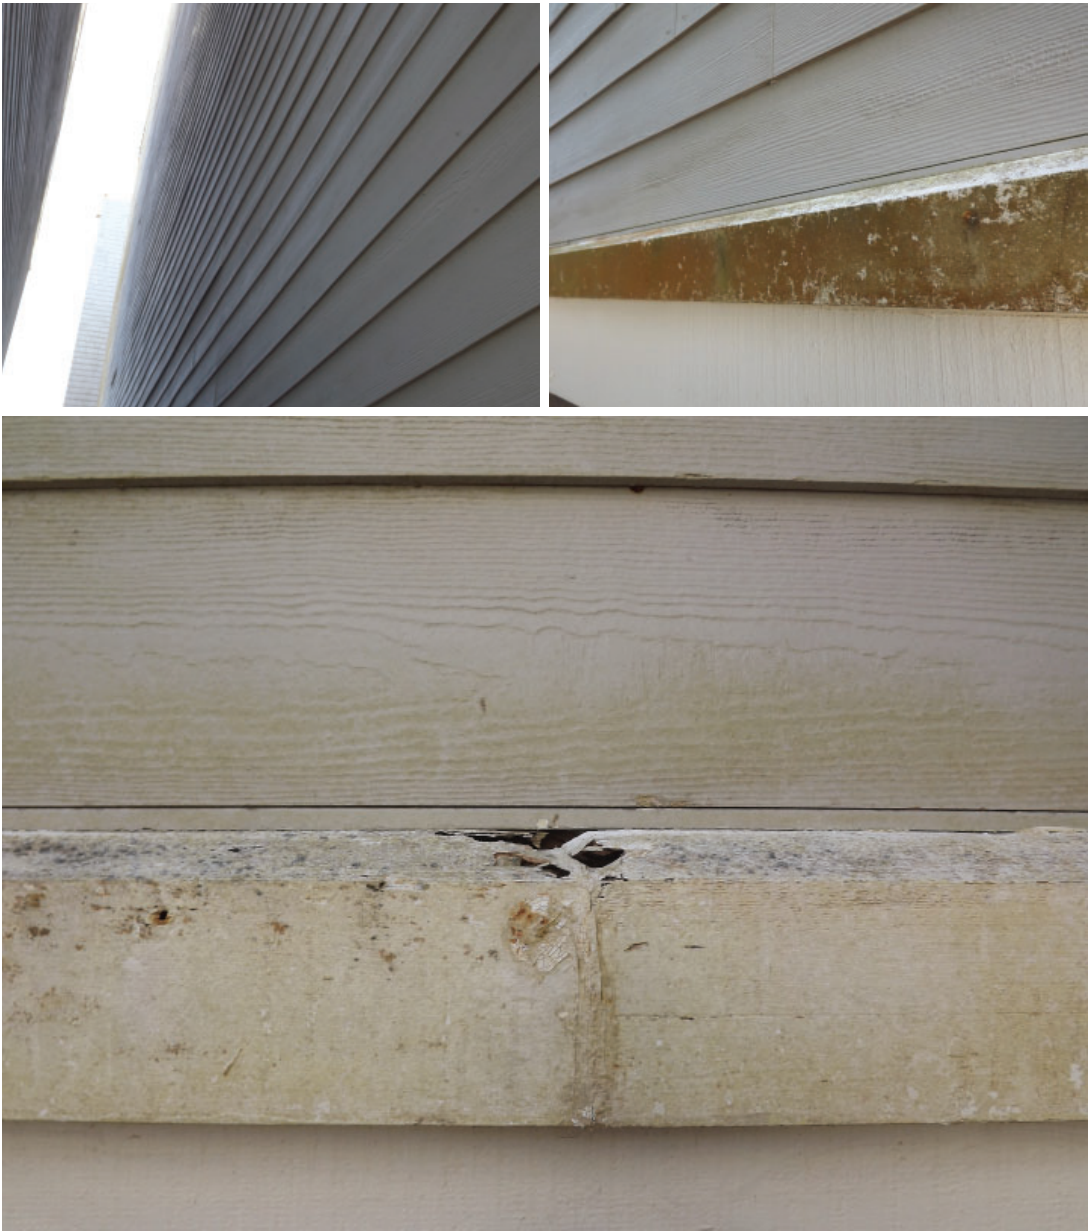
Flash Over Trim - Dry Rot.

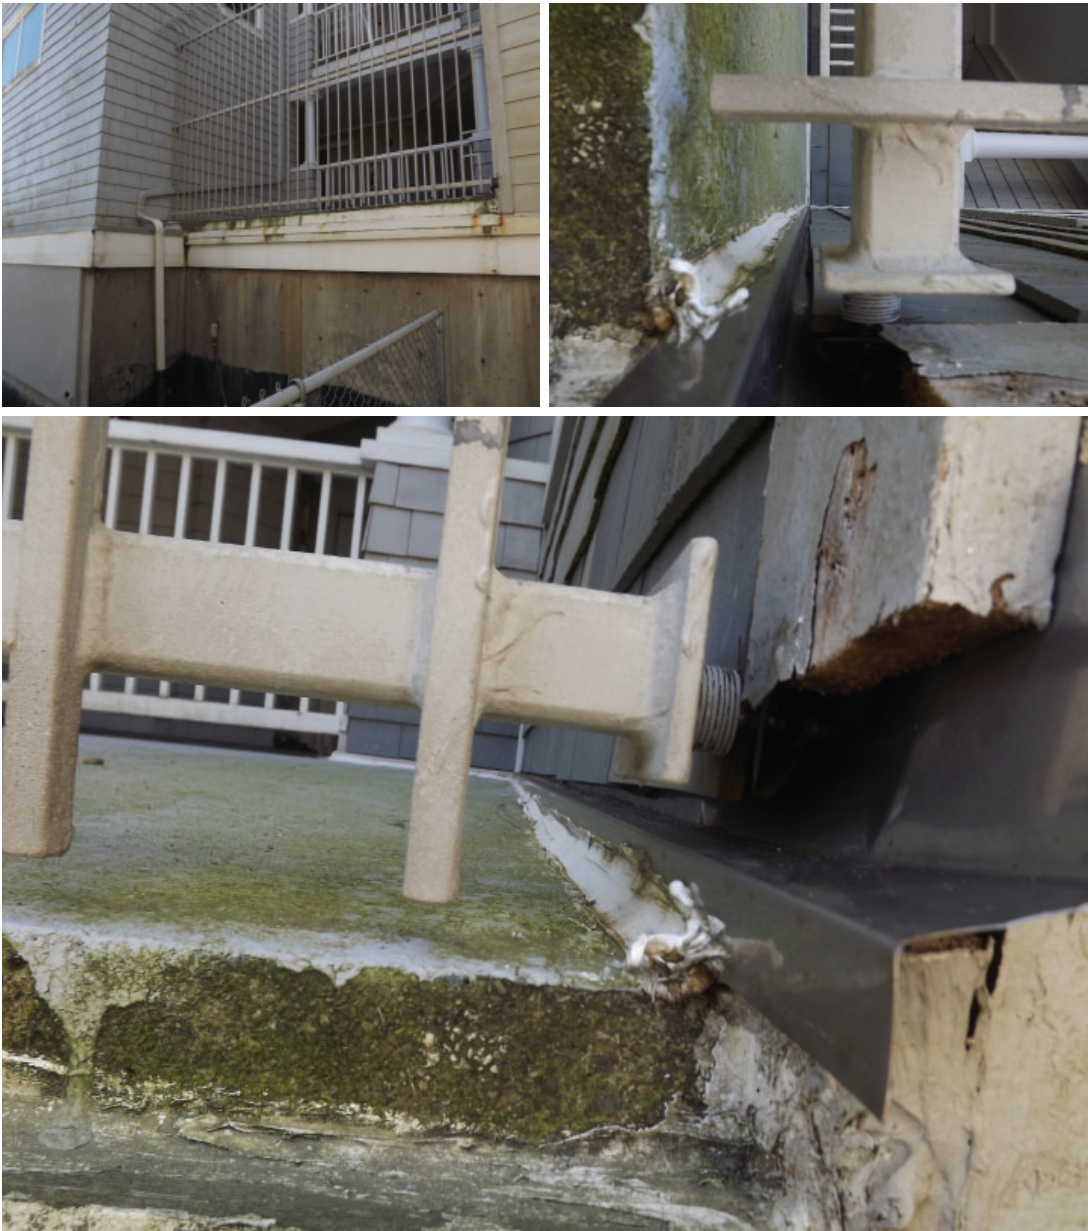
## Incorrect Flashing At Concrete - No Kerf Cut To Set Flashing.

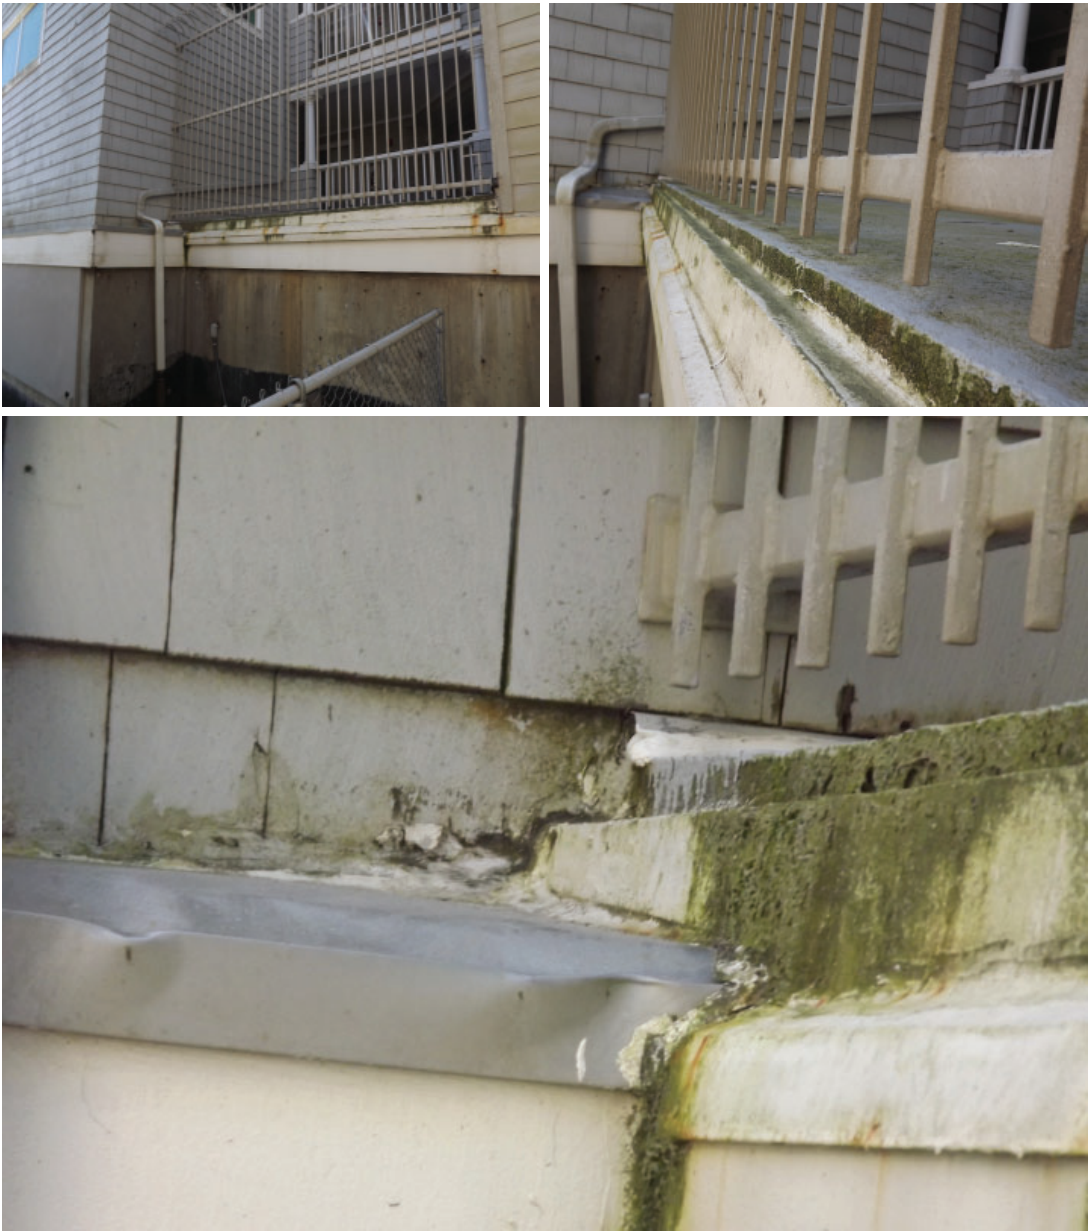
Incorrect Flashing Type.
