# PRELIMINARY BUILDING ENVELOPE EVALUATION OF SEAVIEW CONDOMINIUMS

LOCATED AT:  
115 N. MILLER STREET  
ROCKAWAY BEACH, OR 97136

August 2nd, 2022

Client # B22265 Seaview Condominiums

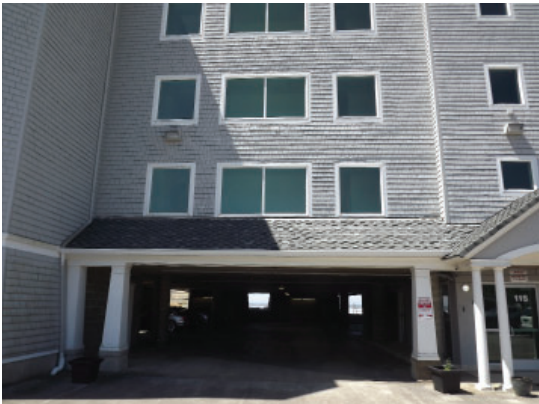
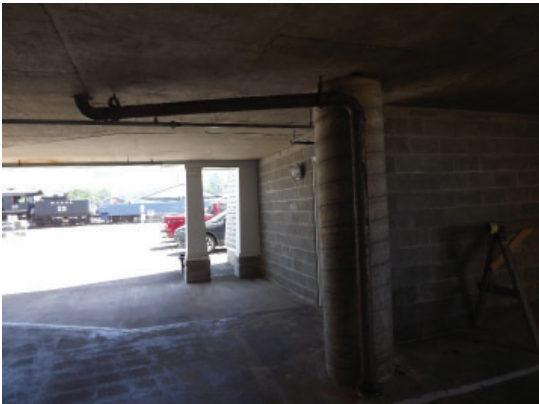
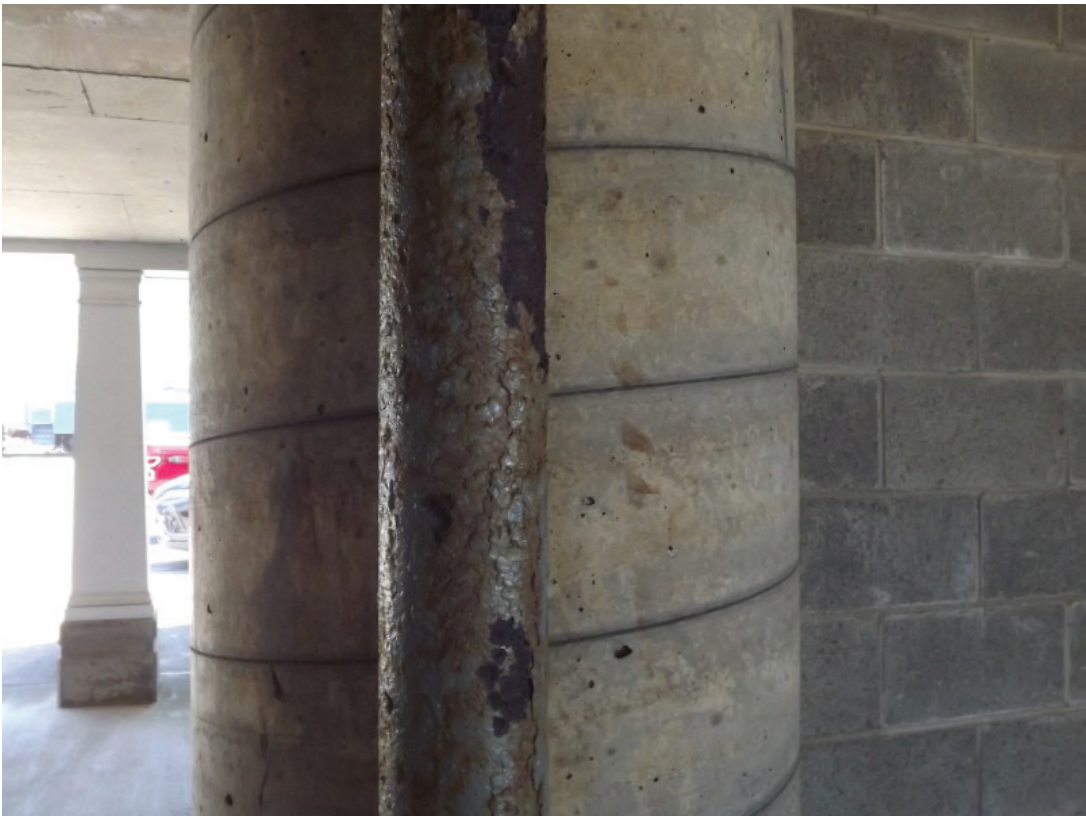
Corrosion.

Significant corrosion on DWV cast iron lines.

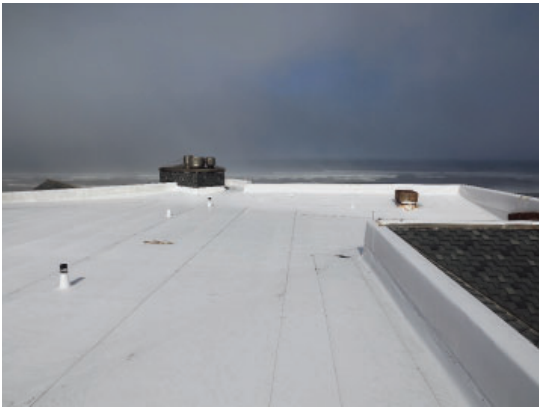
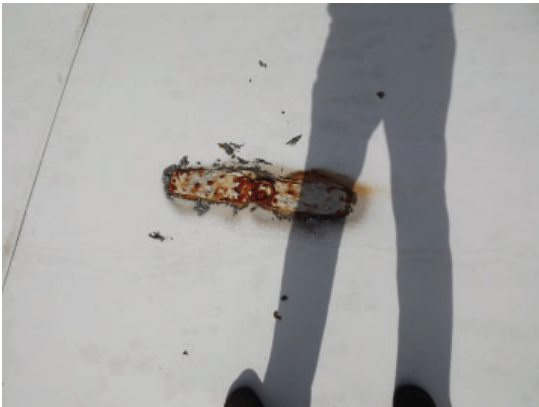
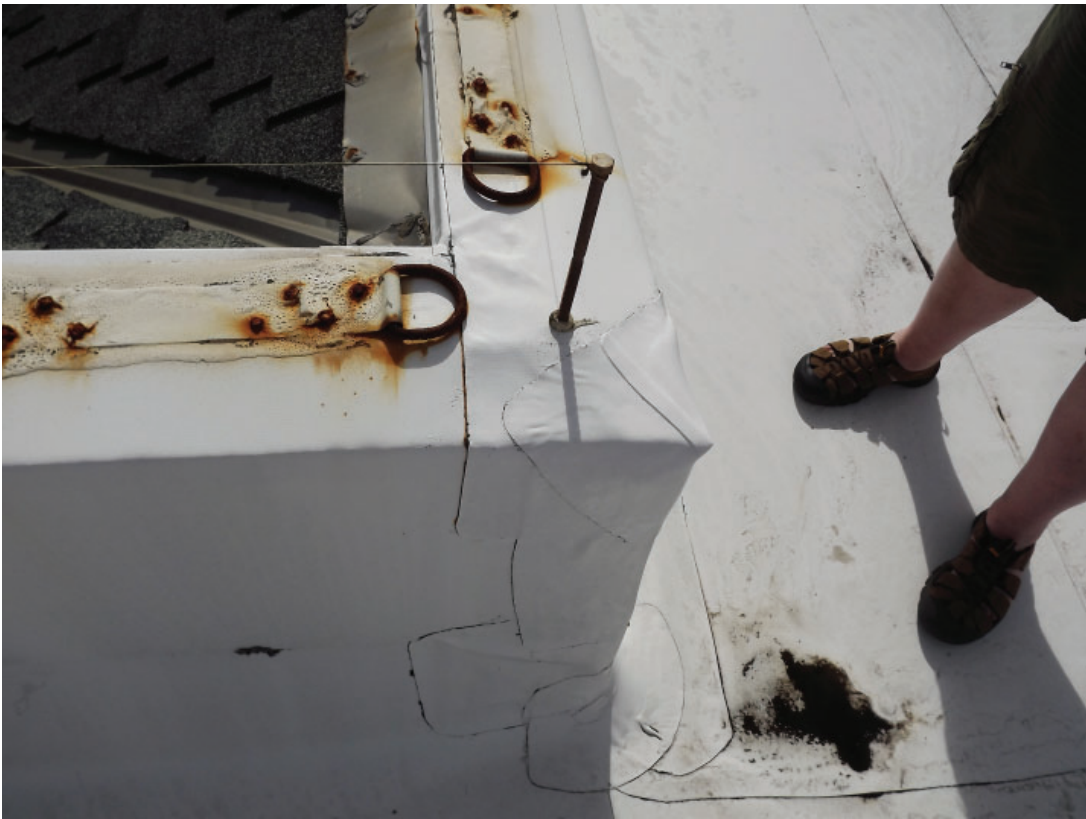
Safety Tie Offs Are Bolted Thru The Roof Membrane.

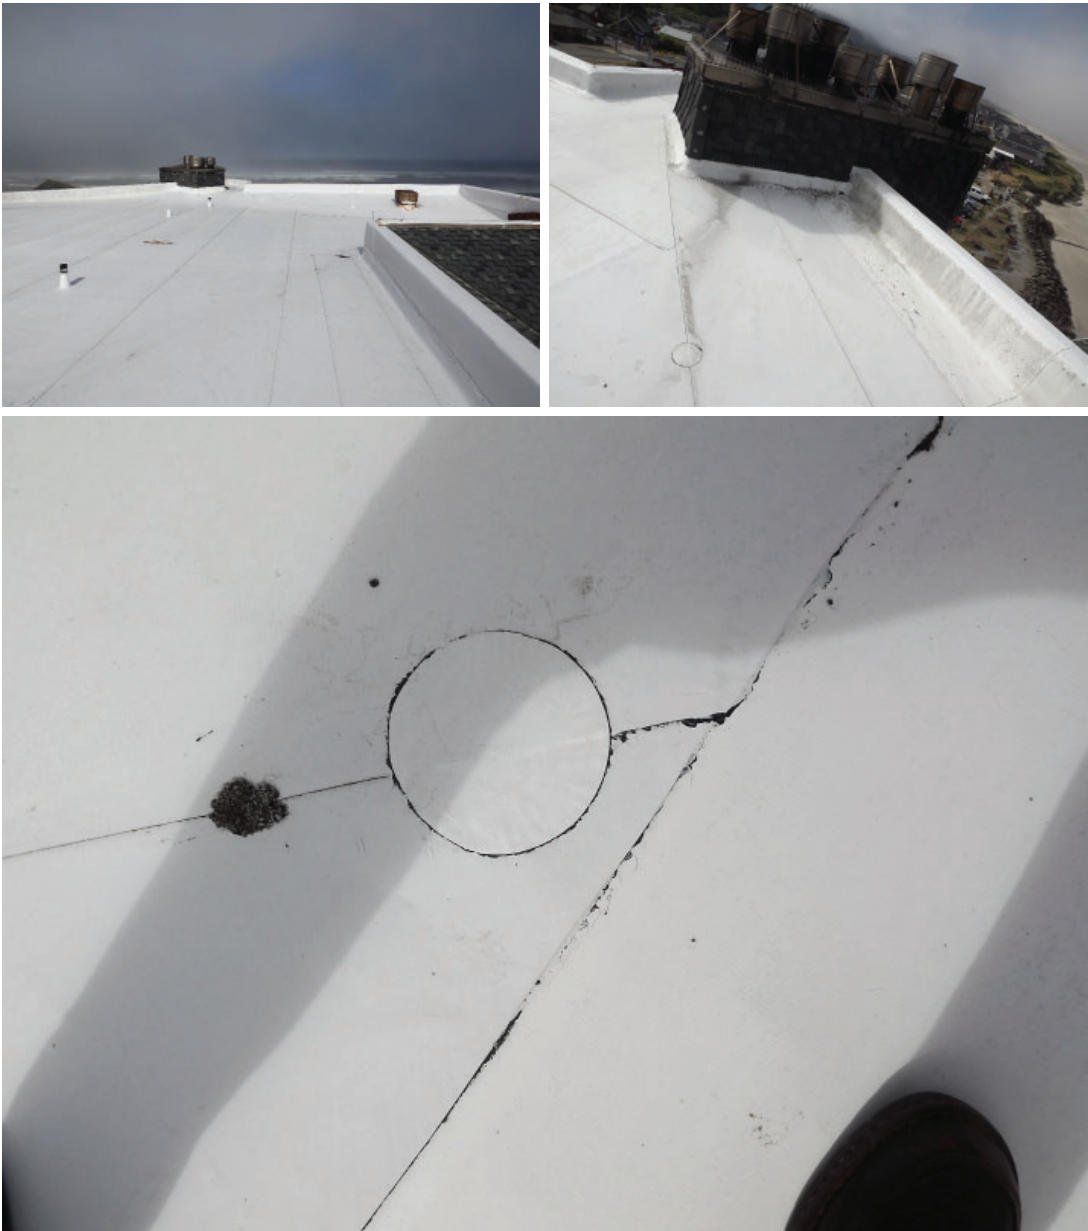
Roof Seams Are Tight And Clean.

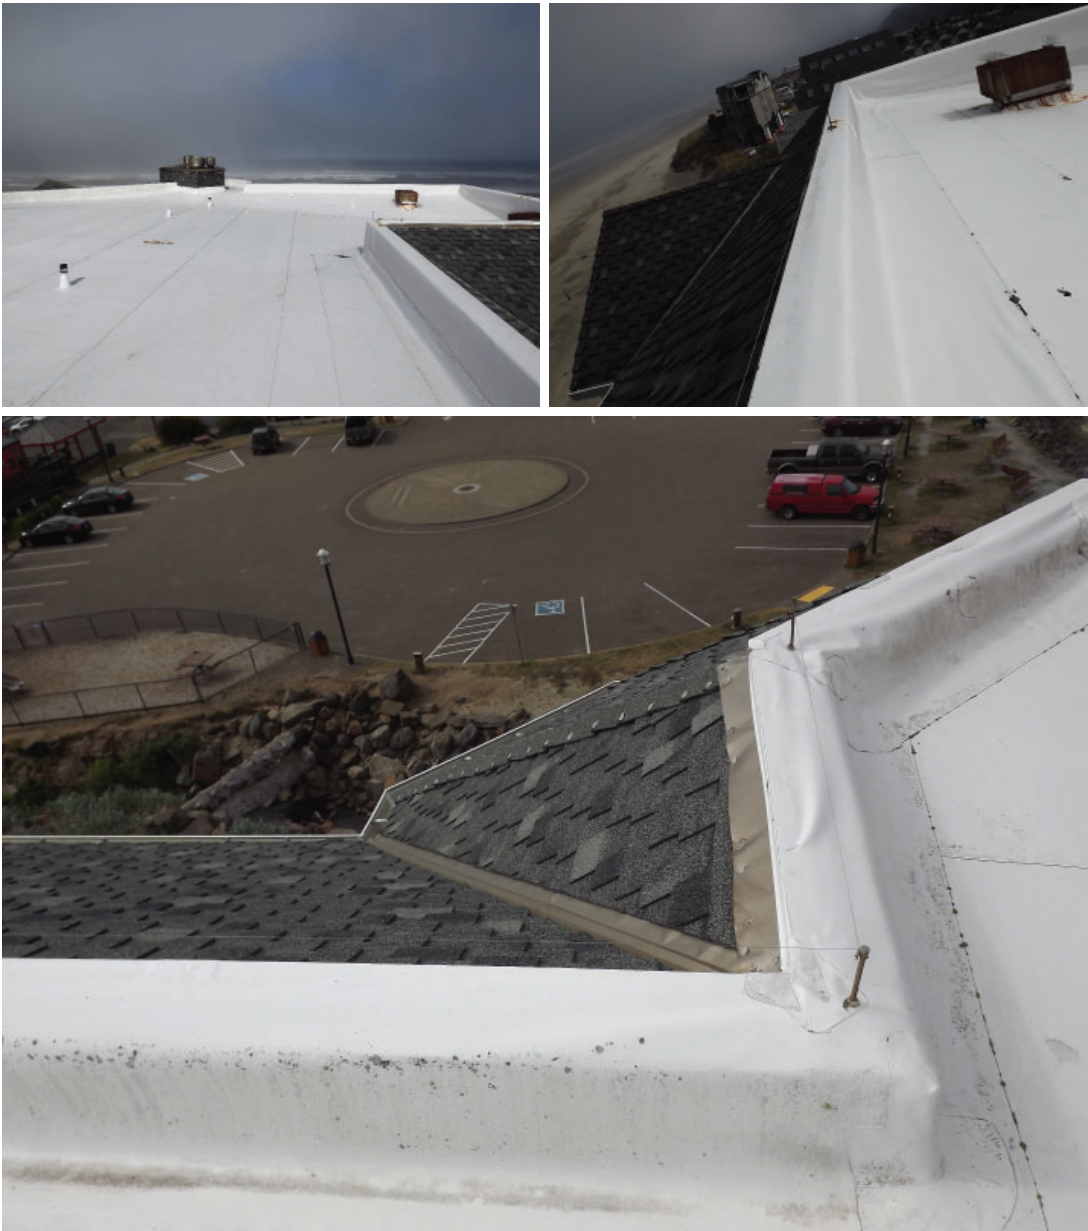
Flashing.

Bolt penetrations not properly flashed.

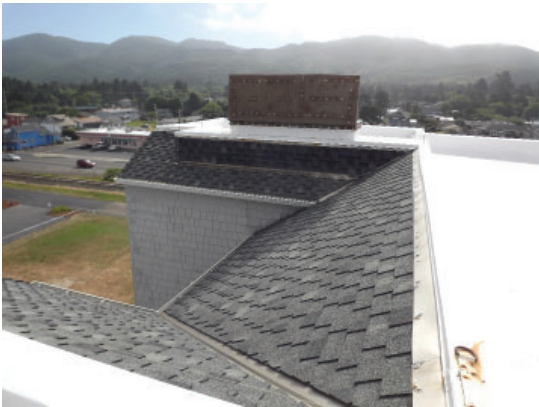
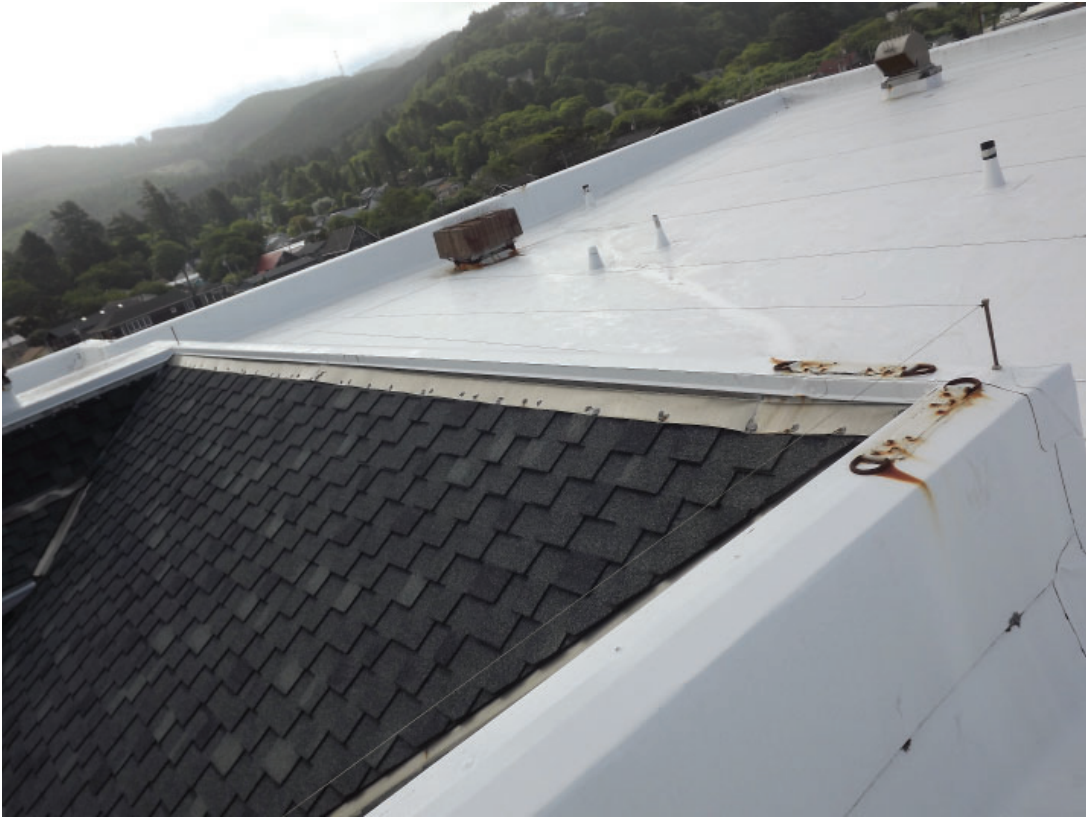
Cap Flashing.

Downleg of cap flashing is short.

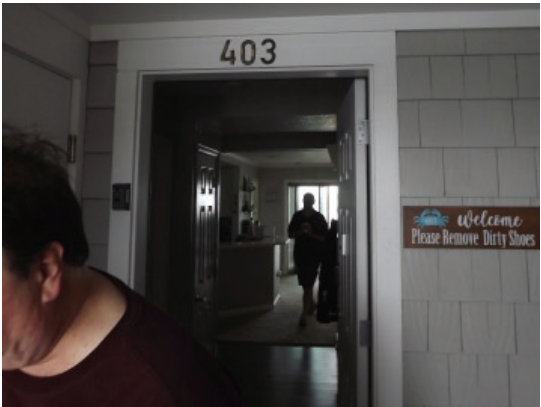
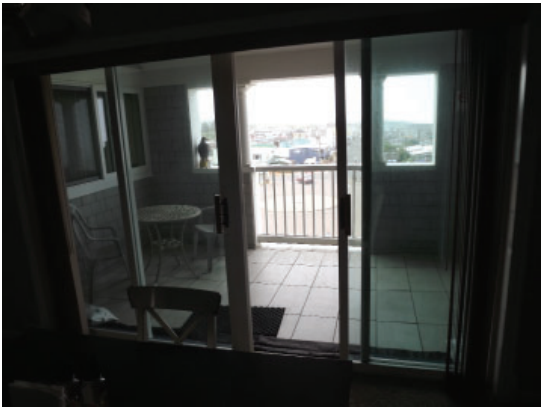
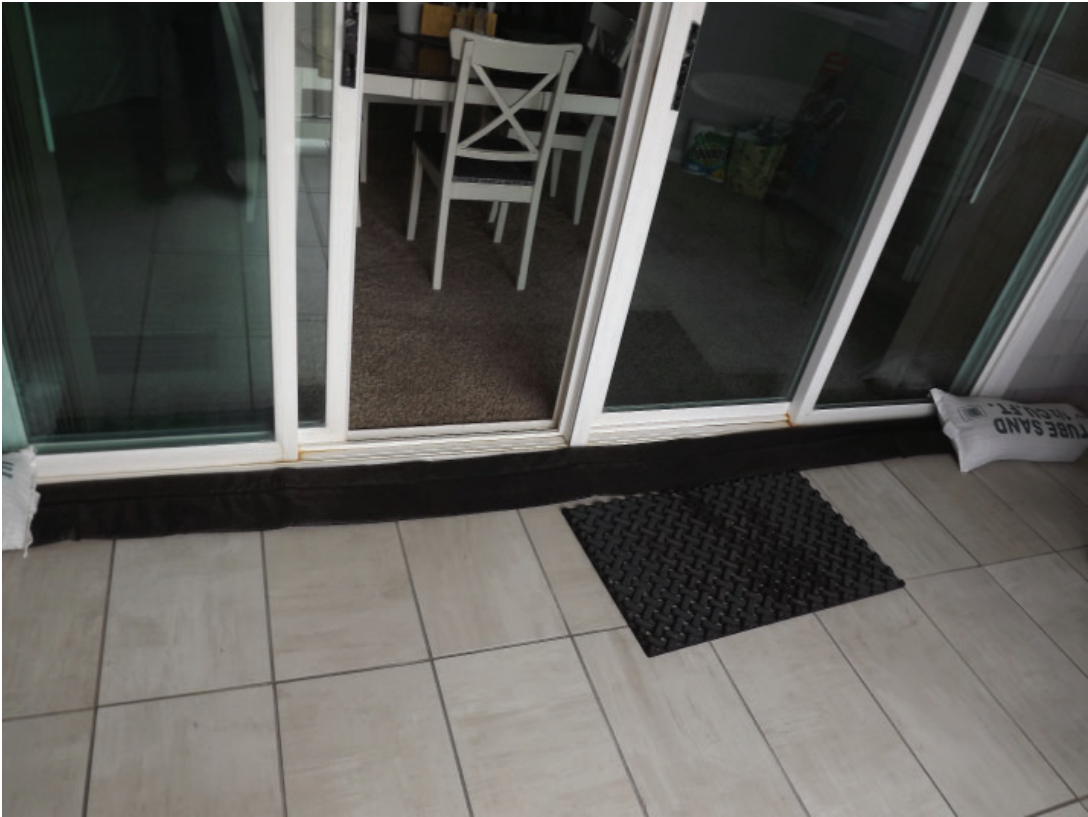
Water Intrusion.

Water intrusion occurs at door sill.

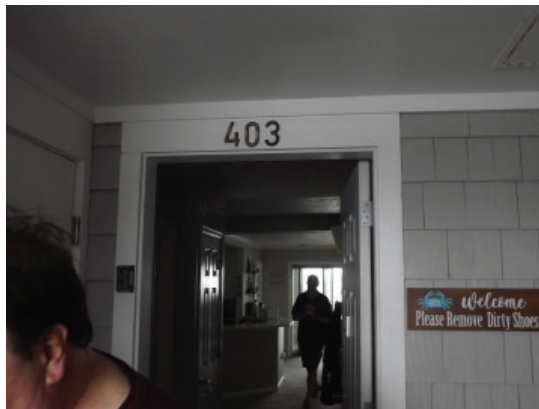
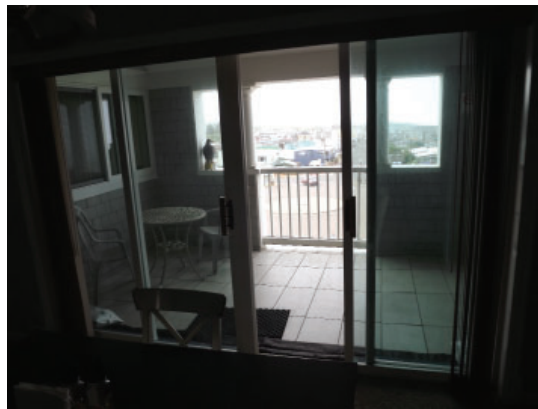
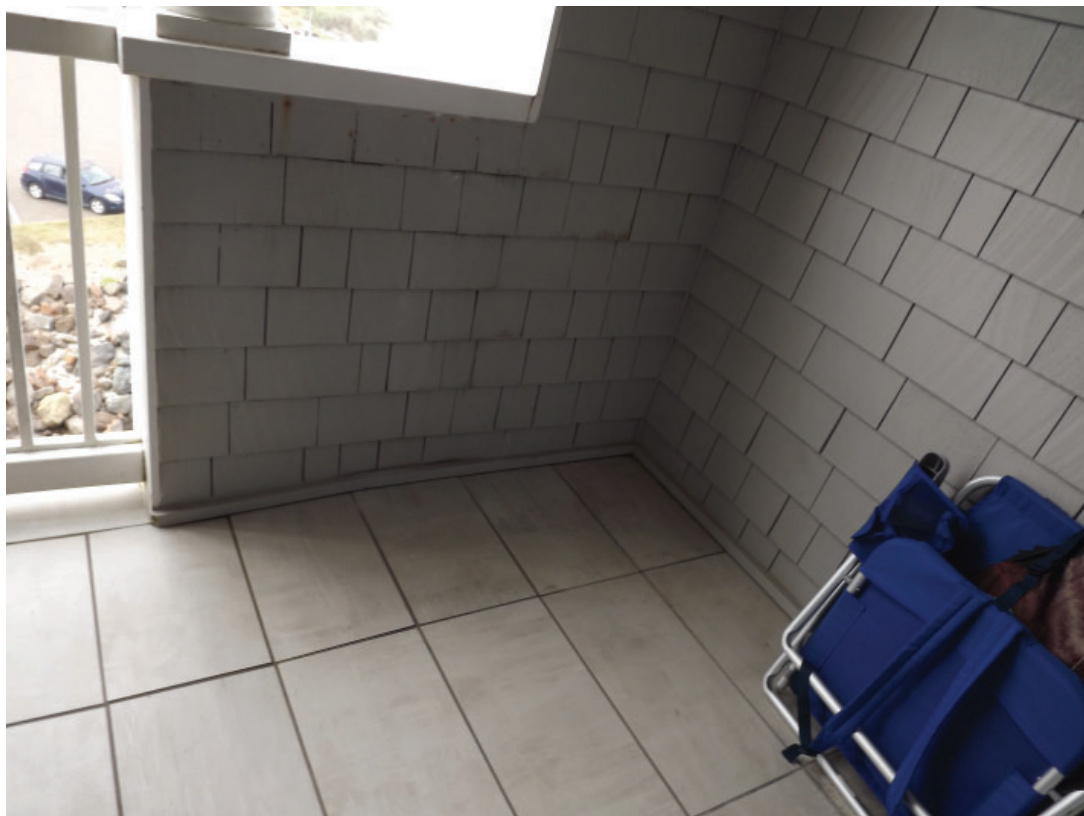
## Trim Terminates Too Closely To Hard Surface.

A separation of 1-2" is required between trim or siding and hard surfaces. The gap prevents moisture from wicking into the material and allows moisture to drain effectively. The siding and trim shown below were installed too close to the hard surface.

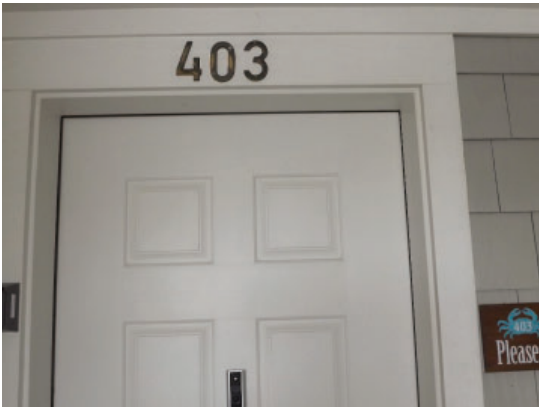
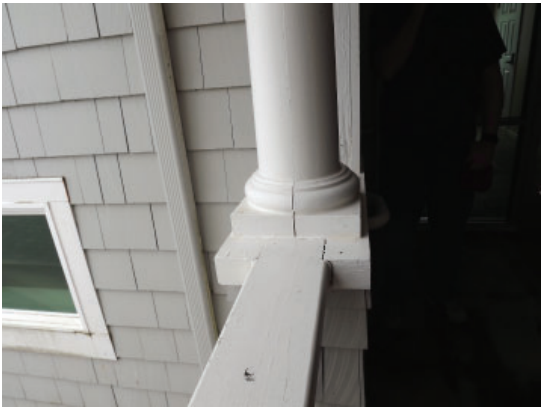
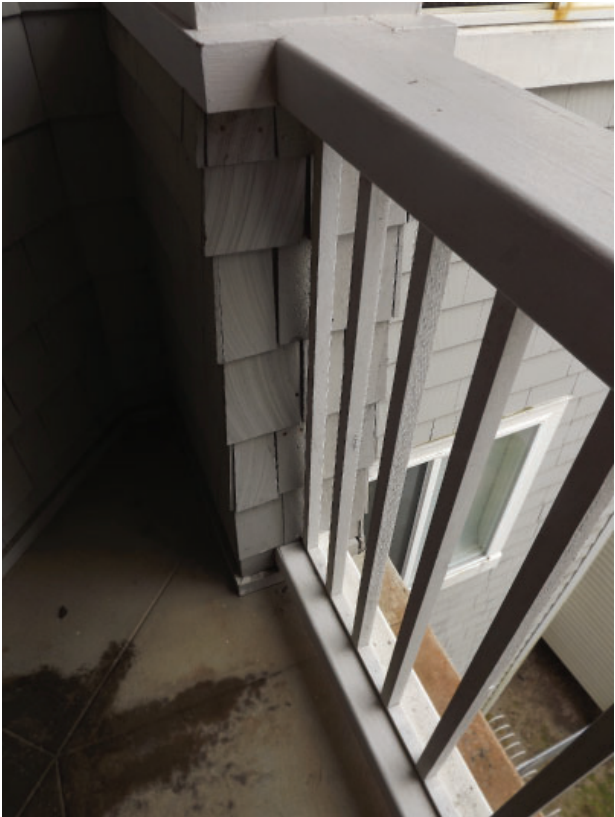
Missing Flashing.

No evidence of flashing at base of wall

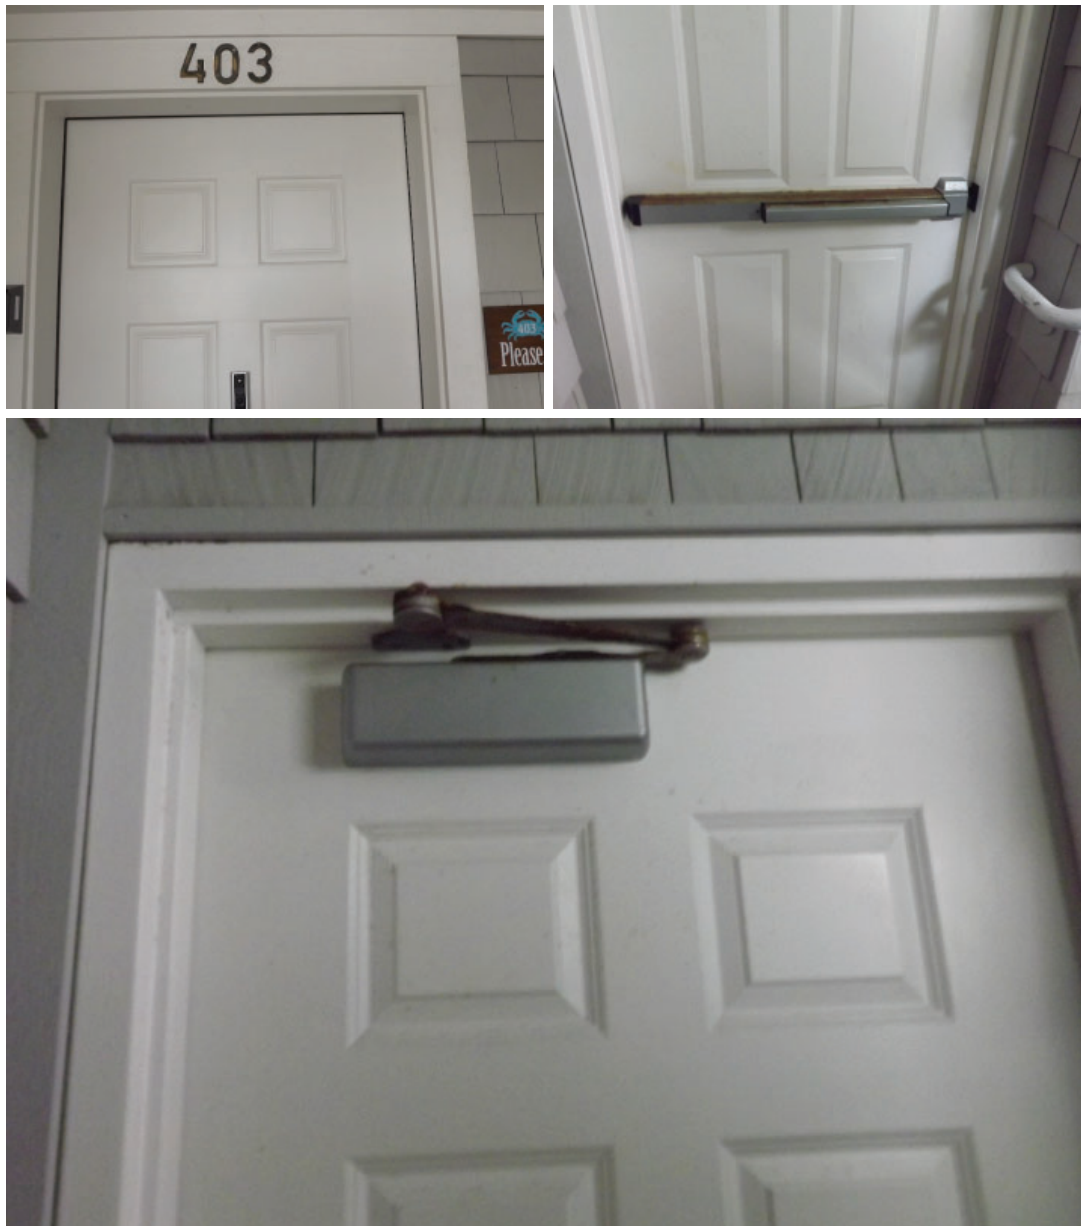
## Rust.

Rust has developed on the metal components at this location. Rust is the corrosion of metal products and indicates failure or potential failure. Rust also weakens the product.

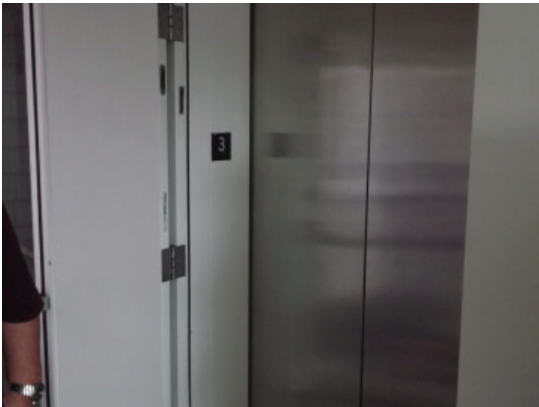
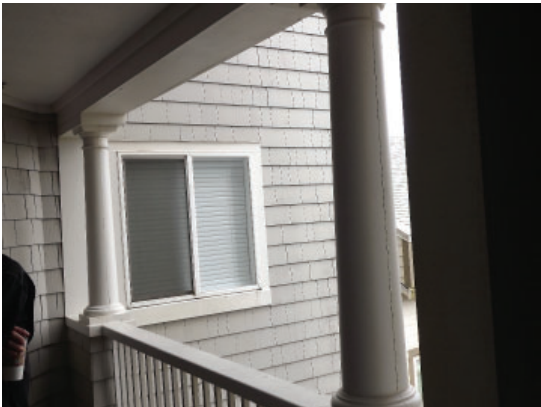
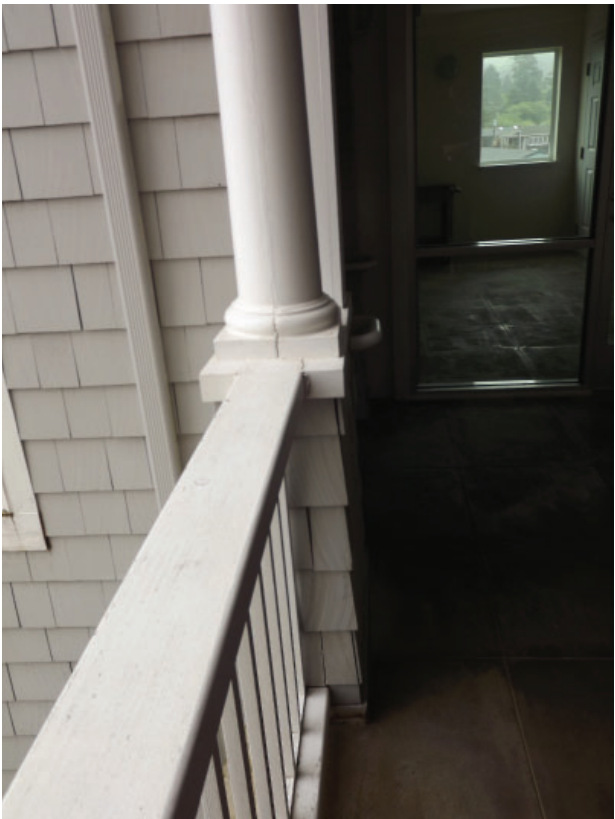
Bottom Rail Penetrates Siding & Missing Saddle Flashing.

Saddle flashings are flashings that cover and divert moisture out and away from the vertical wall of the structure in combination with horizontal penetrations of the structure.

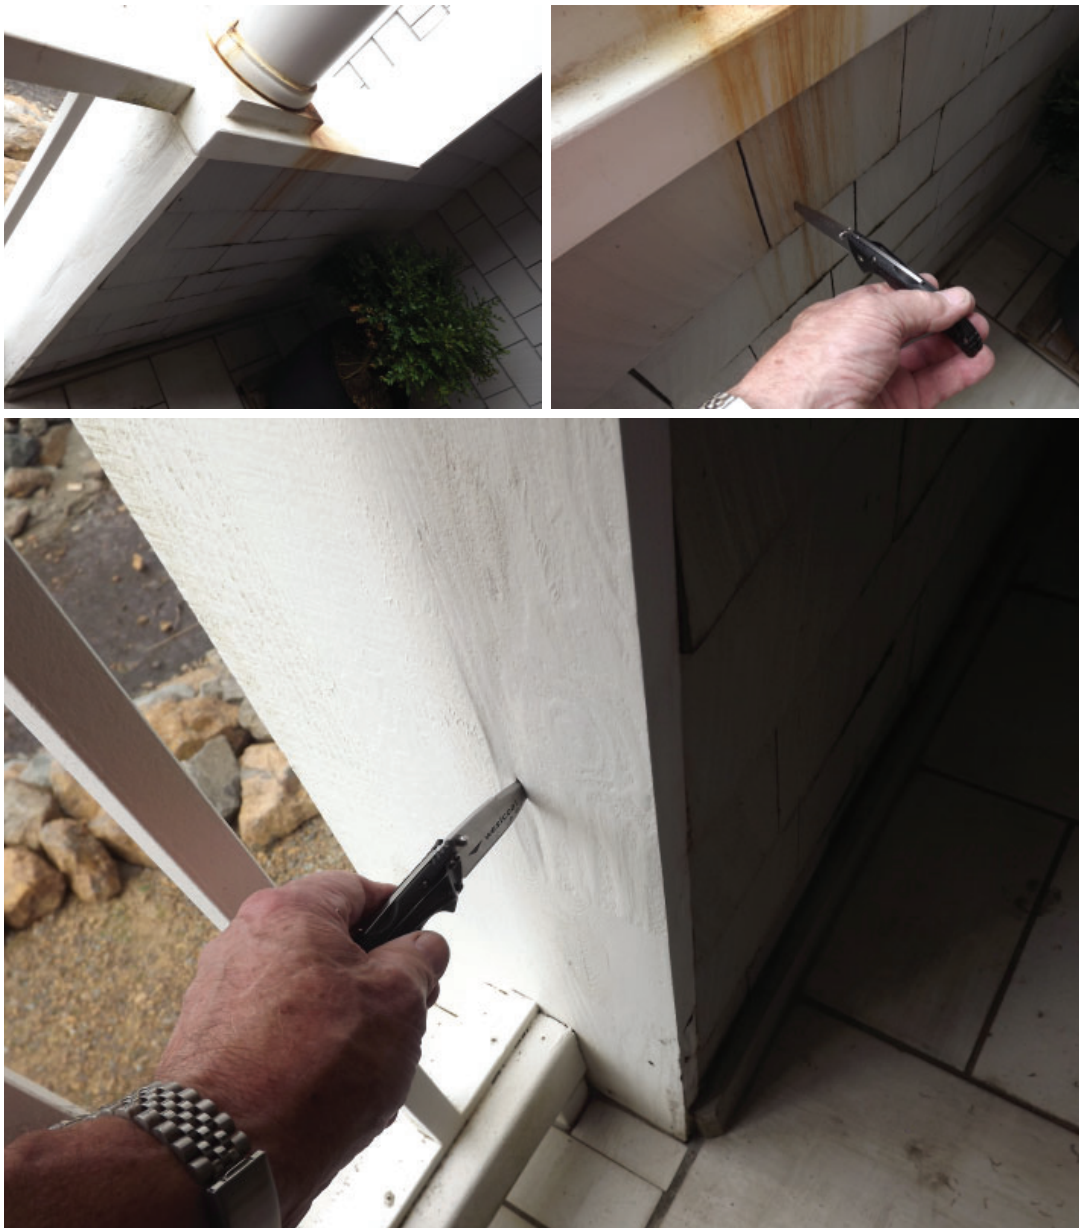
## Dry Rot In Trim, Cedar Shingle.

Dry rot is the decay of wood products. One main purpose of exterior envelope waterproofing is to deter dry rot because it causes substantial damage to the building and structural members. Dry rot is present at this location.

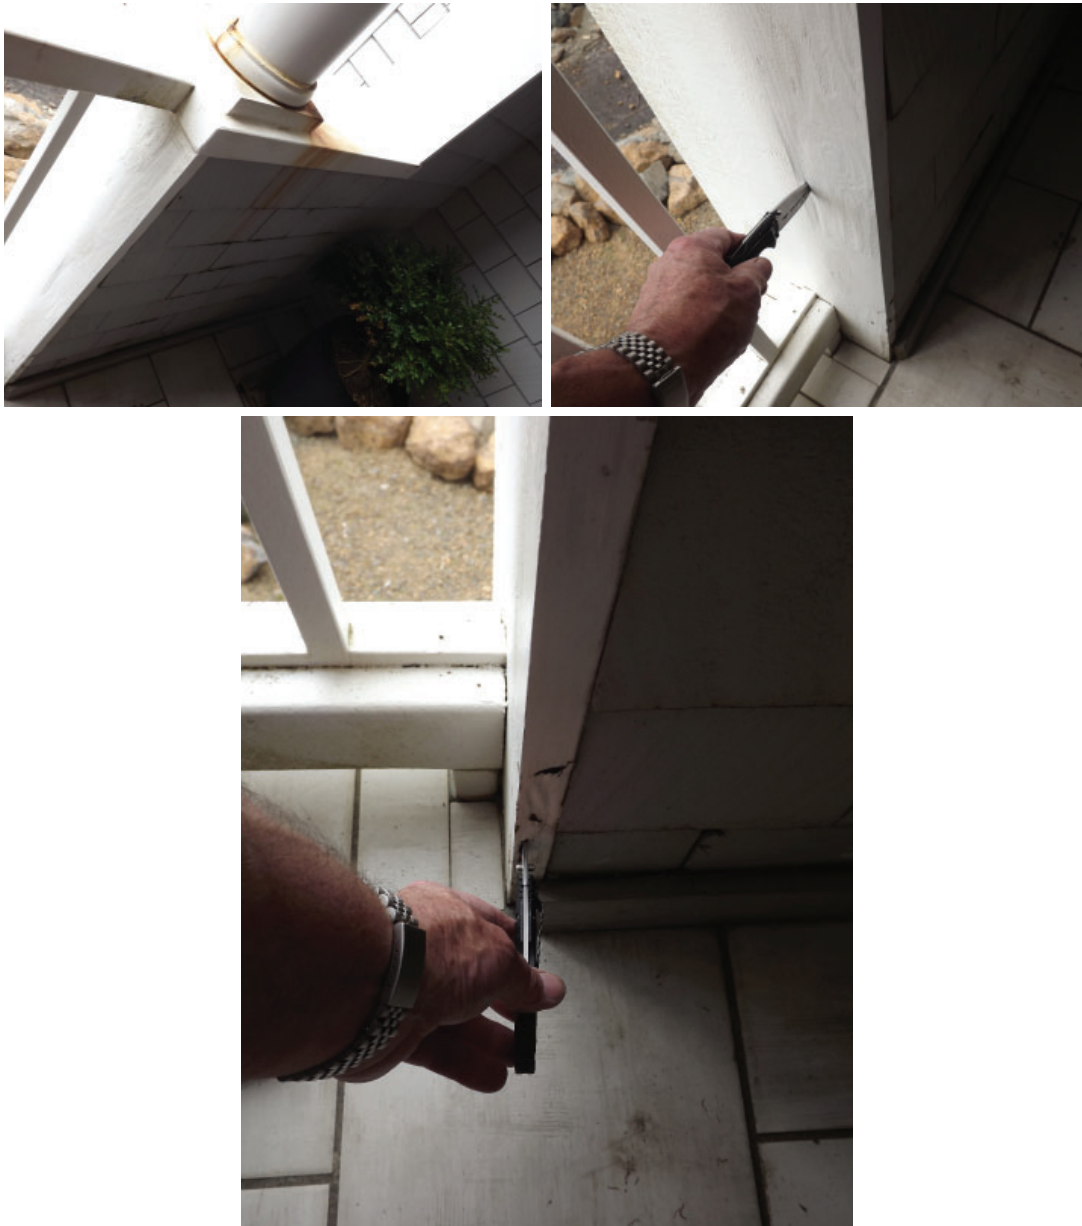
## Trim Is Surface Mounted & Terminates Too Closely To Hard Surface.

A separation of 1-2" is required between trim or siding and hard surfaces. The gap prevents moisture from wicking into the material and allows moisture to drain effectively. The siding and trim shown below were installed too close to the hard surface.

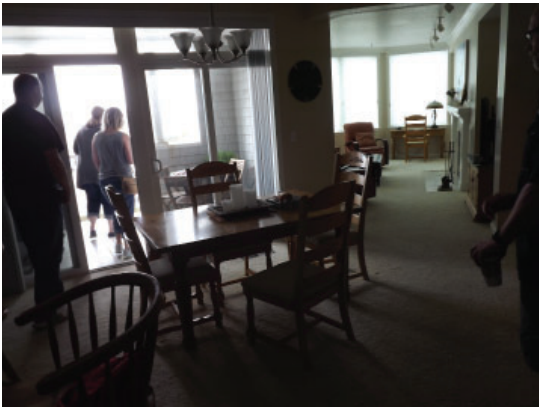
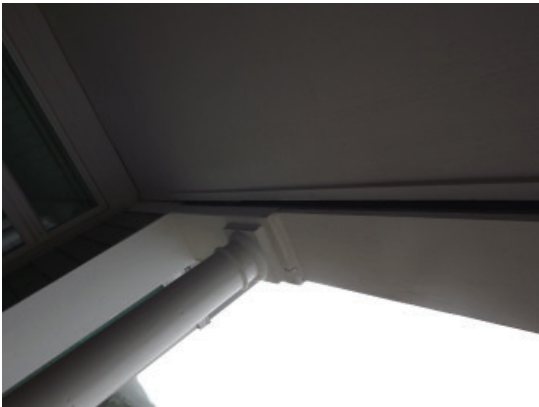
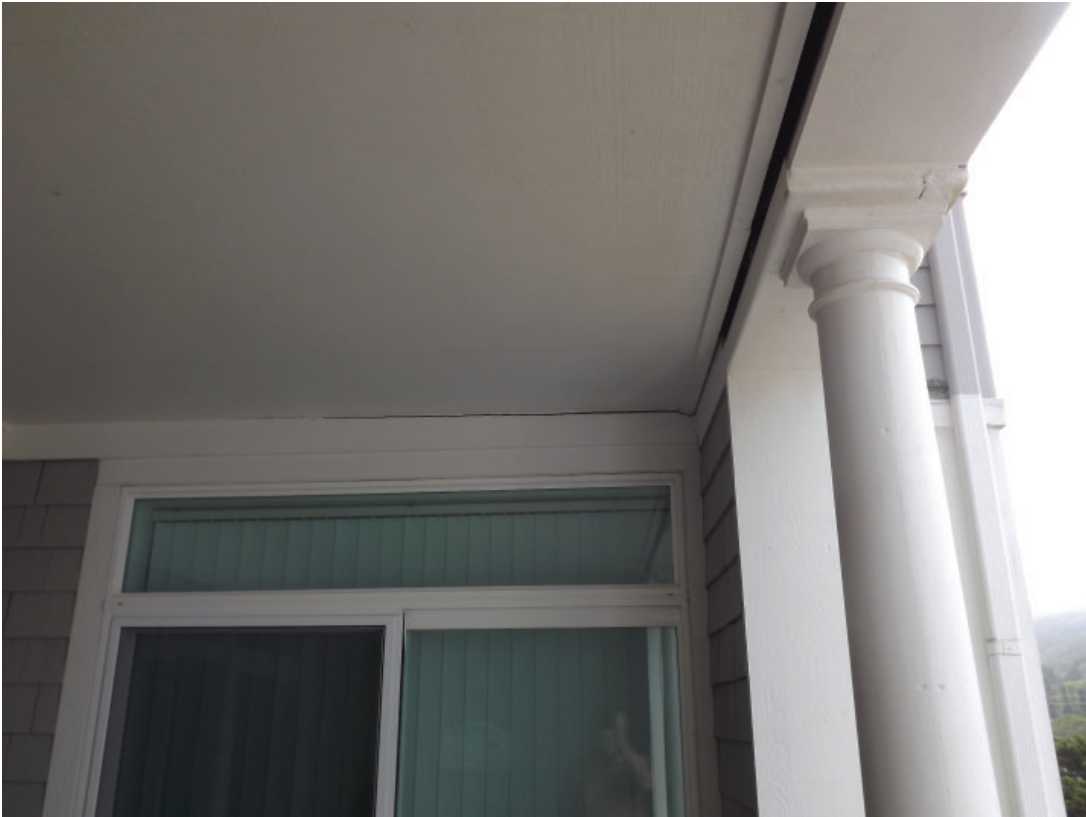
Damage.

The soffit is damaged indicating possible water intrusion.

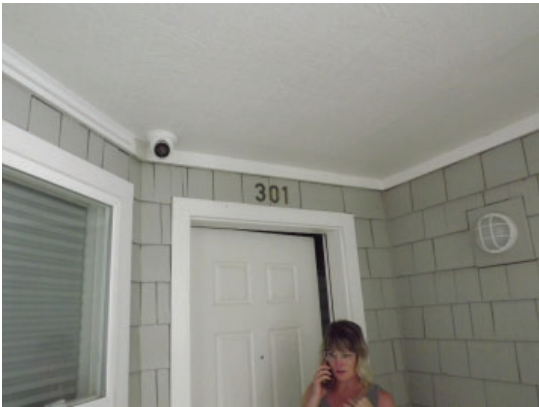
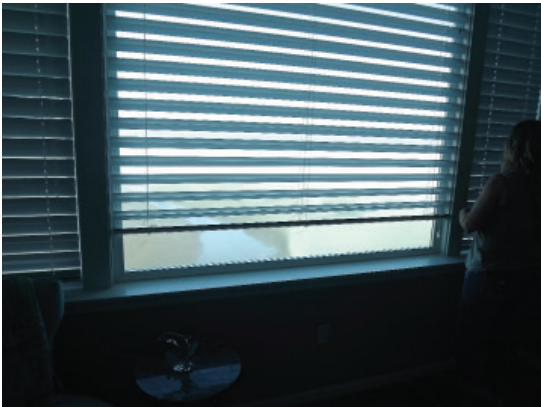
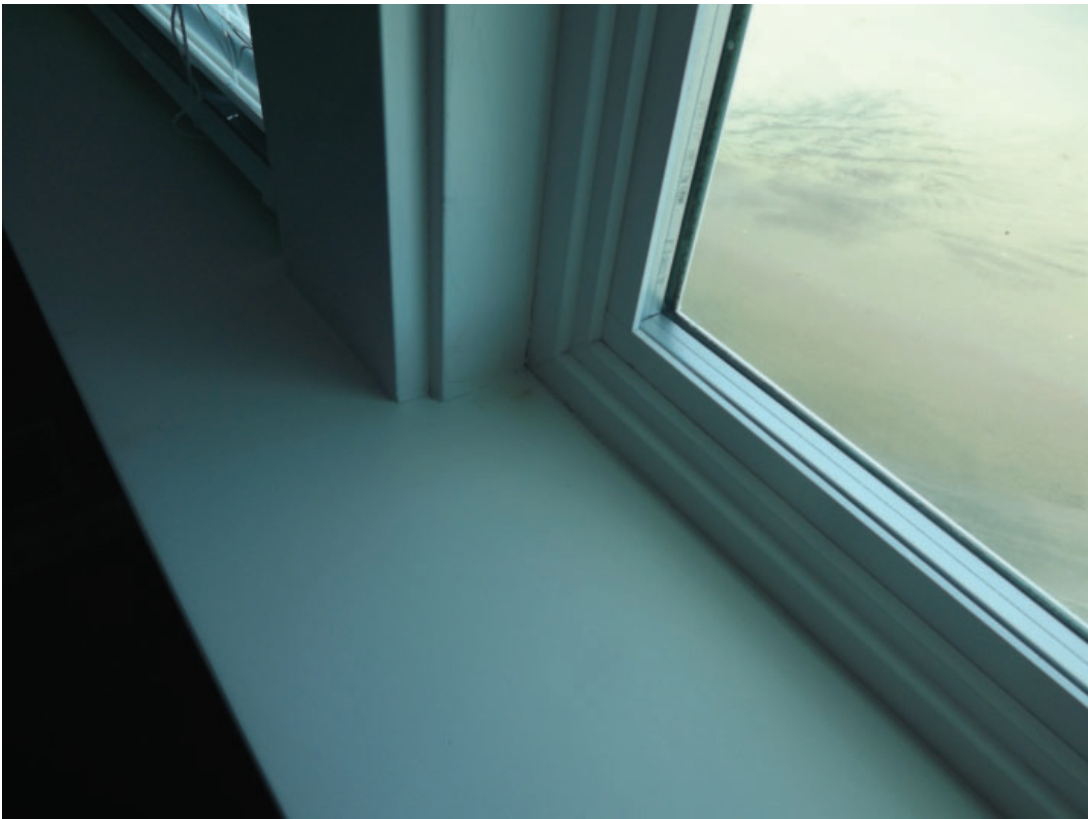
Visible Moisture Intrusion At Window Sill.

Windows may leak from many different reasons. Regardless of the reason, the windows shouldn't be leaking. At this location staining/leaking was visible to the eye.

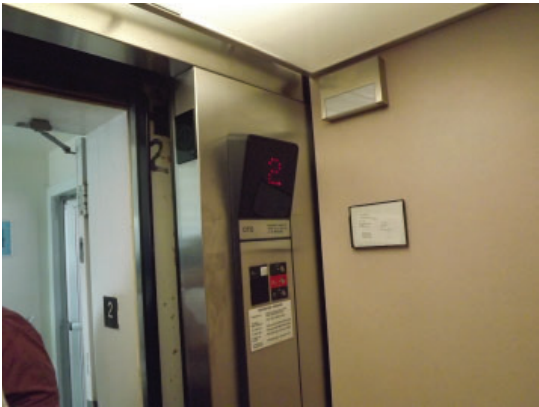
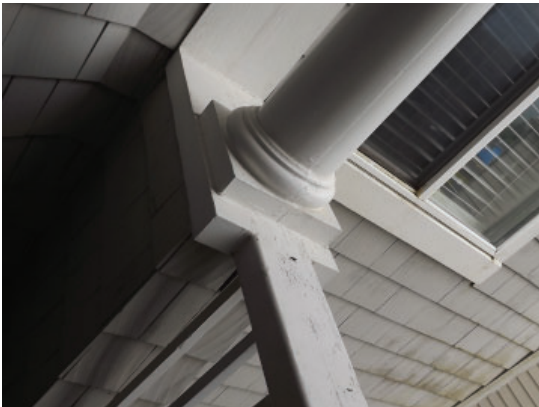
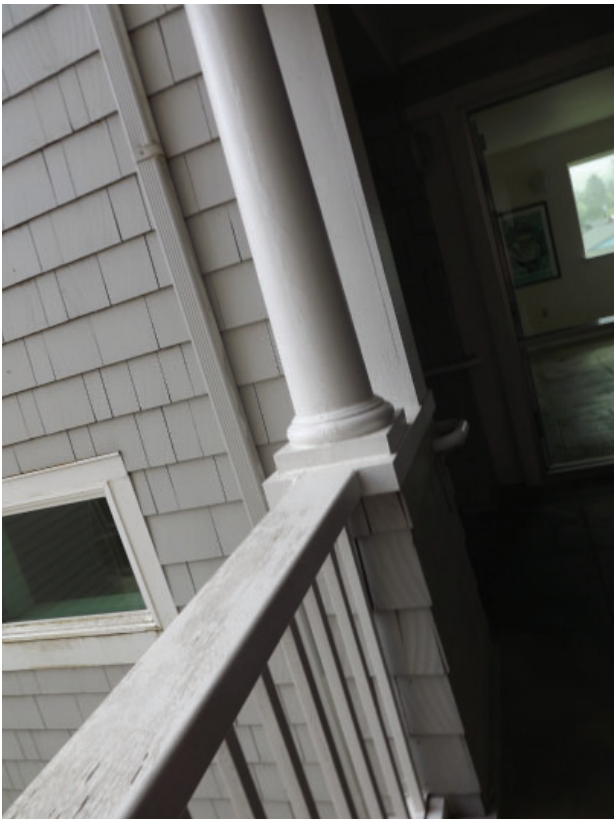
Missing Cap Flashings For Exterior Walls.

Cap flashings are flashings that protect exterior walls. These flashings provide slope and protect from moisture intrusion.

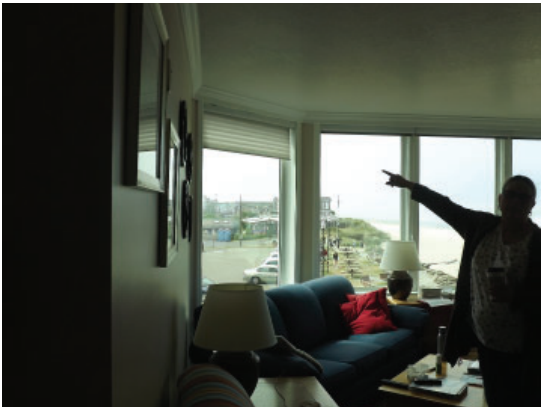
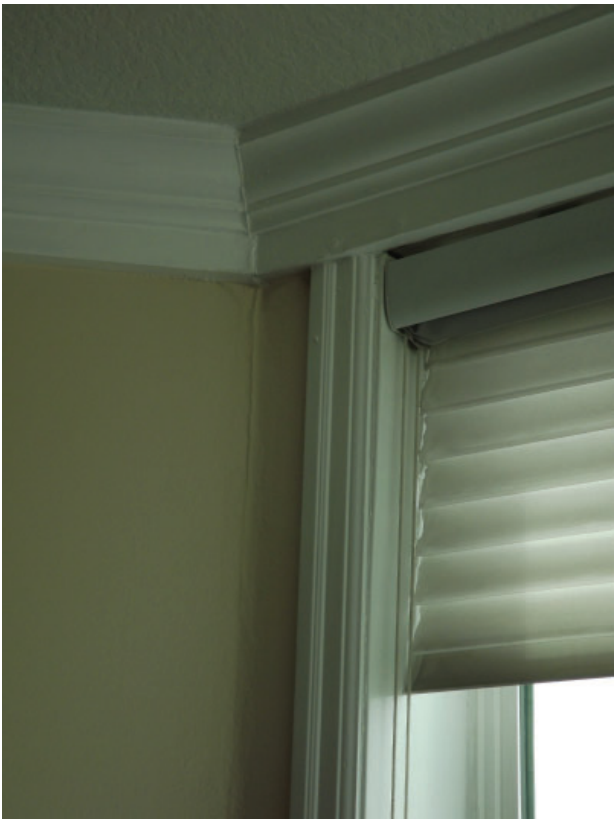
Moisture Damage.

Moisture damage was discovered at this location. Moisture damage is the precursor to dry rot.

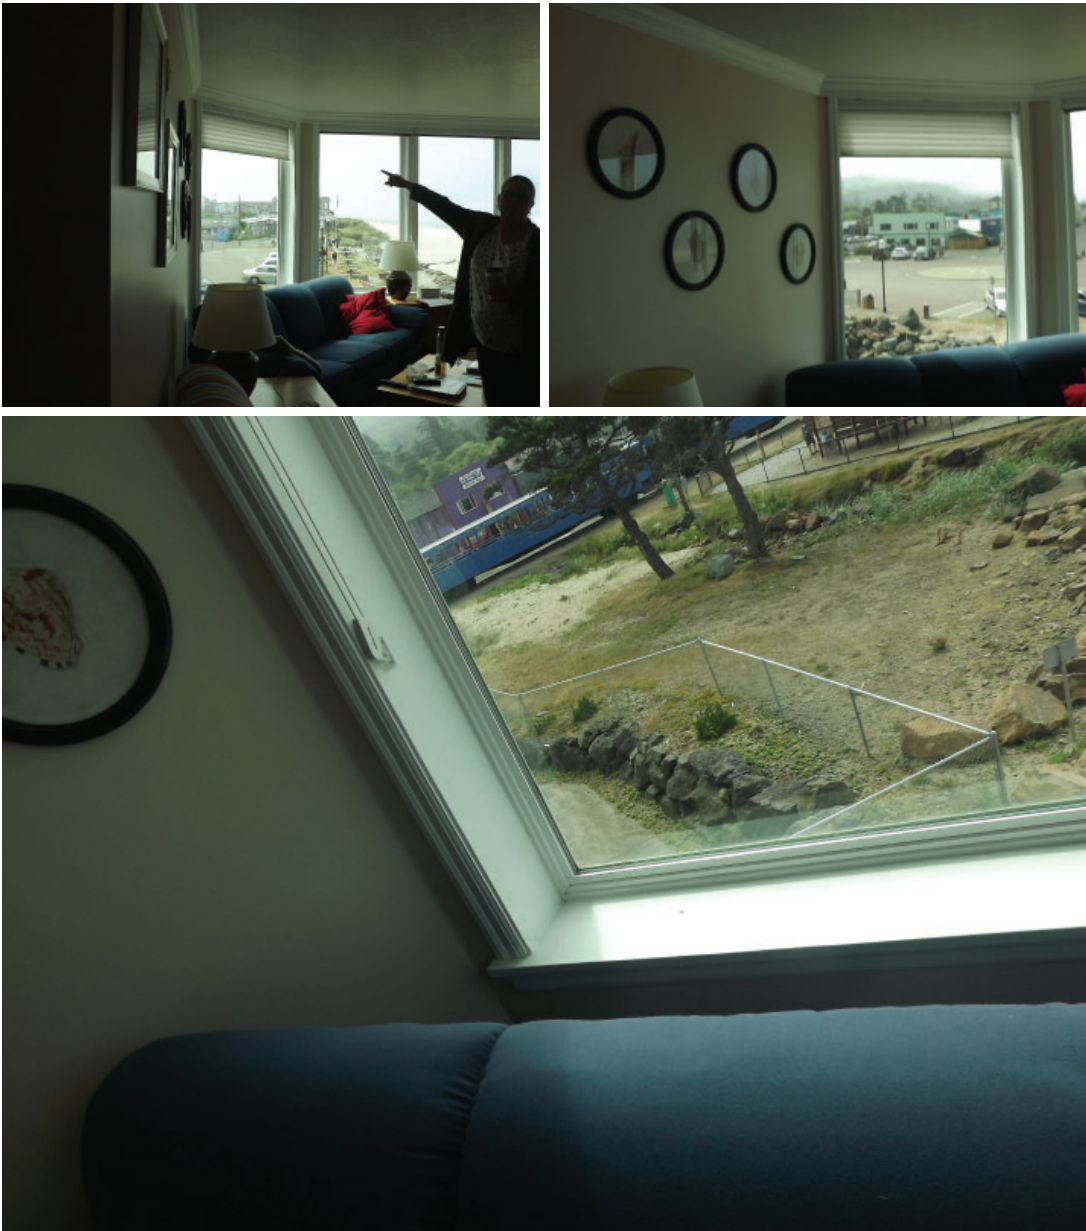
Moisture Staining.

Moisture staining was discovered at this location. The staining indicates that excess moisture is allowed to penetrate in this location, causing damage.

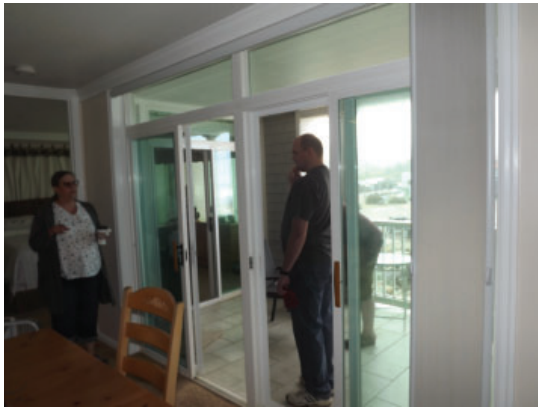
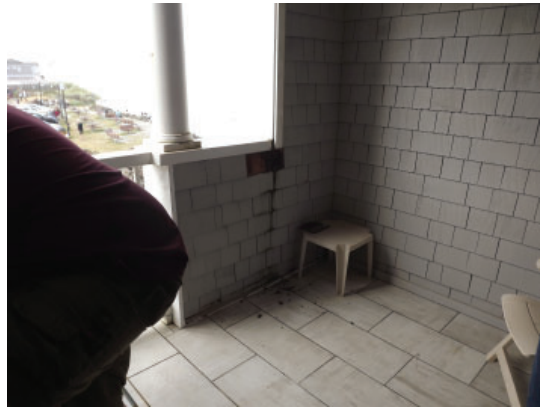
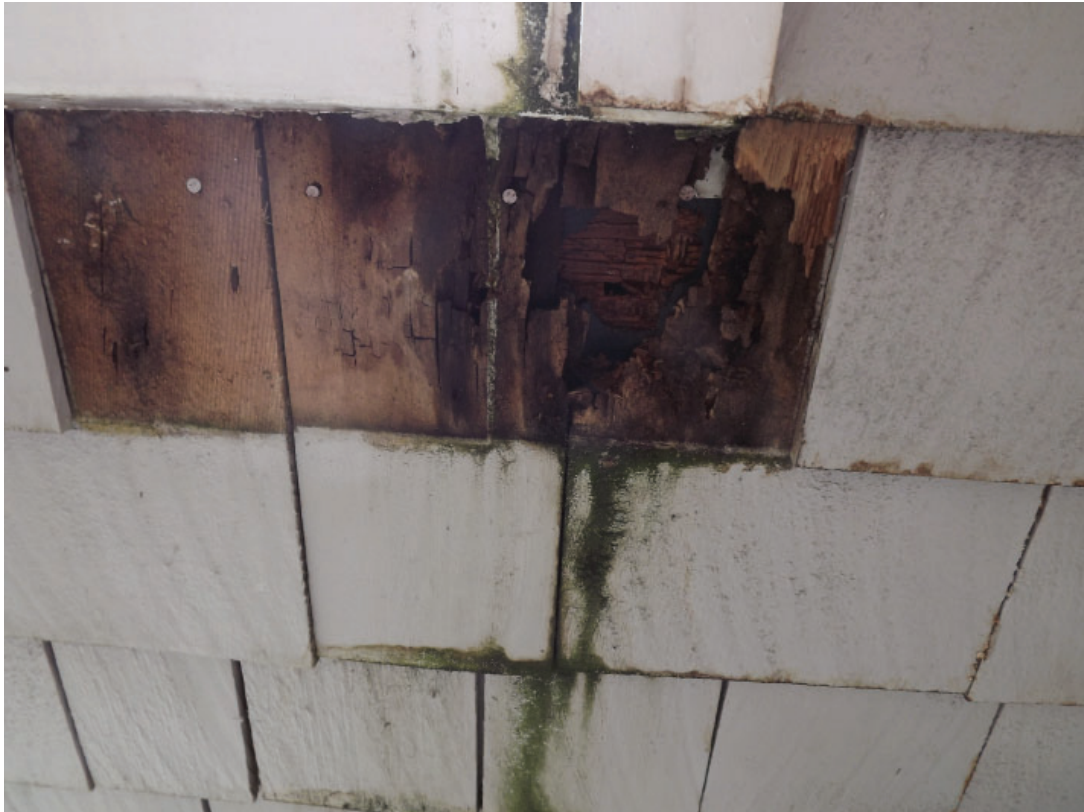
## Dry Rot.

Dry rot is the decay of wood products. One main purpose of exterior envelope waterproofing is to deter dry rot because it causes substantial damage to the building and structural members. Dry rot is present at this location.
