# PRELIMINARY BUILDING ENVELOPE EVALUATION OF SEAVIEW CONDOMINIUMS

LOCATED AT:  
115 N. MILLER STREET  
ROCKAWAY BEACH, OR 97136

August 2nd, 2022

Client # B22265 Seaview Condominiums

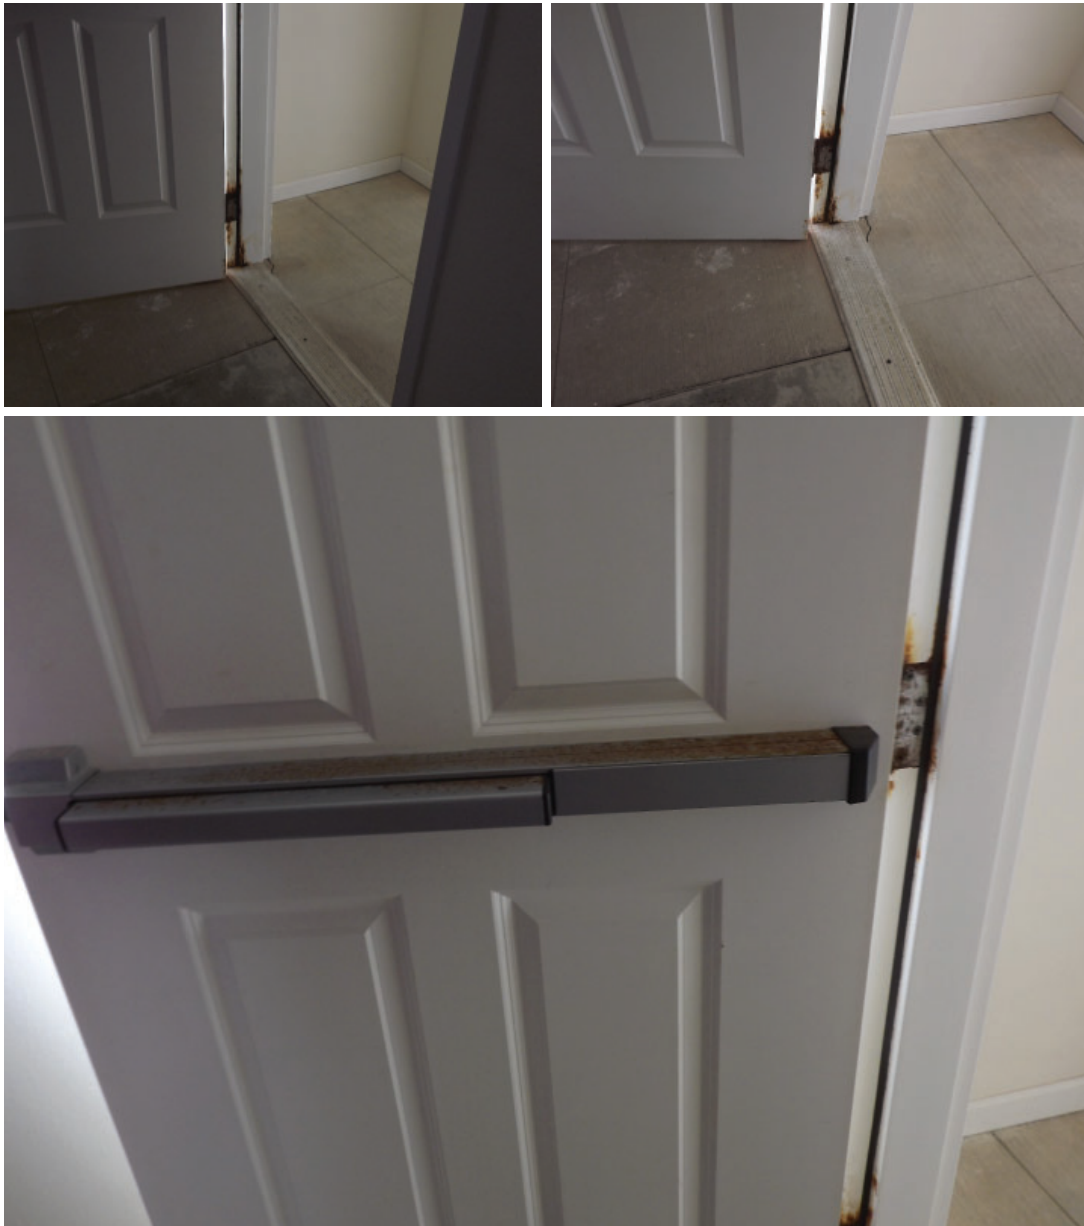
## Rust.

Rust has developed on the metal components at this location. Rust is the corrosion of metal products and indicates failure or potential failure. Rust also weakens the product.

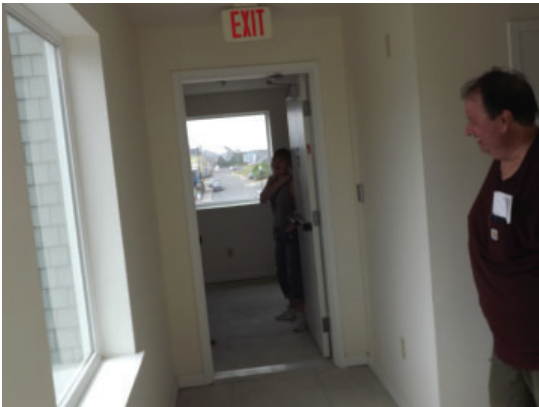
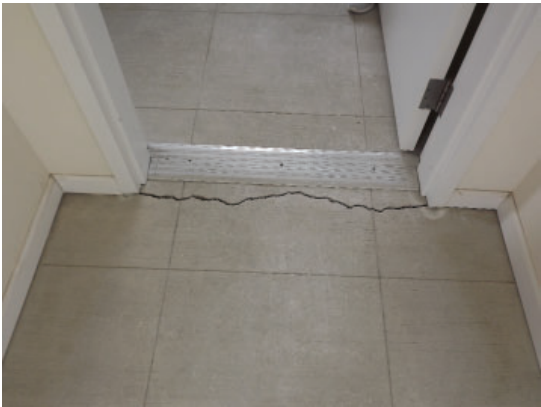
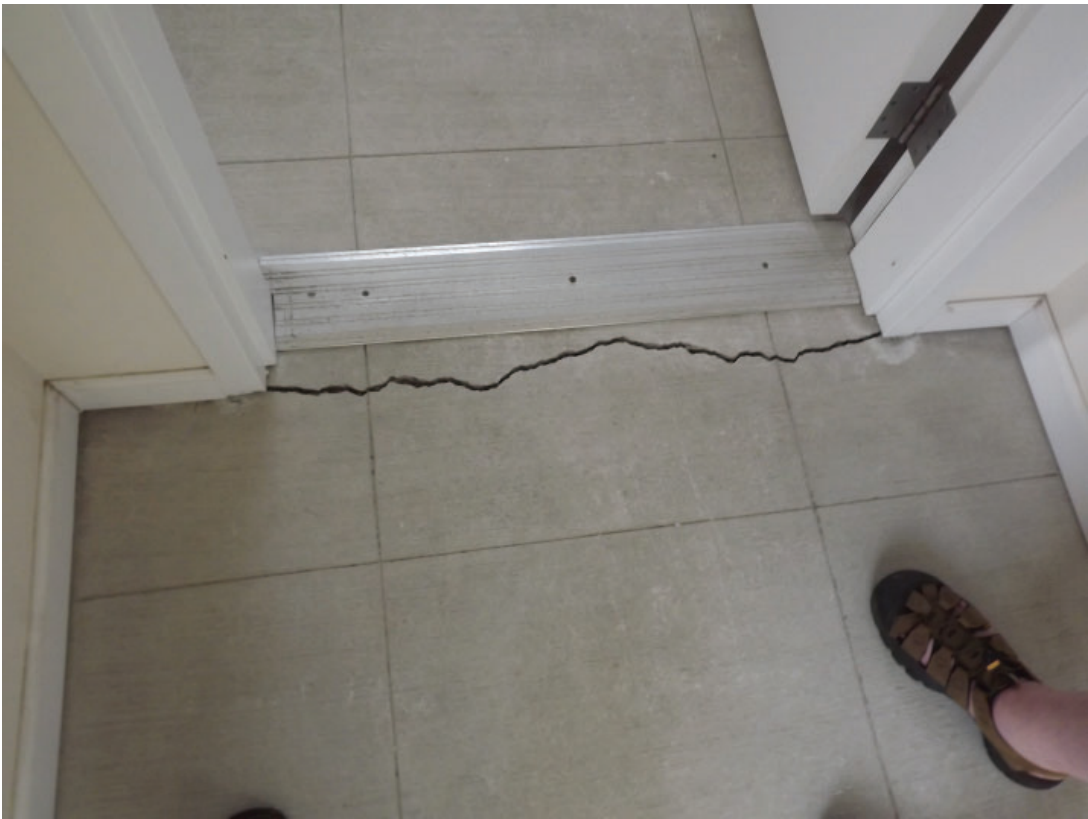
Cracking In Concrete.

Concrete application requires close attention to compaction prior to pouring the concrete. When the compaction is not performed correctly the concrete will move and crack. Concrete is and will crack although to much will produce thick large cracks.

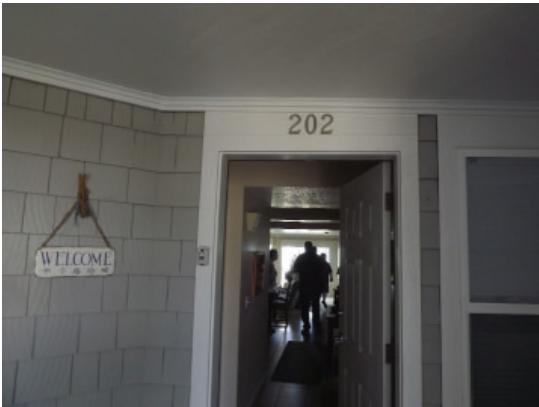
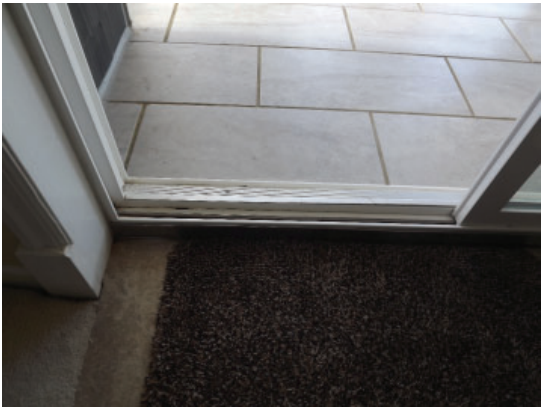
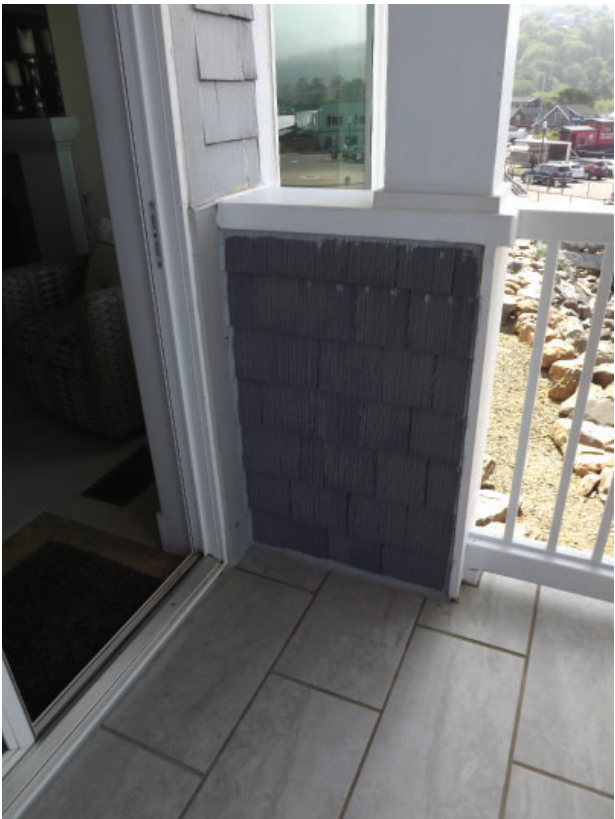
Sill Pan Sealed.

A sill pan is a collection device. This device collects moisture from the item that is set inside of it and directs moisture out to the drainage plane or out to the exterior of the cladding.

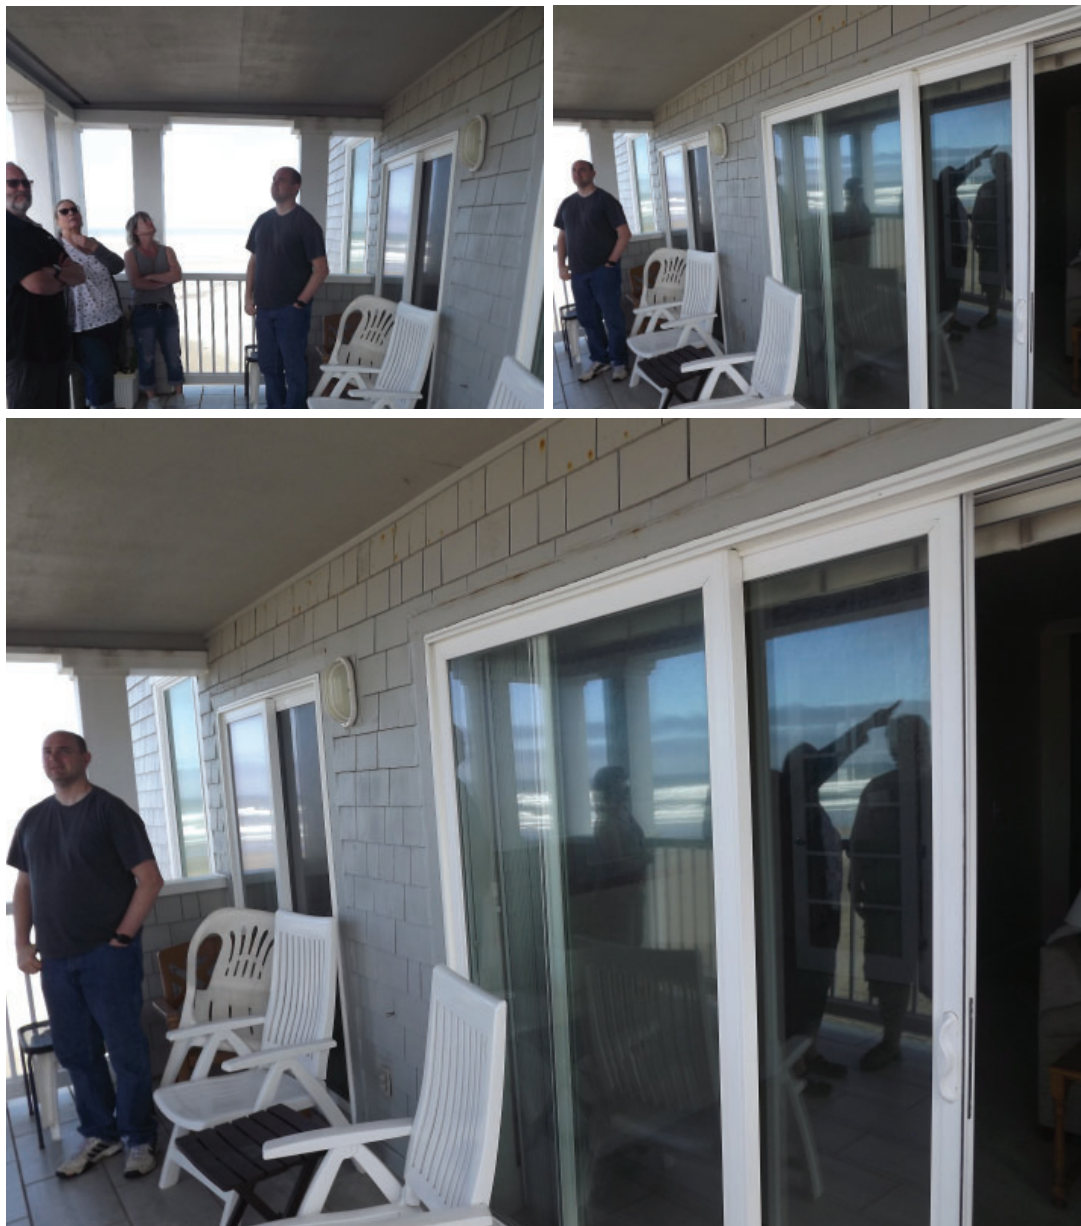
## Rusting Fasteners.

Rust has developed on the metal fasteners at this location. Rust is the corrosion of metal products and indicates failure or potential failure. Rust also weakens the product.

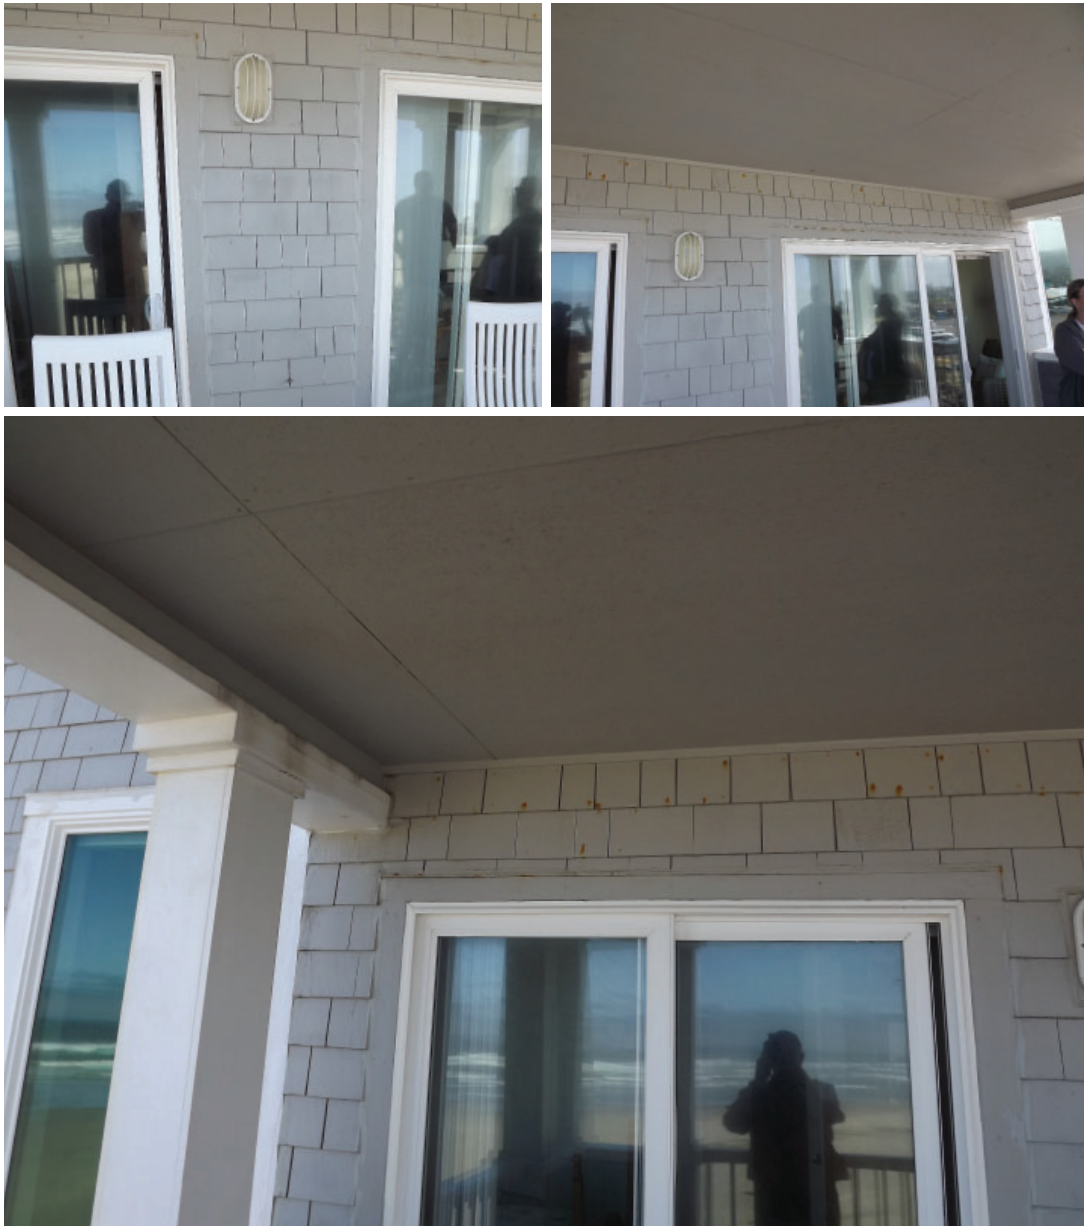
## Sealed Flashing.

Flashings allow incidental moisture travelling behind the siding to drain into an appropriate drainage path. When flashings are sealed to products, moisture cannot drain and instead becomes trapped, which will cause damage to the products and adjacent components. This has happened here.

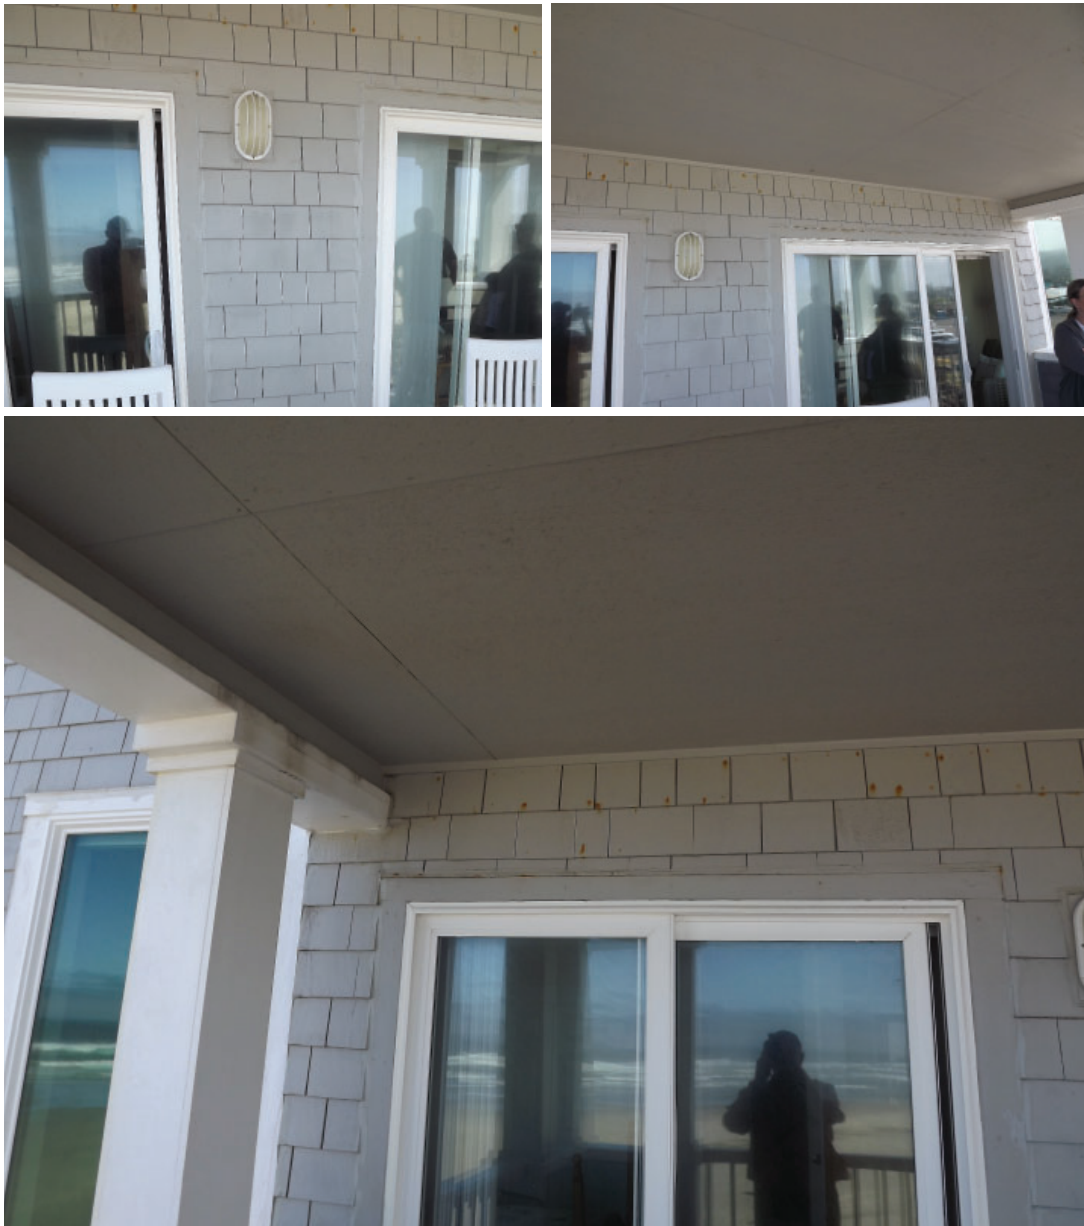
### Incorrect Fasteners Used On Shake.

Product is required to be applied in a specific manner and with specific types of fasteners. The fasteners that were used on this project are less than adequate. The minimum is 7/16" minimum horizontal. The nails at this location are corroded and stainless was not used.

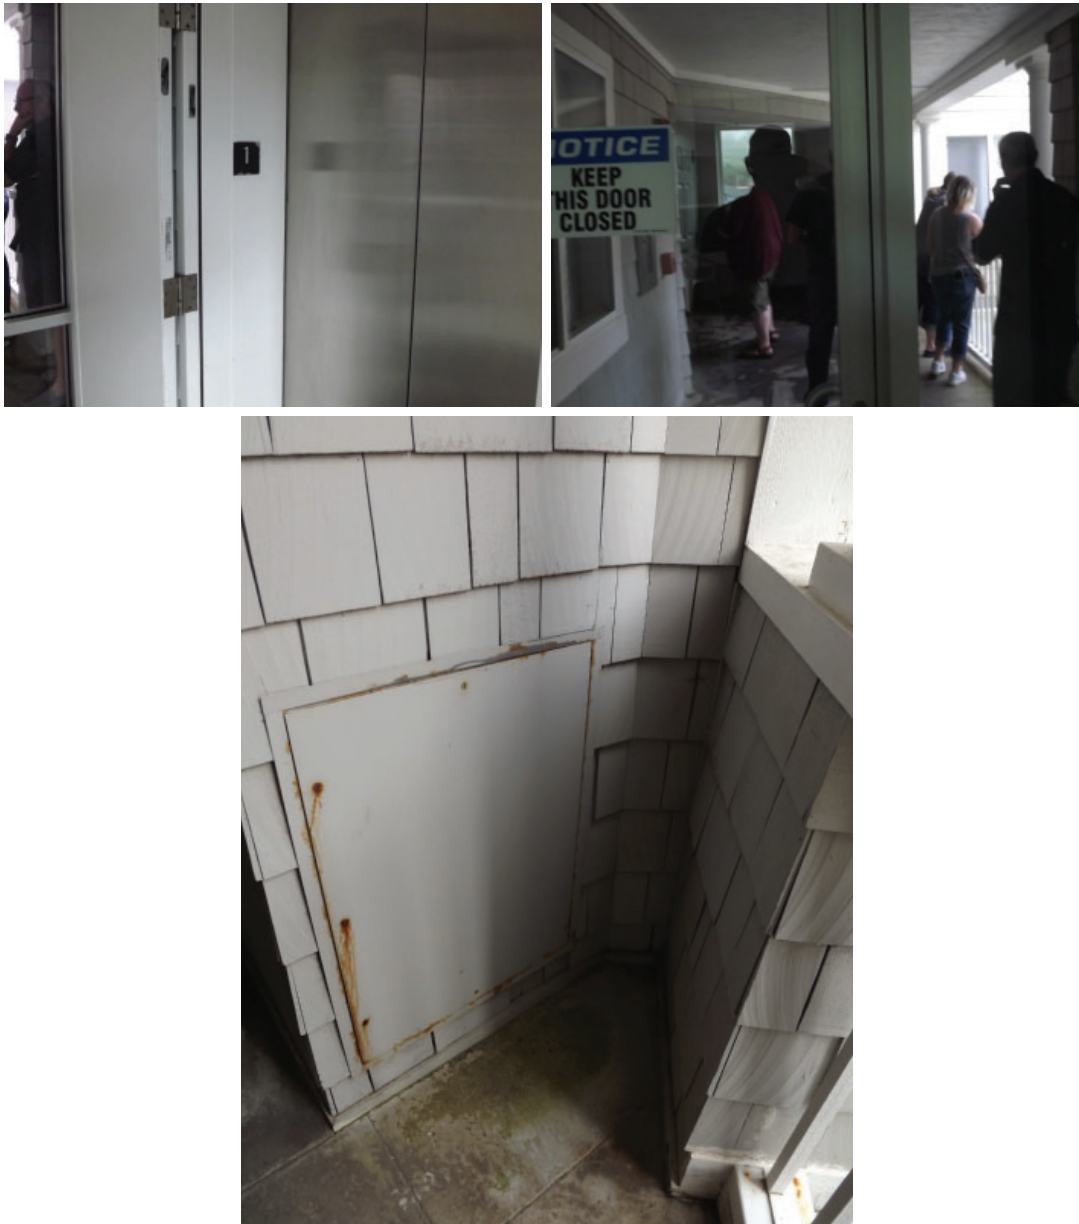
## Rust.

Rust has developed on the metal components at this location. Rust is the corrosion of metal products and indicates failure or potential failure. Rust also weakens the product.

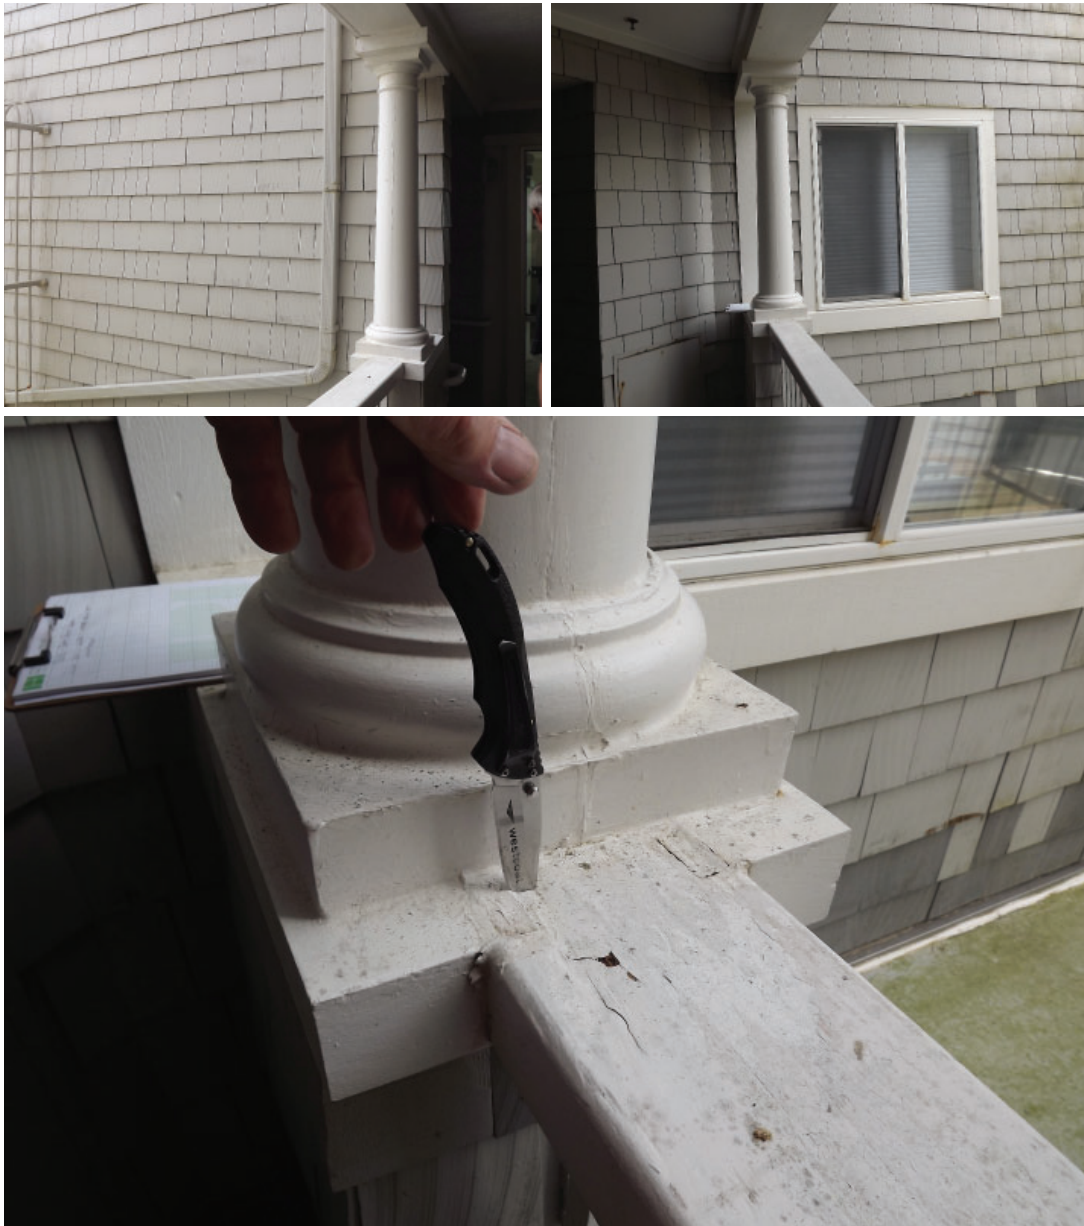
## Dry Rot.

Dry rot is the decay of wood products. One main purpose of exterior envelope waterproofing is to deter dry rot because it causes substantial damage to the building and structural members. Dry rot is present at this location.

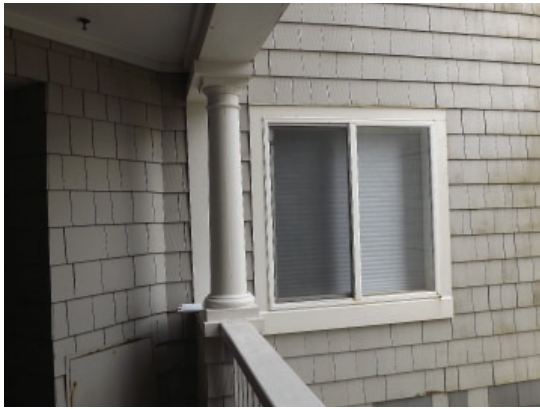
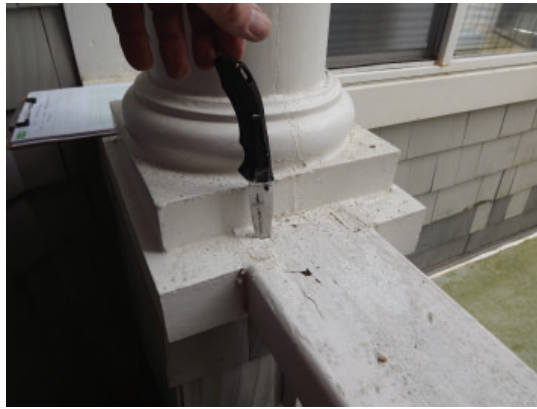
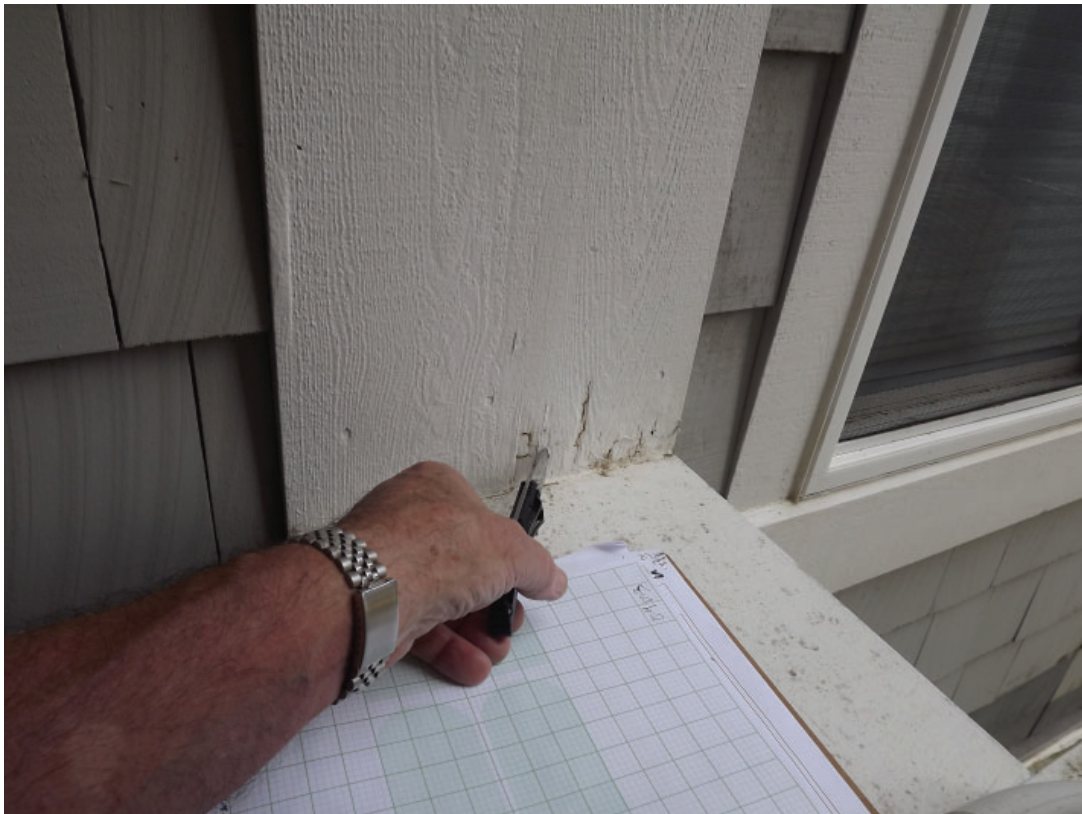
## Missing Saddle Flashing.

Saddle flashings are flashings that cover and divert moisture out and away from the vertical wall of the structure in combination with horizontal penetrations of the structure.

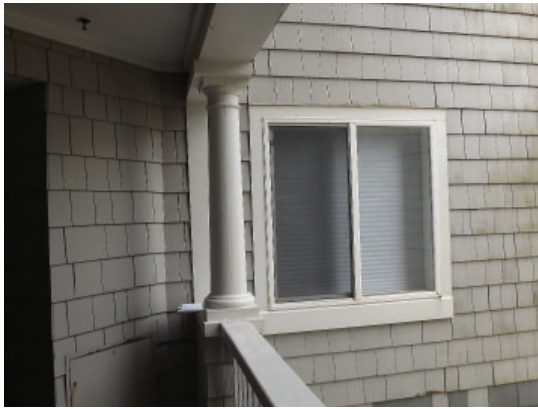
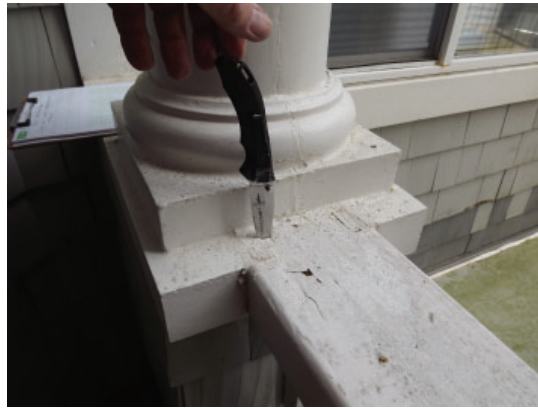
## Dry Rot.

Dry rot is the decay of wood products. One main purpose of exterior envelope waterproofing is to deter dry rot because it causes substantial damage to the building and structural members. Dry rot is present at this location.

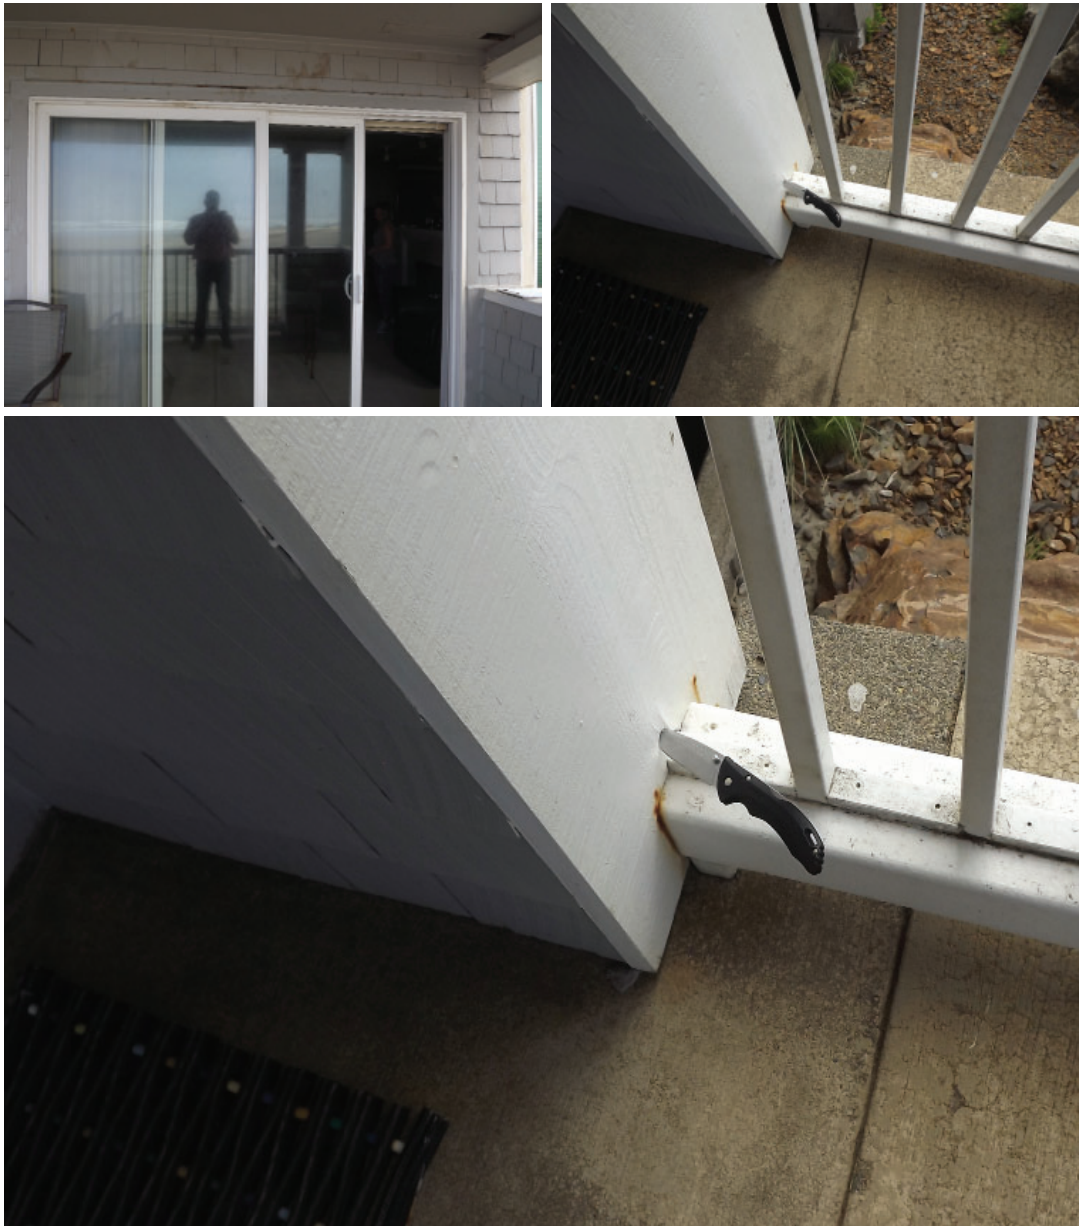
## Dry Rot.

Dry rot is the decay of wood products. One main purpose of exterior envelope waterproofing is to deter dry rot because it causes substantial damage to the building and structural members. Dry rot is present at this location.

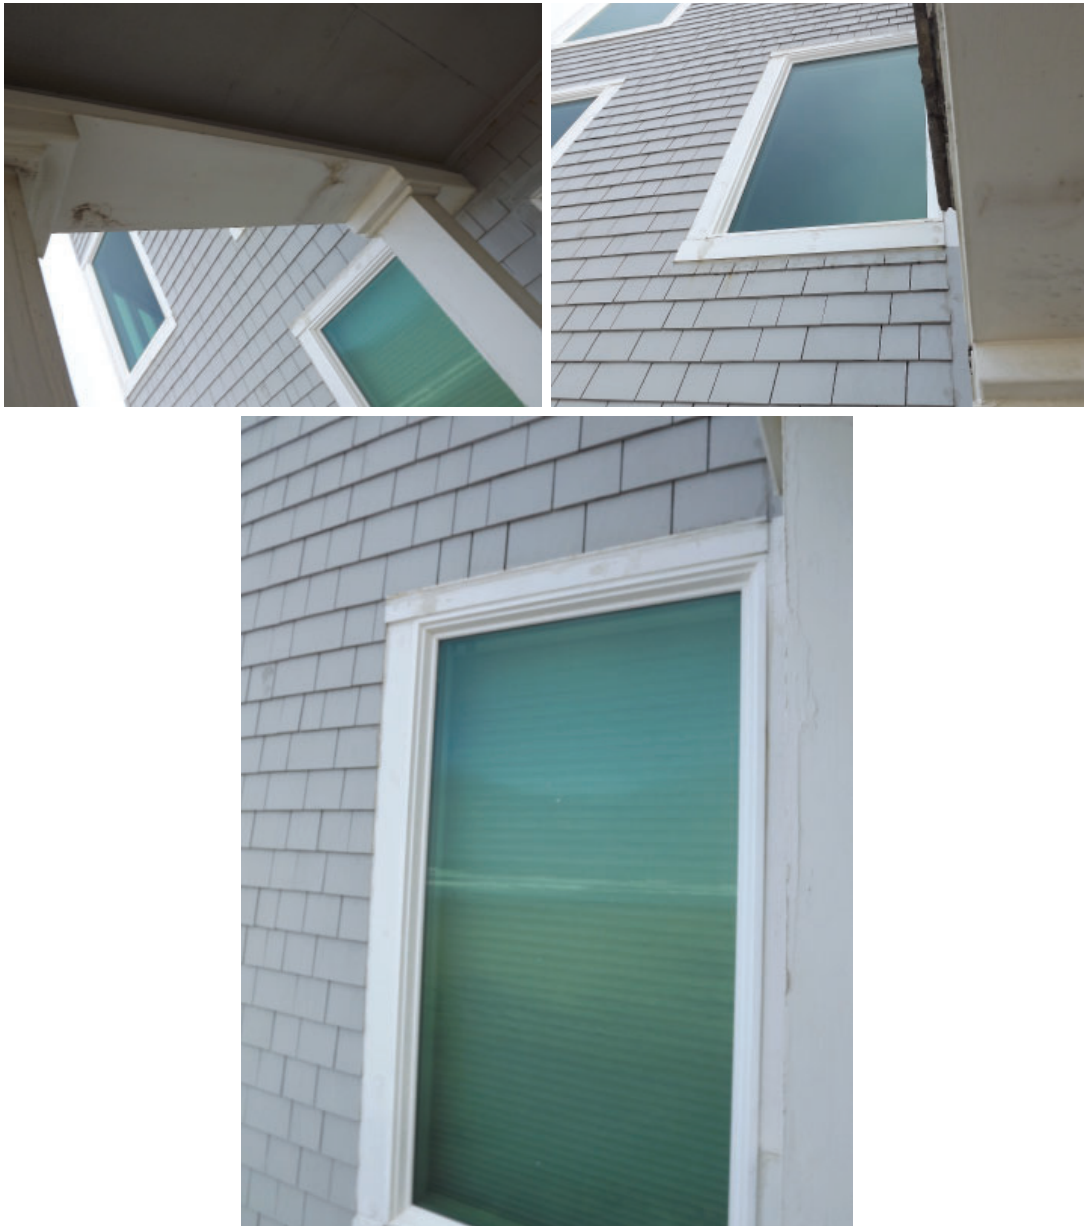
## Missing End Dam.

All horizontally protruding surfaces require flashings to prevent moisture accumulation and intrusion. To work effectively, the flashings must be installed correctly. Correct installation includes sealing the flashing sides (though not the length) to the component or bending the flashing to fit into the component. This type of installation, called an end dam, creates a channel to prevent moisture from entering below the flashing. End dams were missing at this location.

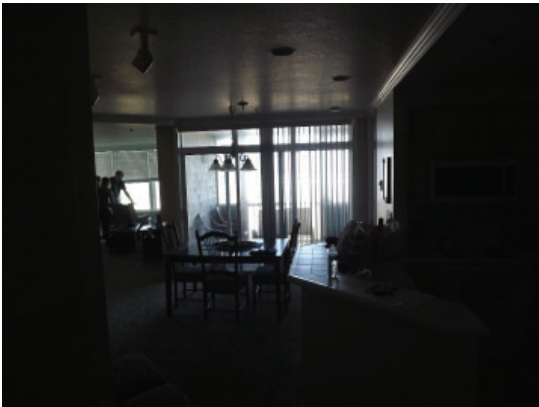
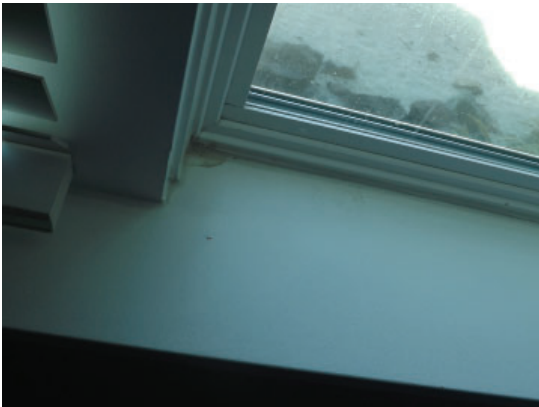
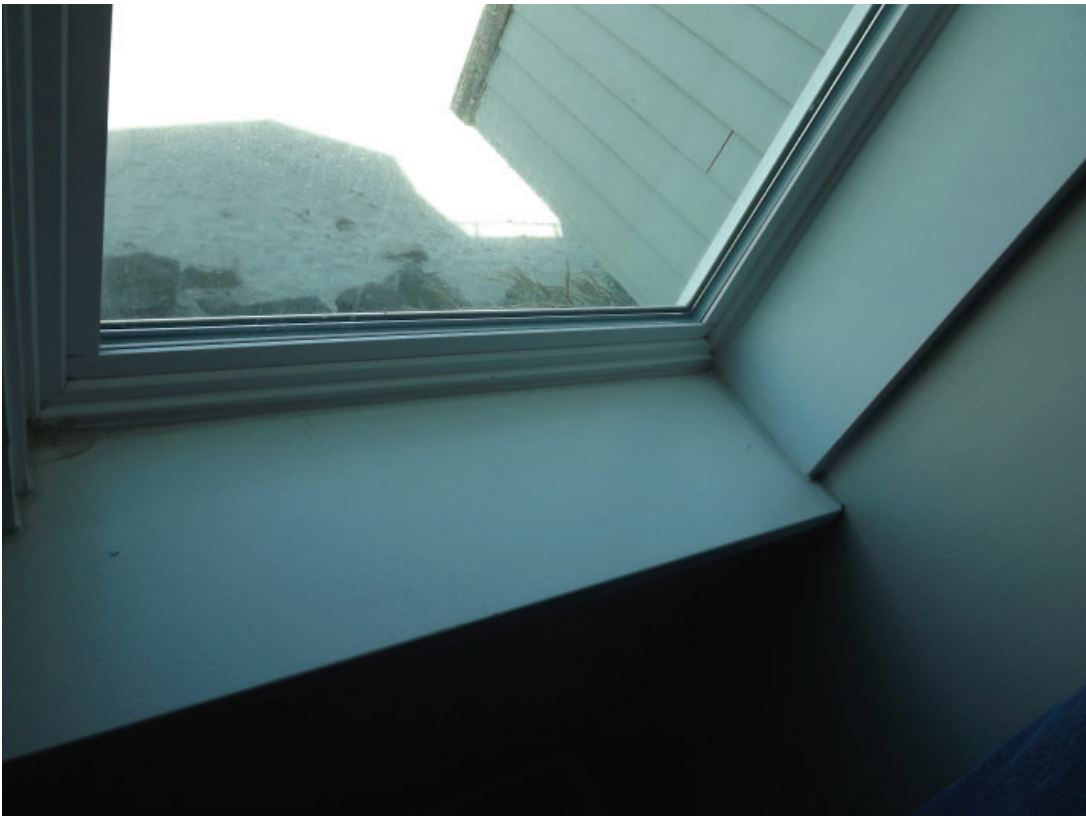
Visible Moisture Intrusion At Window Sill.

Windows may leak from many different reasons. Regardless of the reason, the windows shouldn't be leaking. At this location staining/leaking was visible to the eye.

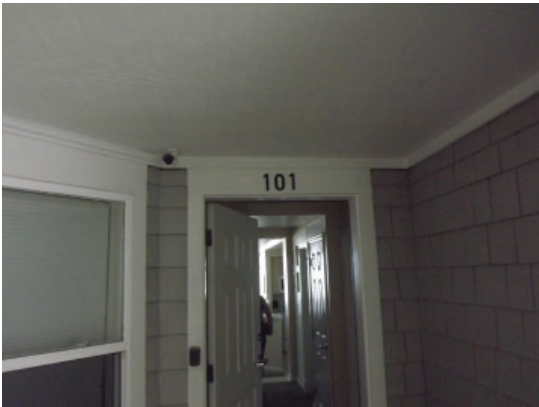
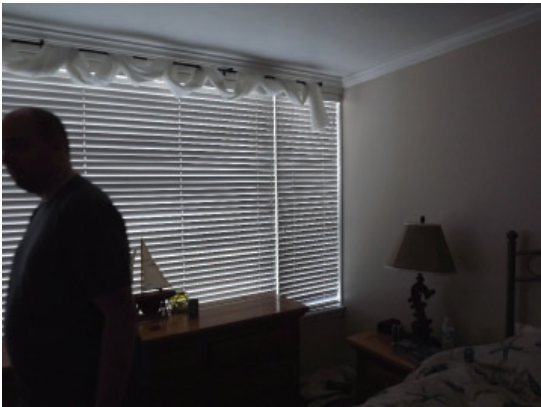
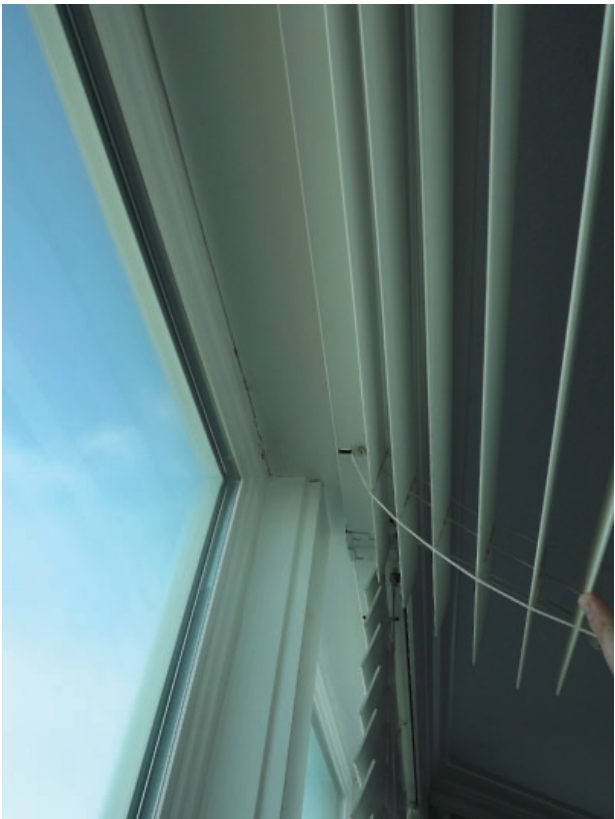
Moisture Damage.

Moisture damage was discovered at this location. Moisture damage is the precursor to dry rot.

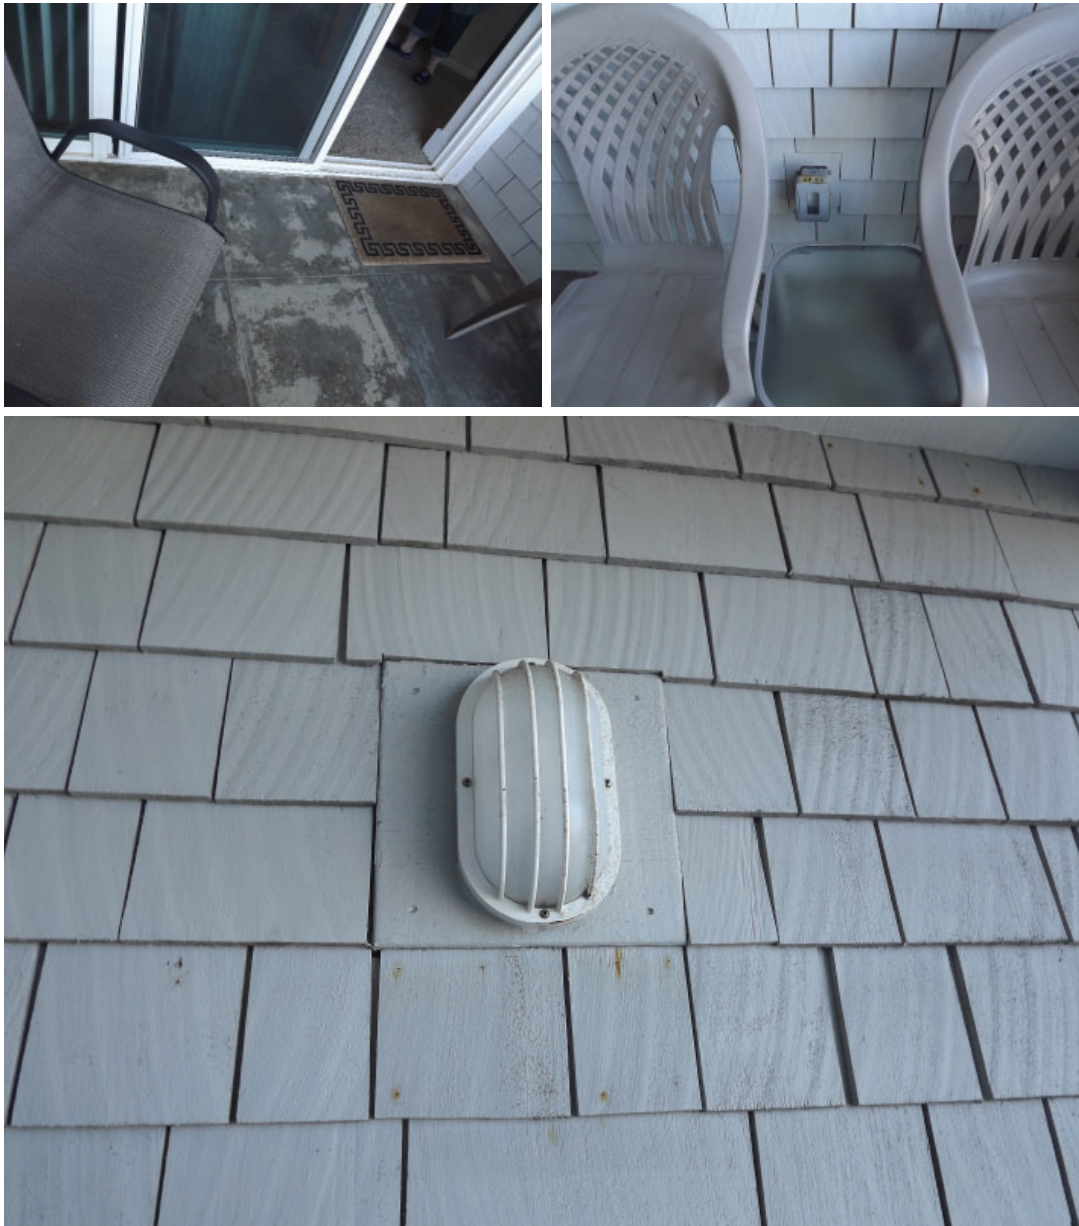
## Missing Flashing.

Flashing is a critical aspect of exterior waterproofing; it directs moisture into appropriate drainage planes. However, flashing was missing from this location.

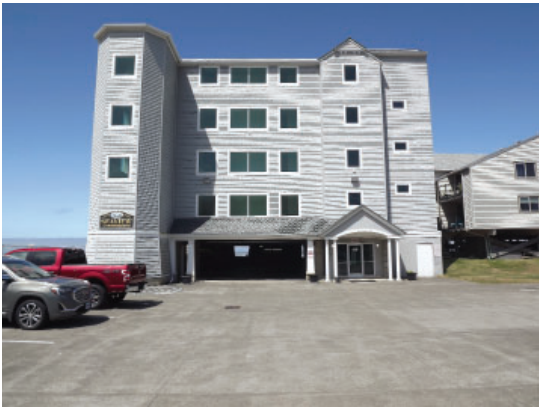
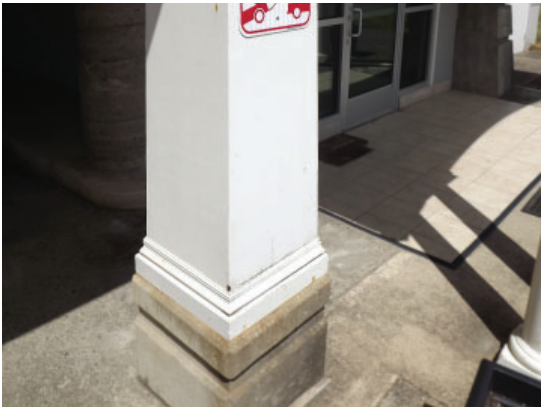
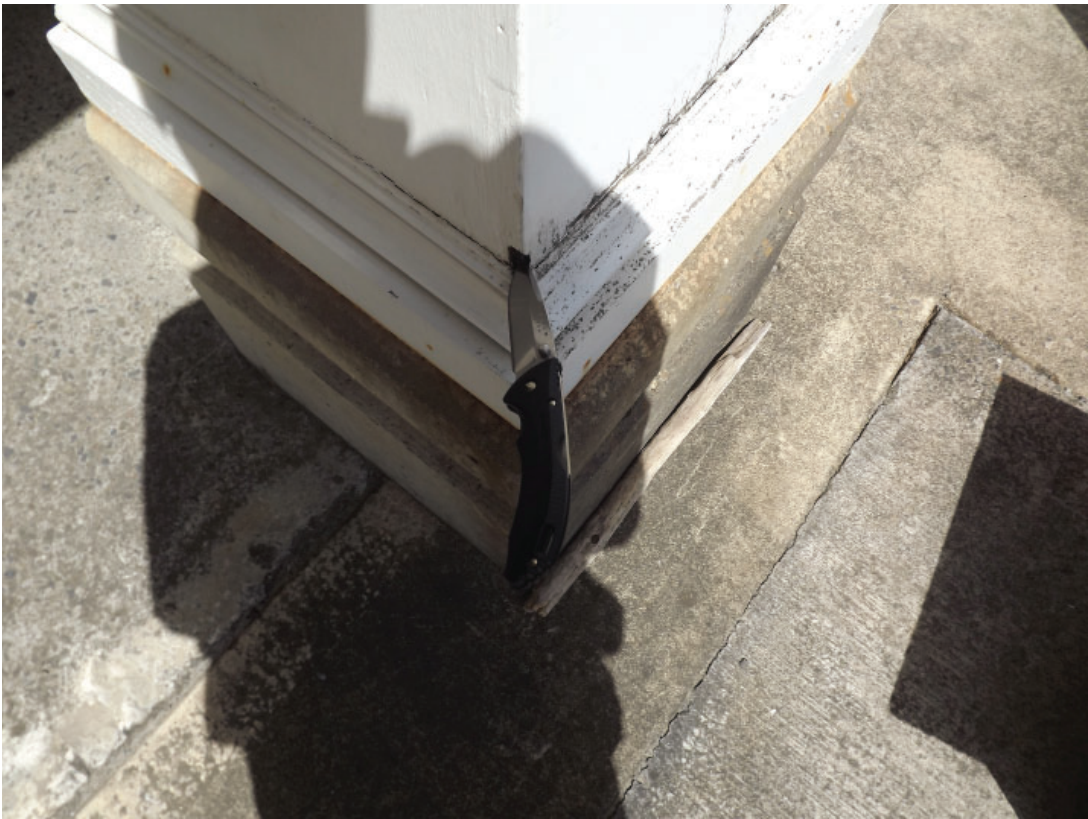
East Elevation Is Showing Dry Rot.

Dry rot is the decay of wood products. One main purpose of exterior envelope waterproofing is to deter dry rot because it causes substantial damage to the building and structural members. Dry rot is present at the East Elevation.

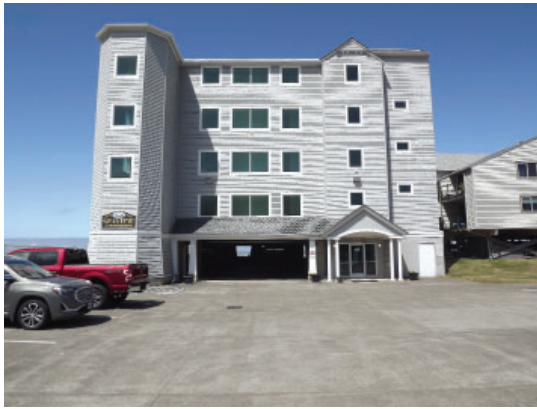
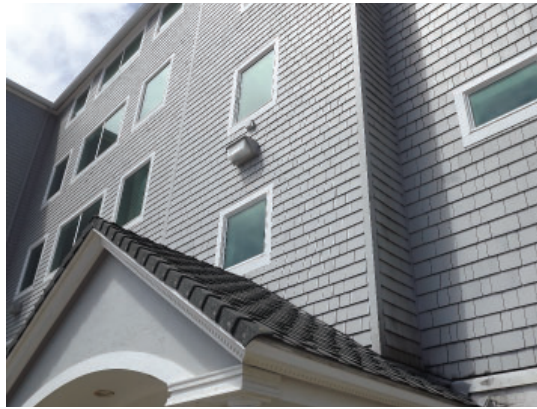
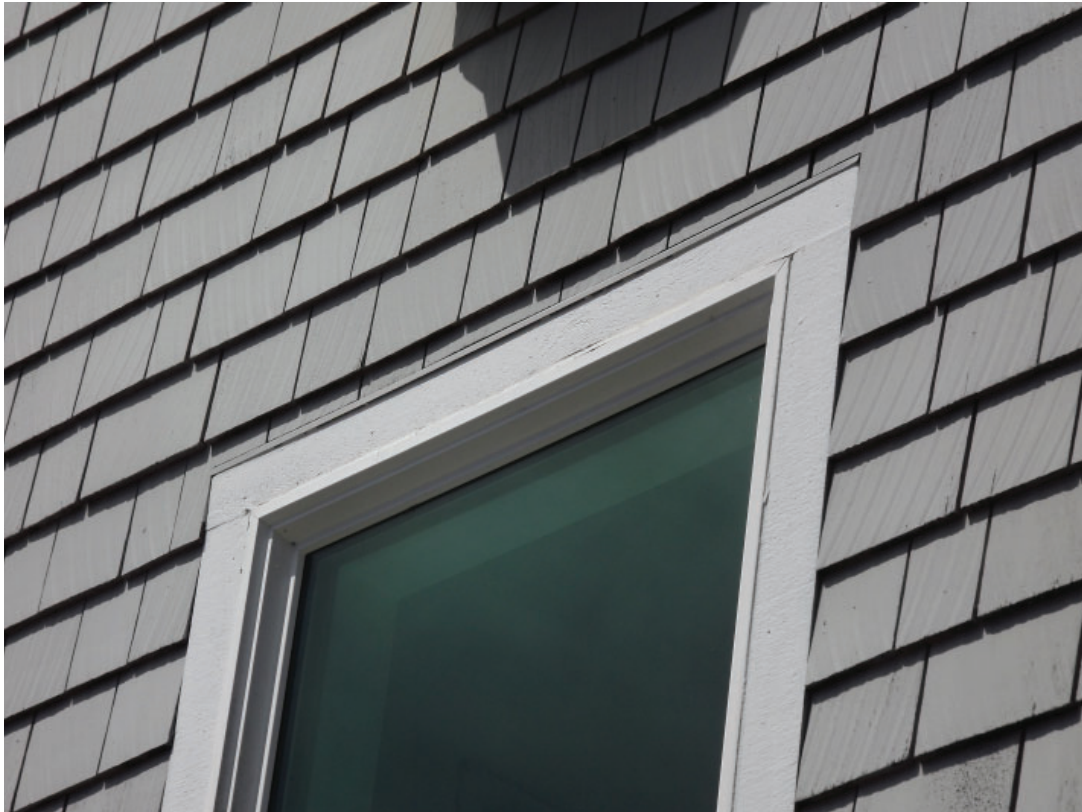
## Missing End Dam.

All horizontally protruding surfaces require flashings to prevent moisture accumulation and intrusion. To work effectively, the flashings must be installed correctly. Correct installation includes sealing the flashing sides (though not the length) to the component or bending the flashing to fit into the component. This type of installation, called an end dam, creates a channel to prevent moisture from entering below the flashing. End dams were missing at this location.

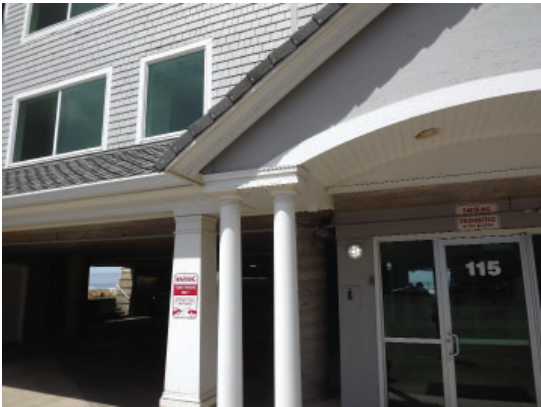
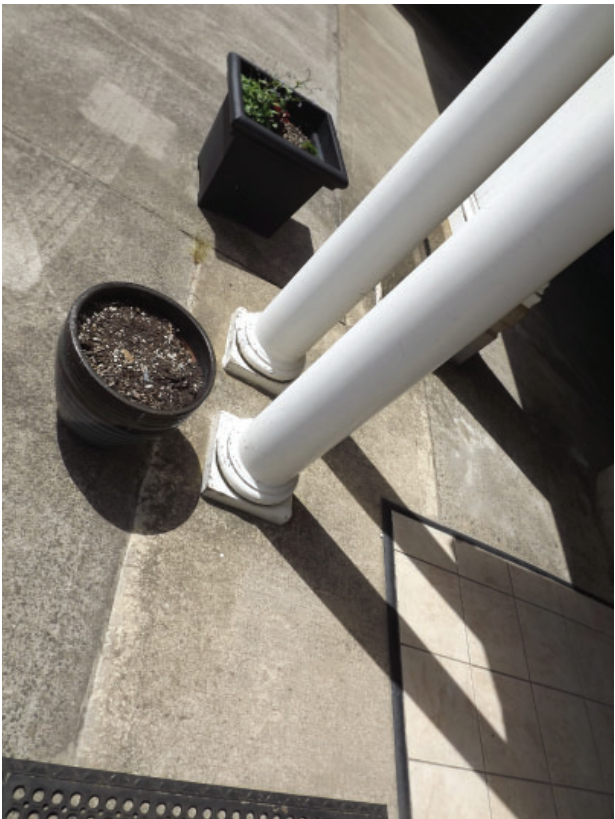
Missing Pedestal Base Application.

The pedestal base is part of the walking surface system. The system requires the application of the base and pedestal buffer pad to properly function. This was not found.
