# PRELIMINARY BUILDING ENVELOPE EVALUATION OF SEAVIEW CONDOMINIUMS

LOCATED AT:  
115 N. MILLER STREET  
ROCKAWAY BEACH, OR 97136

August 2nd, 2022

Client # B22265 Seaview Condominiums

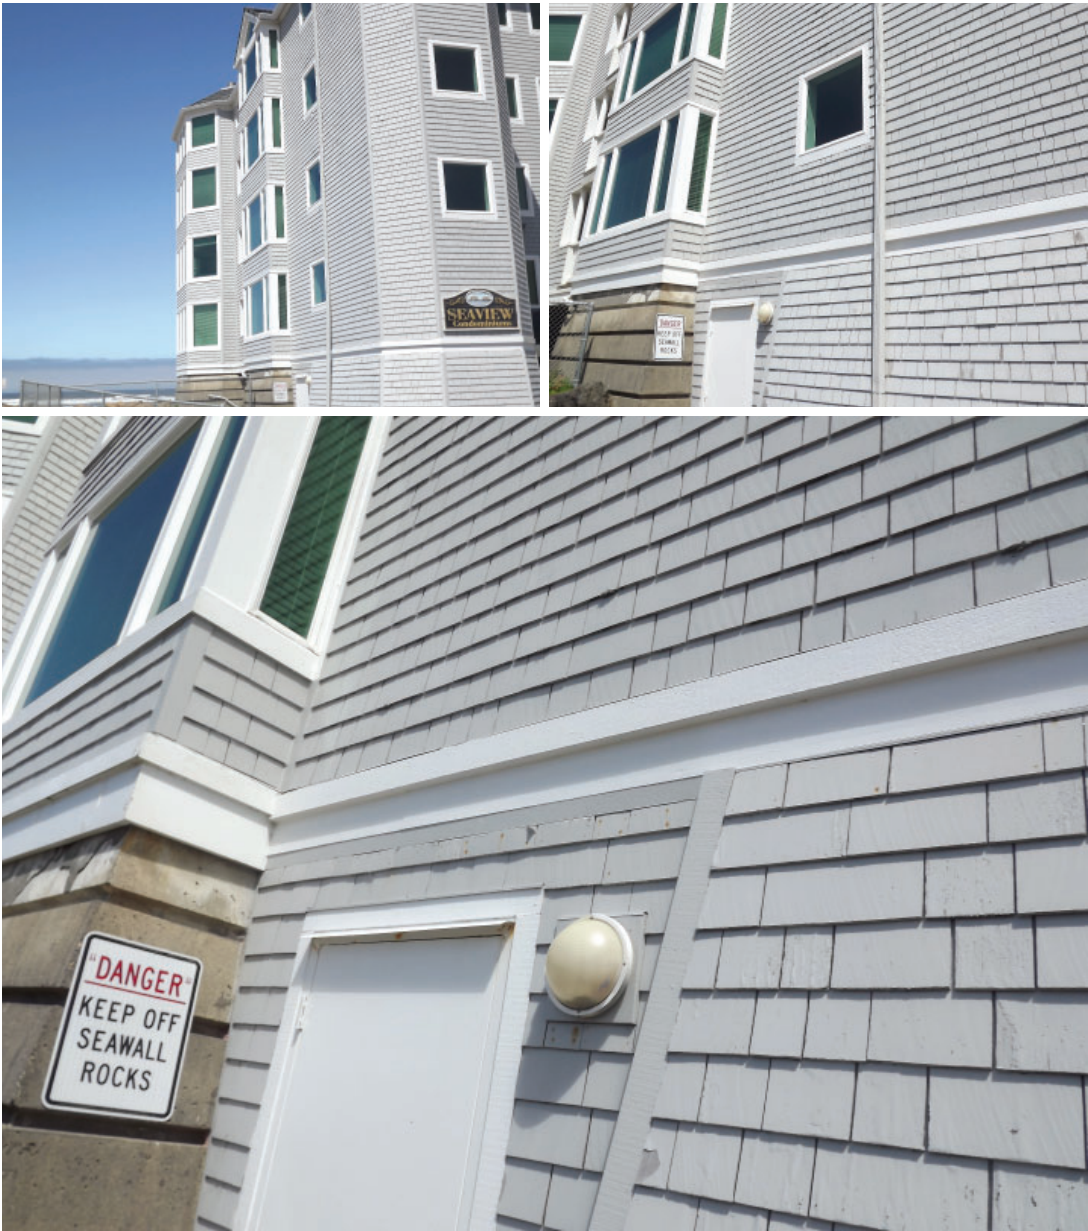
Incorrect Fasteners Used On Shake At South Elevation.

Product is required to be applied in a specific manner and with specific types of fasteners. The fasteners that were used on this project are less then adequate. The minimum is 7/16" minimum horizontal.

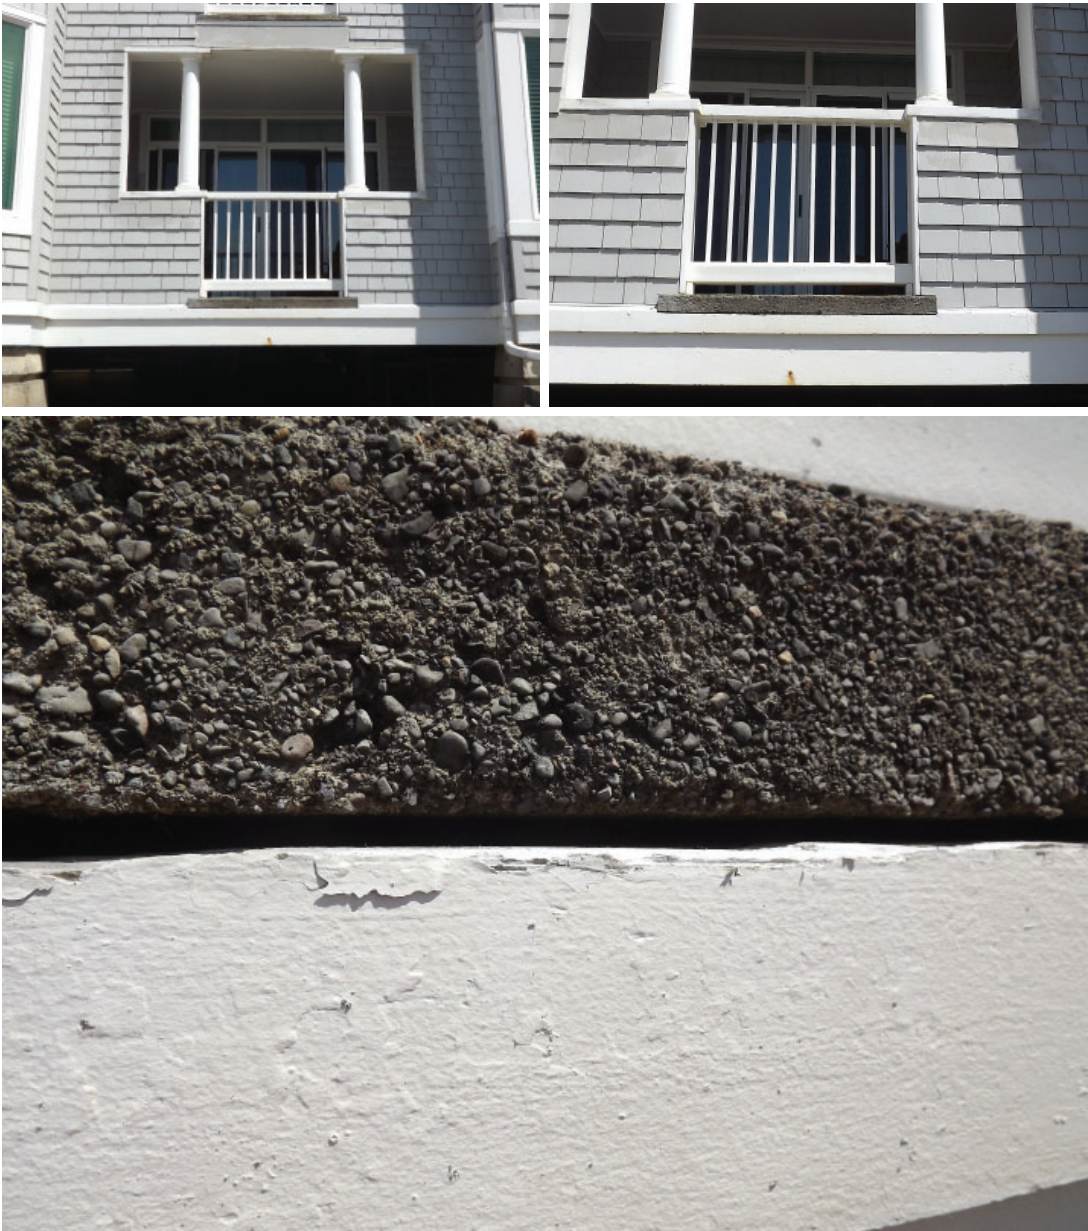
No Drainage Matt Is Visible.

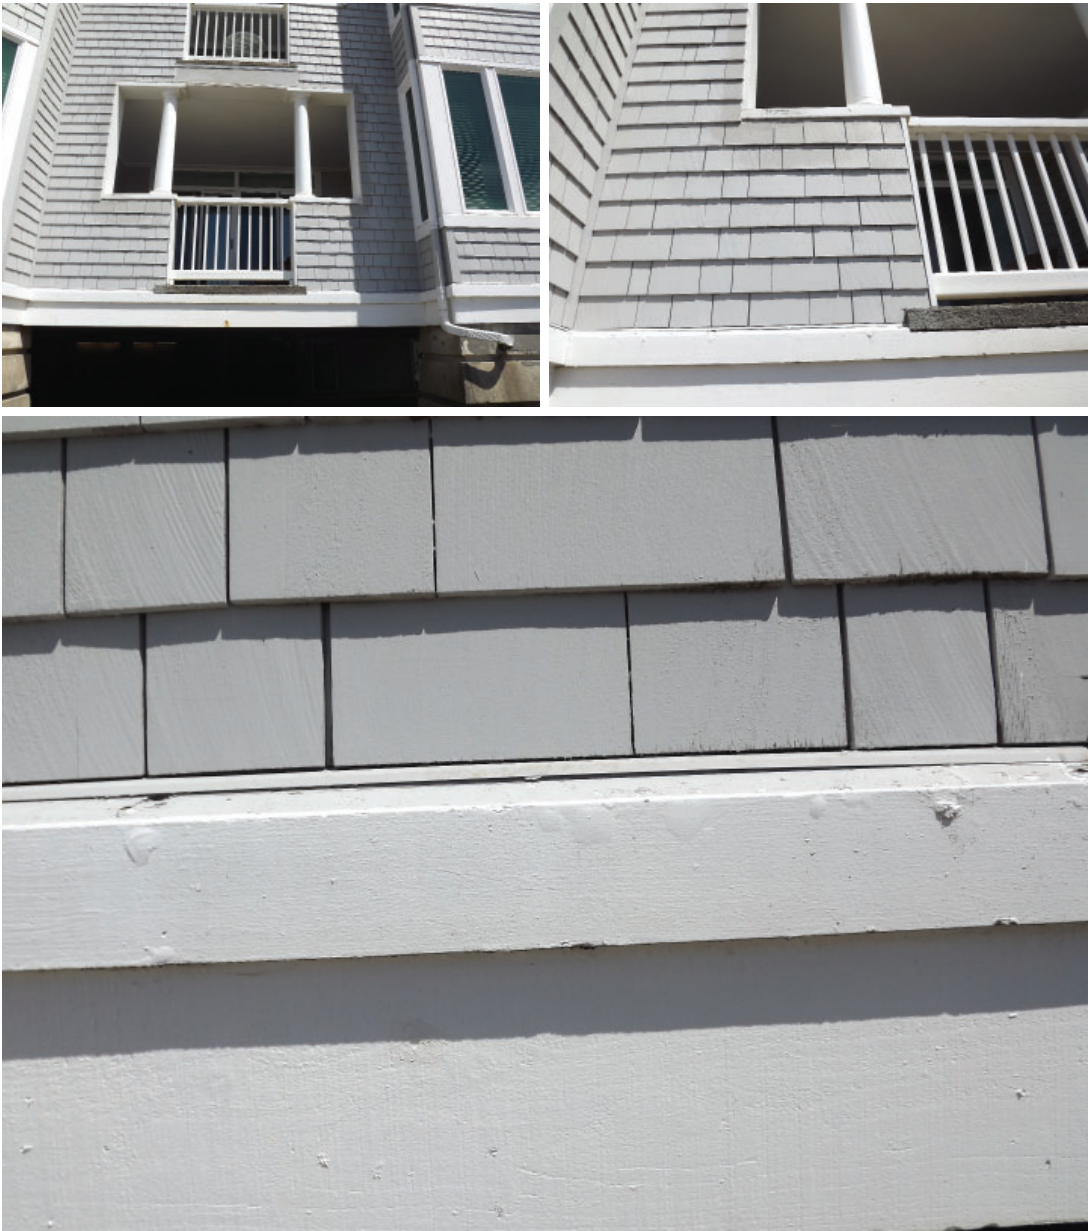
Flashing Should Cover Trim - Incorrect Flashing Type.

The minimum requirement for flashings is exterior grade and that is not has been applied here.

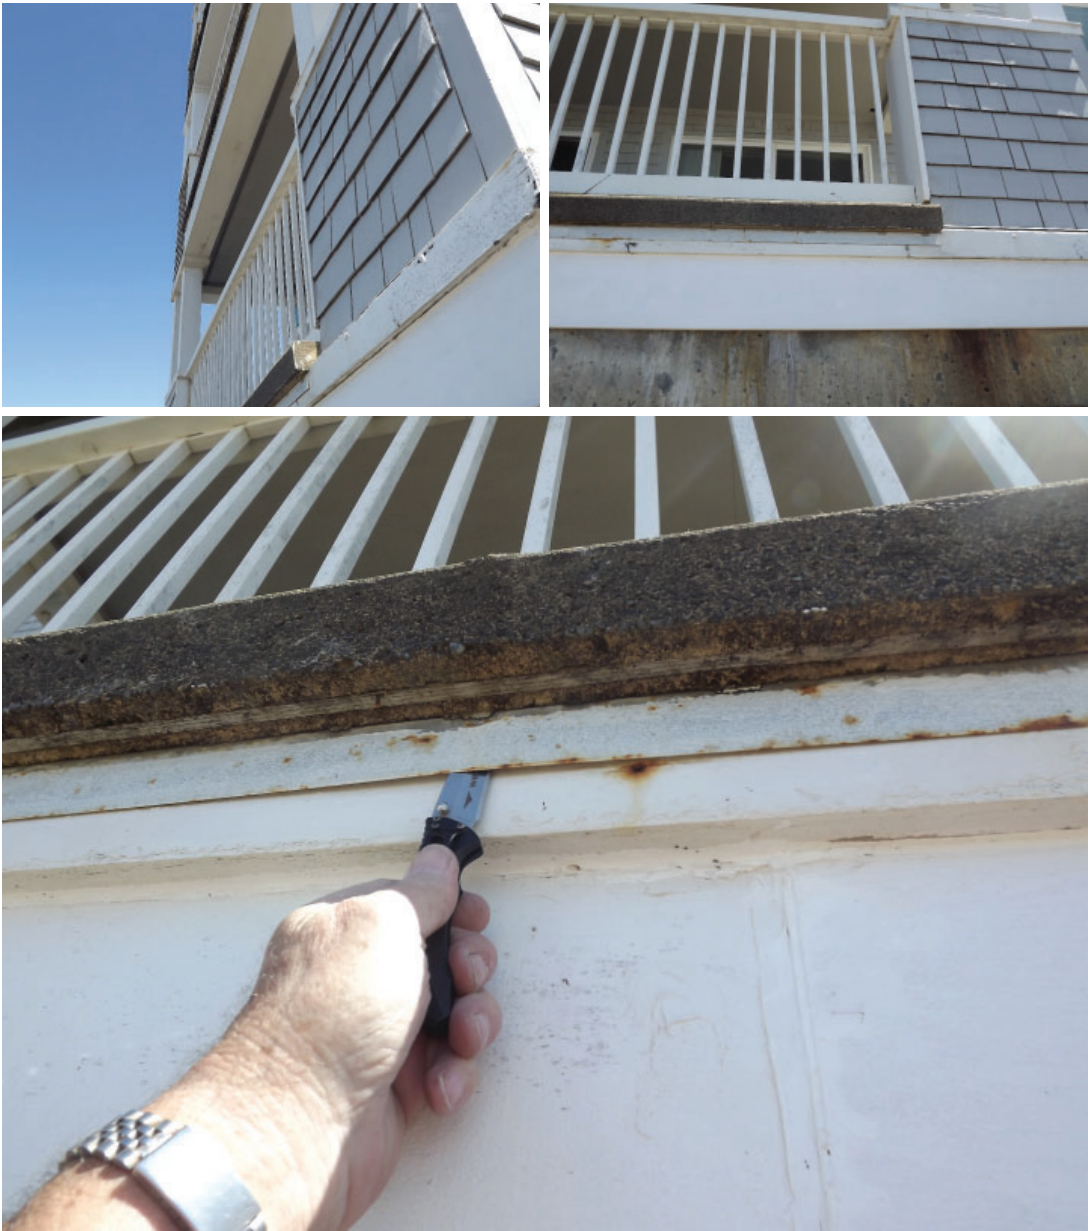
No Drainage Matt Is Visible.

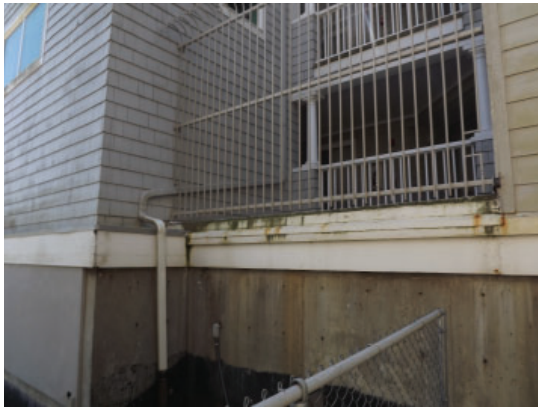
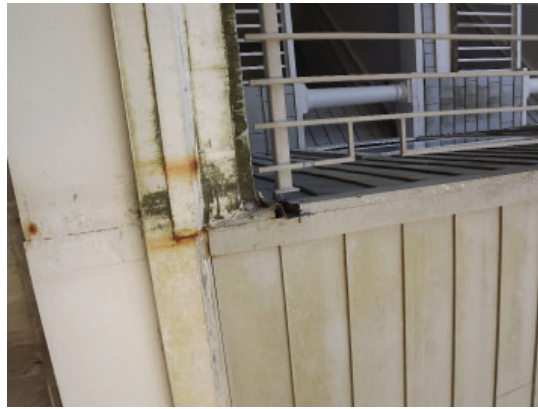
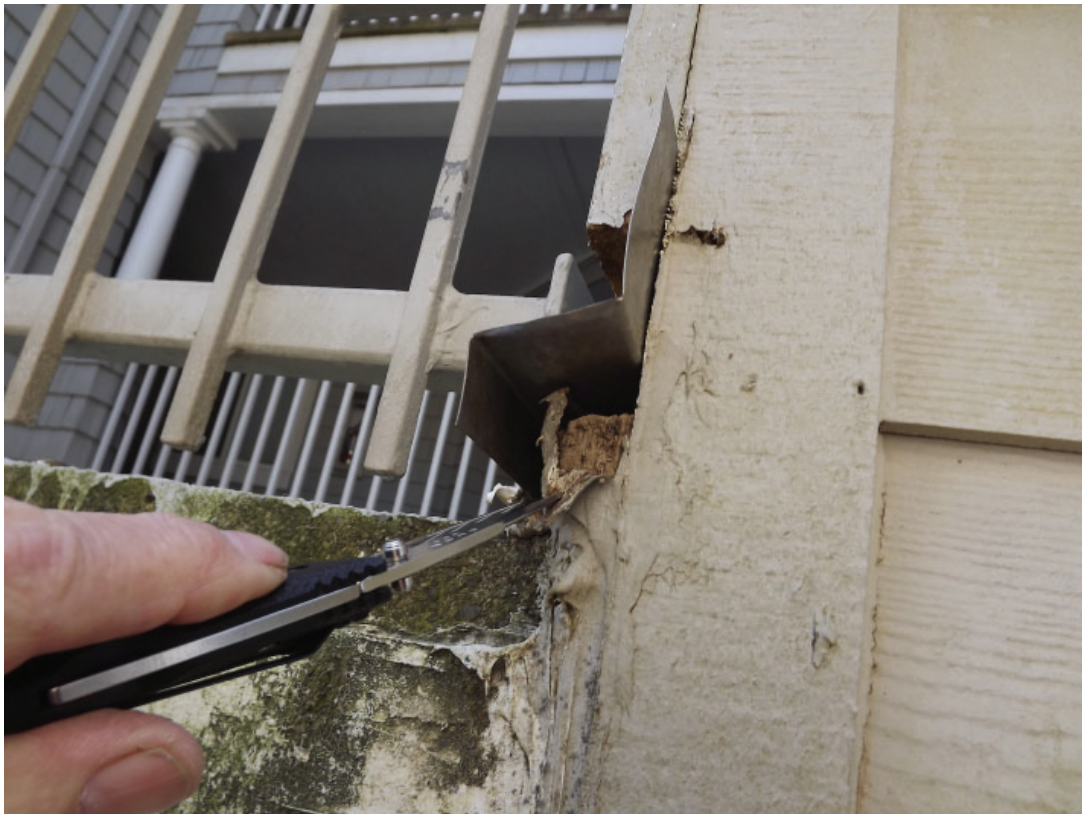
## Incorrect Flashing At Concrete - No Kerf Cut To Set Flashing.

This flashing should be stainless steel for Coastal environments, kerf cut into the concrete and sealed with the appropriate sealant.

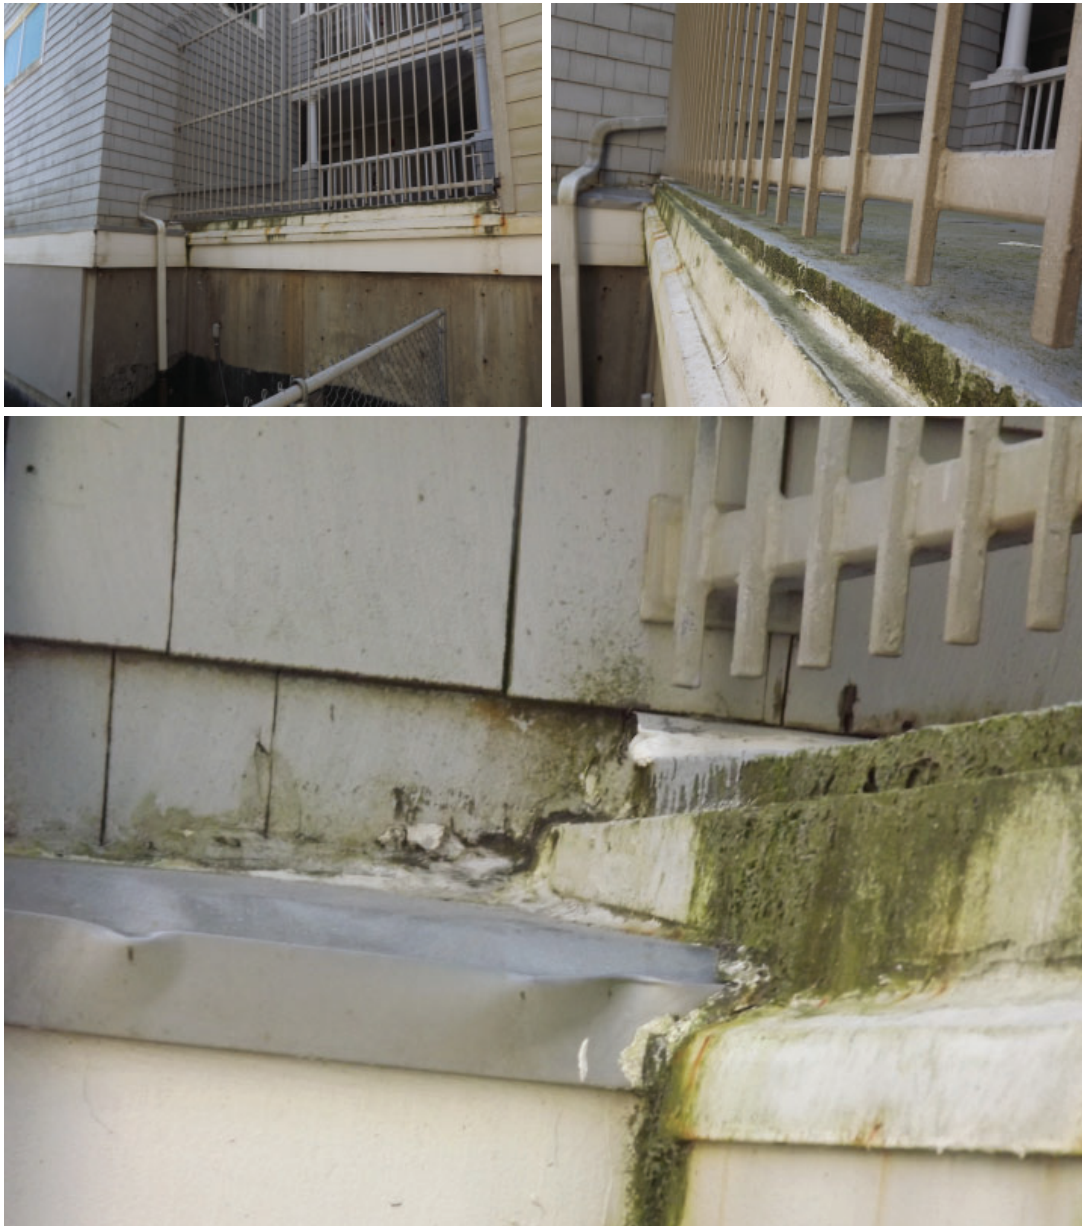
## Sealed Flashing.

Flashings allow incidental moisture travelling behind the siding to drain into an appropriate drainage path. When flashings are sealed to products, moisture cannot drain and instead becomes trapped, which will cause damage to the products and adjacent components. This has happened here.

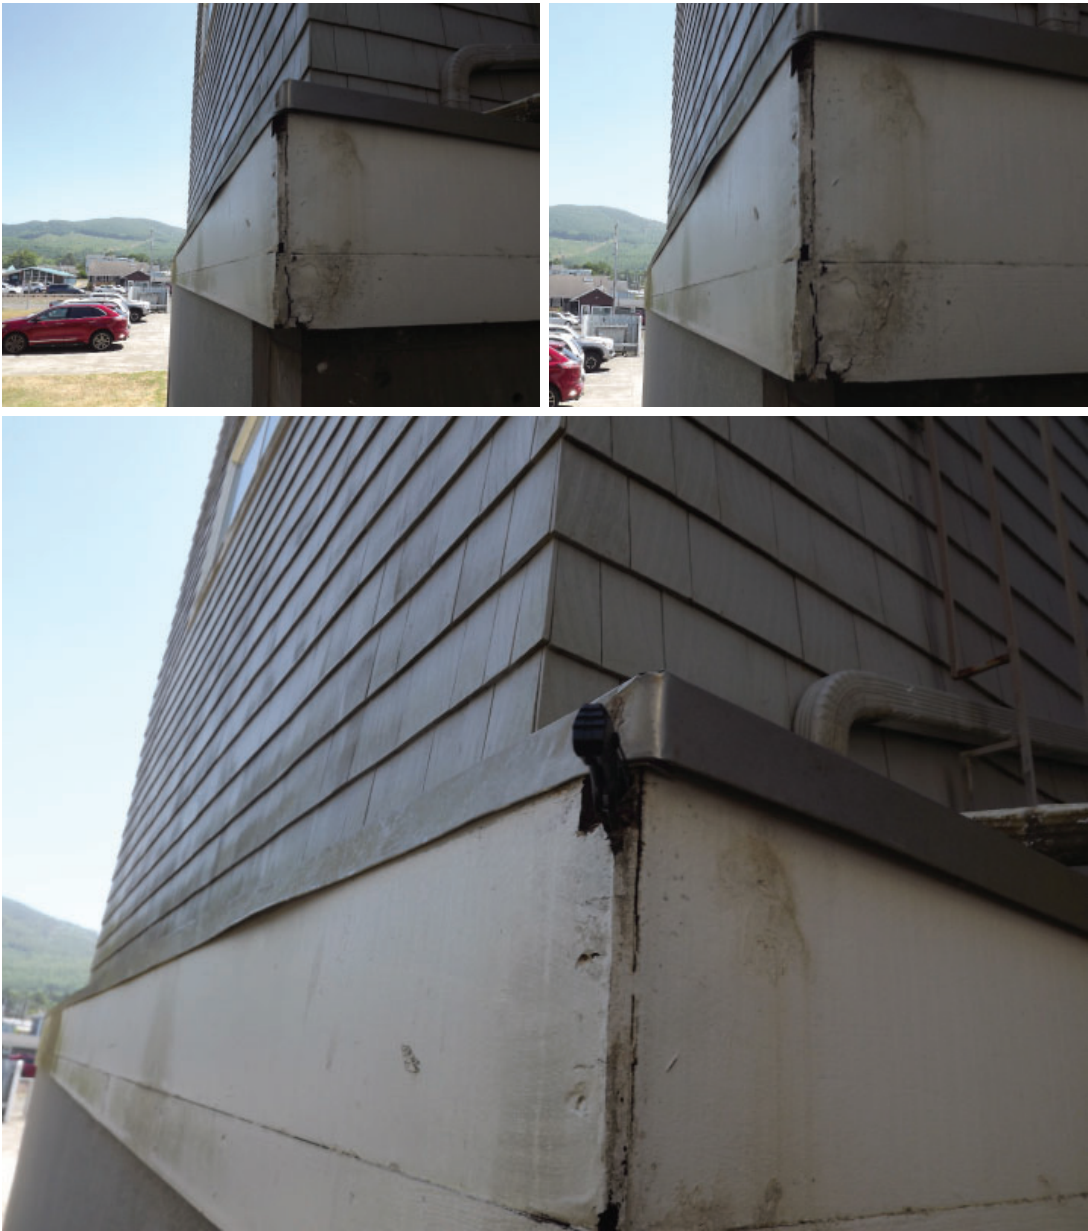
Dry Rot.

Dry rot is the decay of wood products. One main purpose of exterior envelope waterproofing is to deter dry rot because it causes substantial damage to the building and structural members. Dry rot is present at this location.

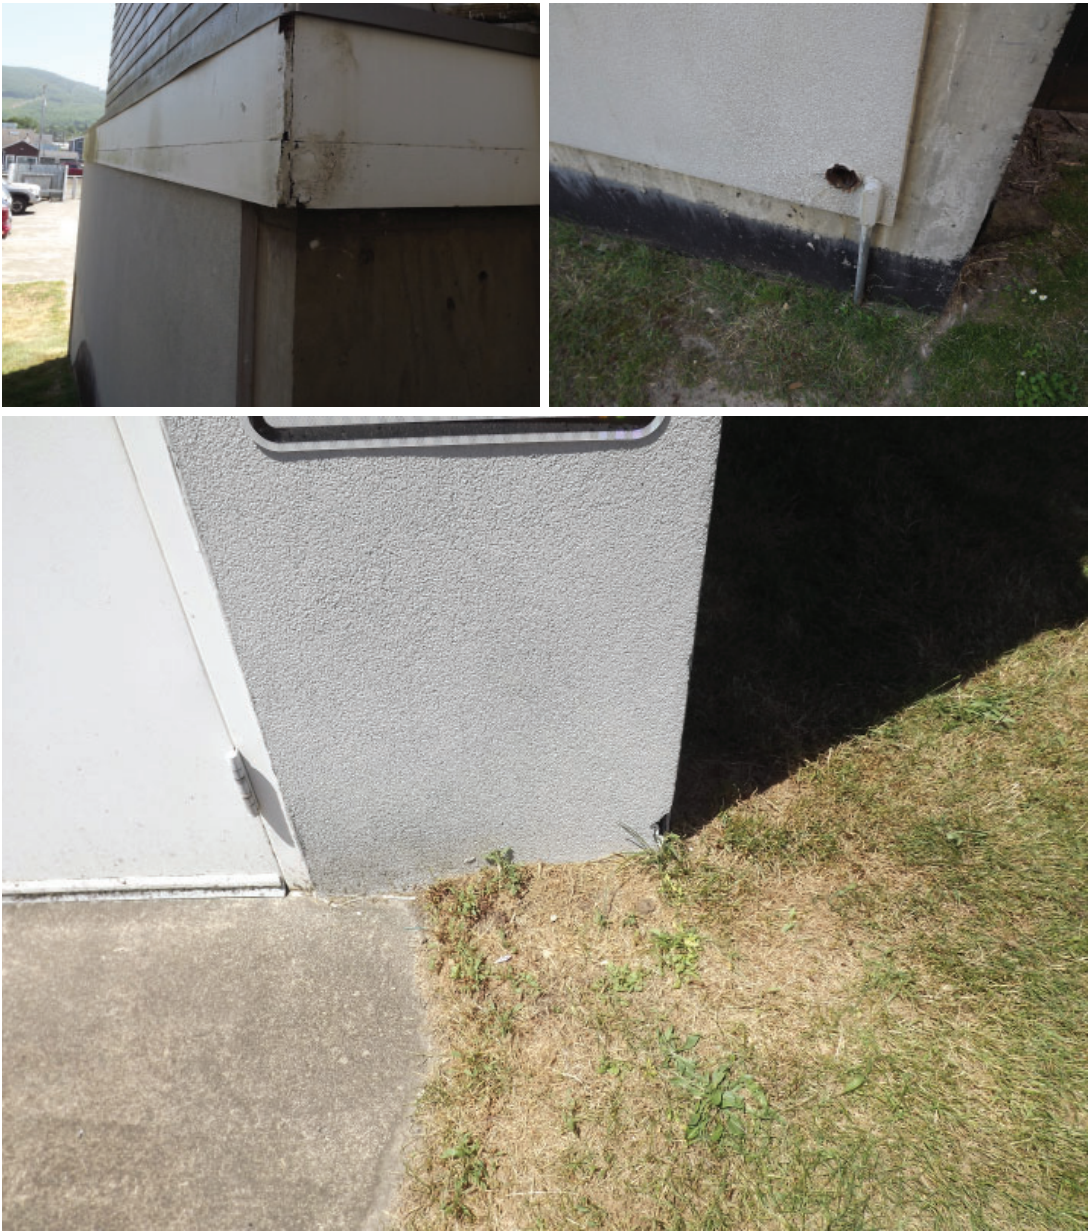
Damage To Synthetic Plaster At North Elevation.

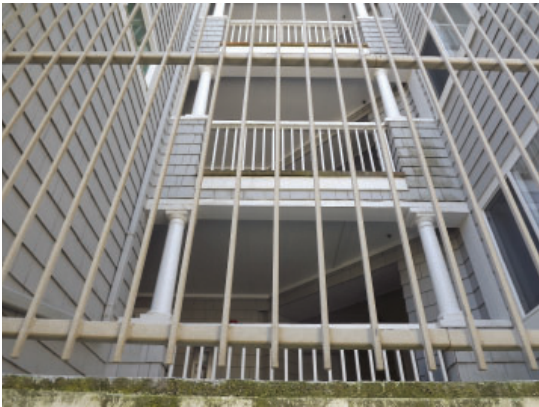
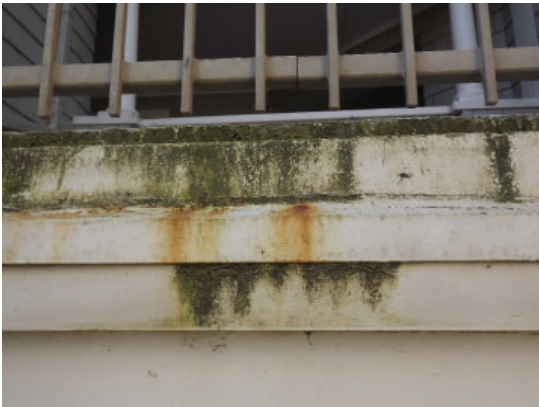
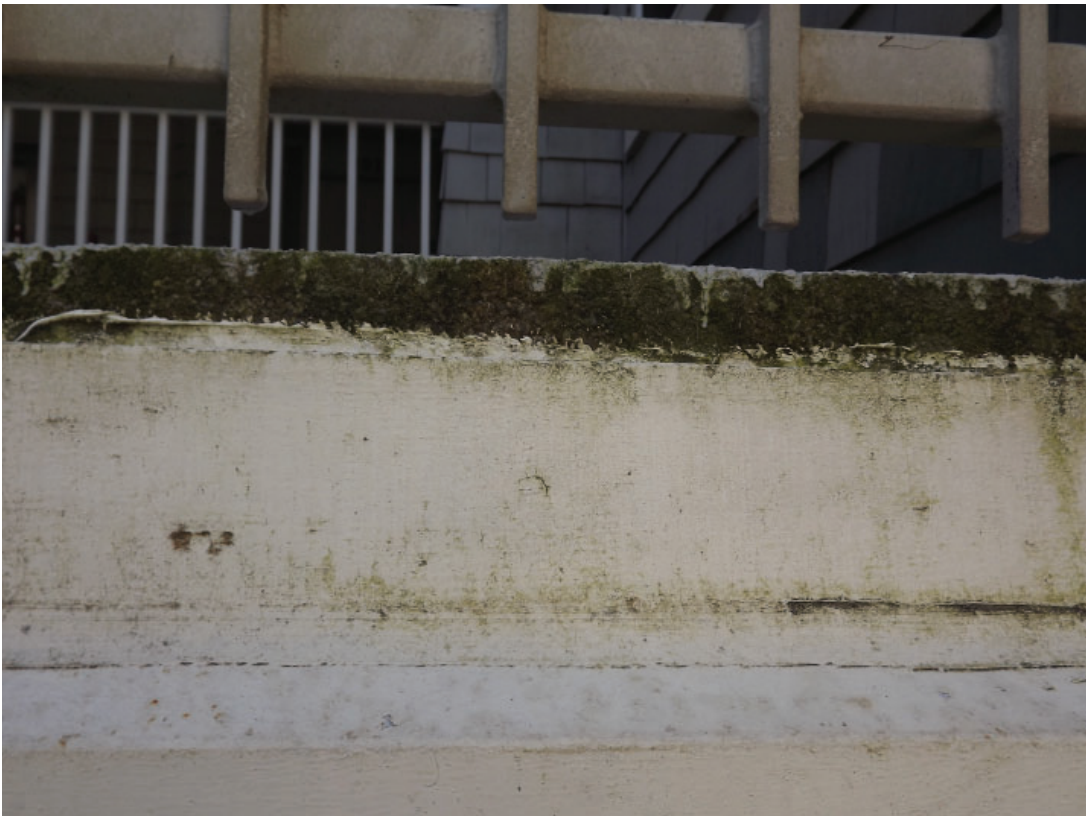
No Drainage Matt Is Visible.

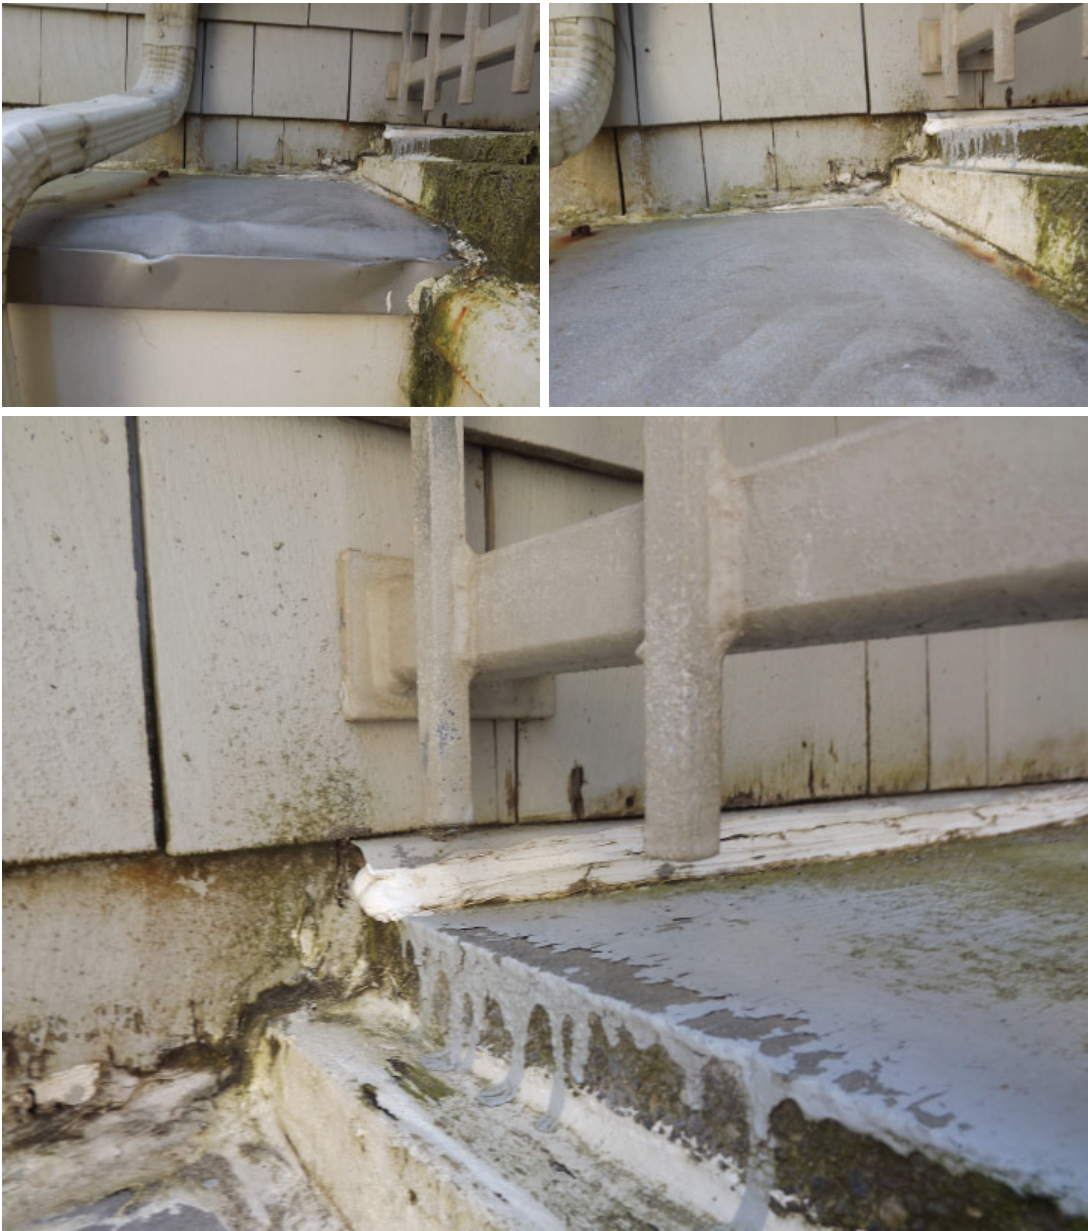
Incorrect Flashing Type.

The minimum requirement for flashings is exterior grade and that is not has been applied here.

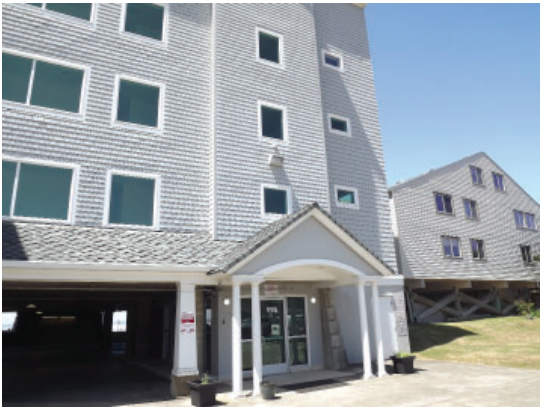
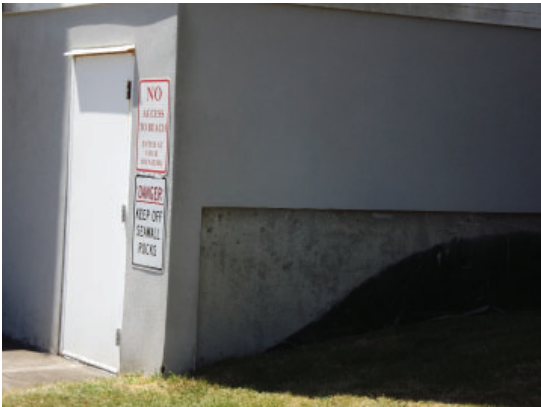
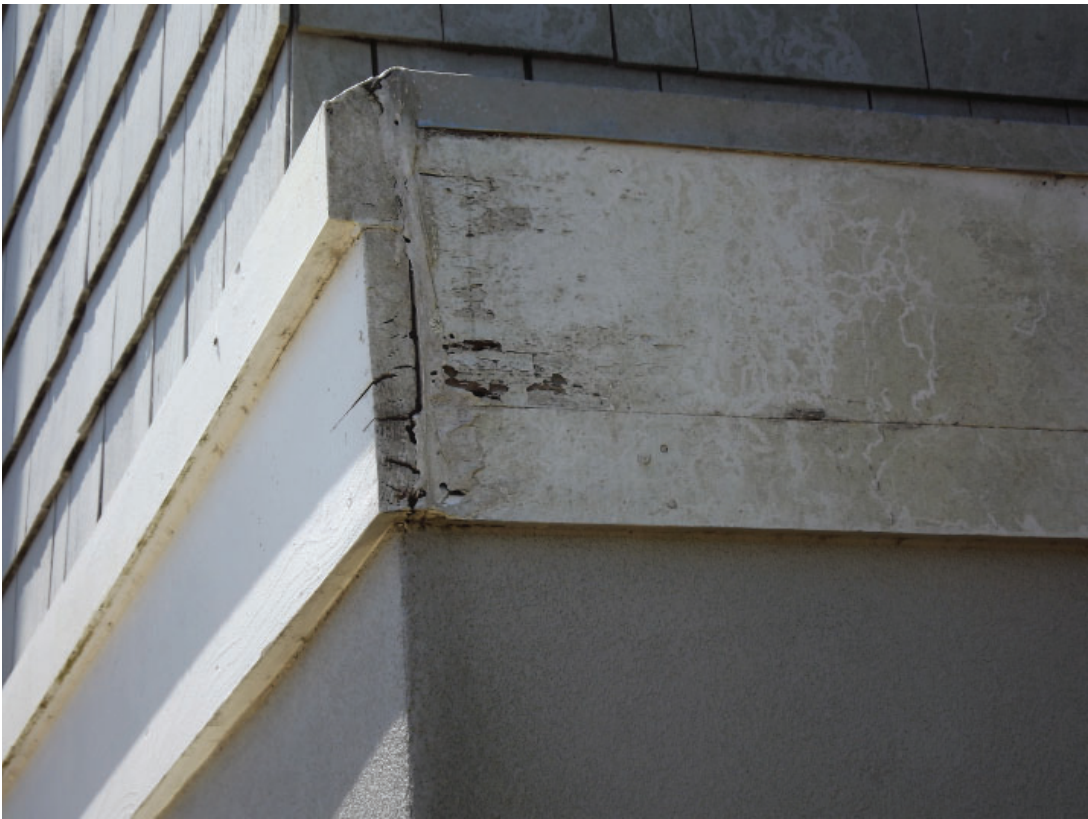
Dry Rot Caused By Improper Flashing.

Dry rot is the decay of wood products. One main purpose of exterior envelope waterproofing is to deter dry rot because it causes substantial damage to the building and structural members. Dry rot is present at this location.

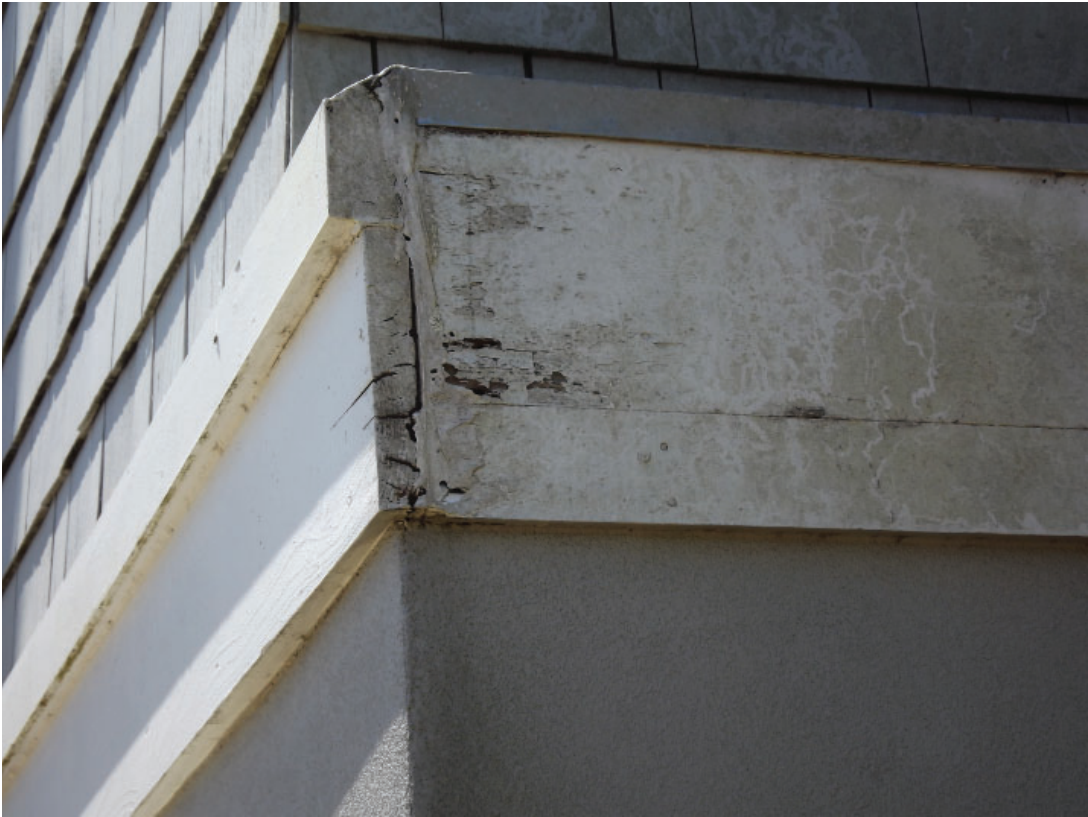
Moisture Intrusion.

Moisture intrusion was discovered at this location, indicating that this area is subject to excess moisture loads.

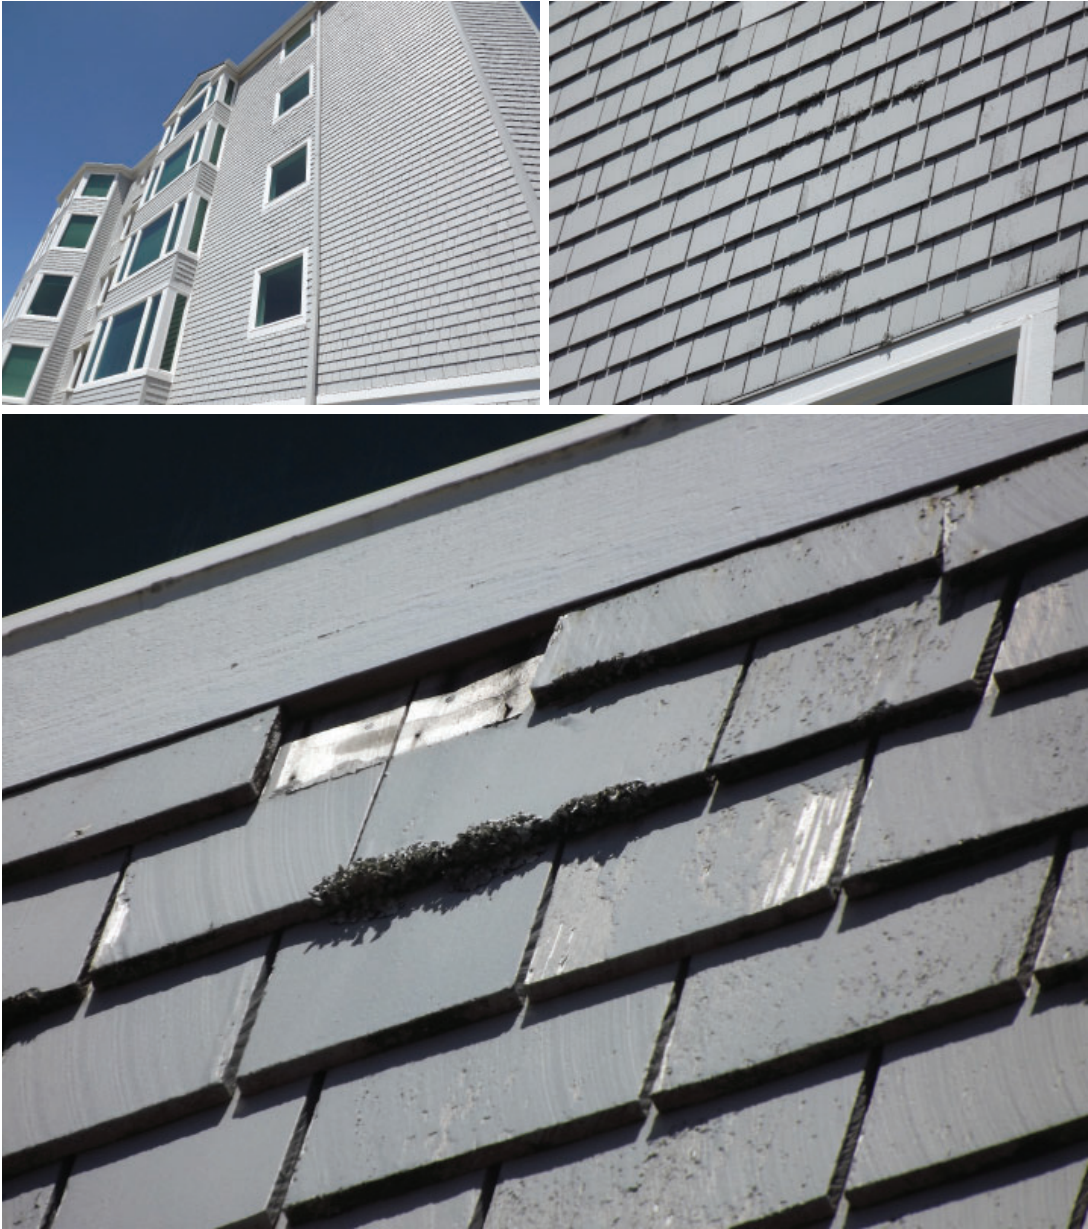
Organic Growth & Missing Shingle.

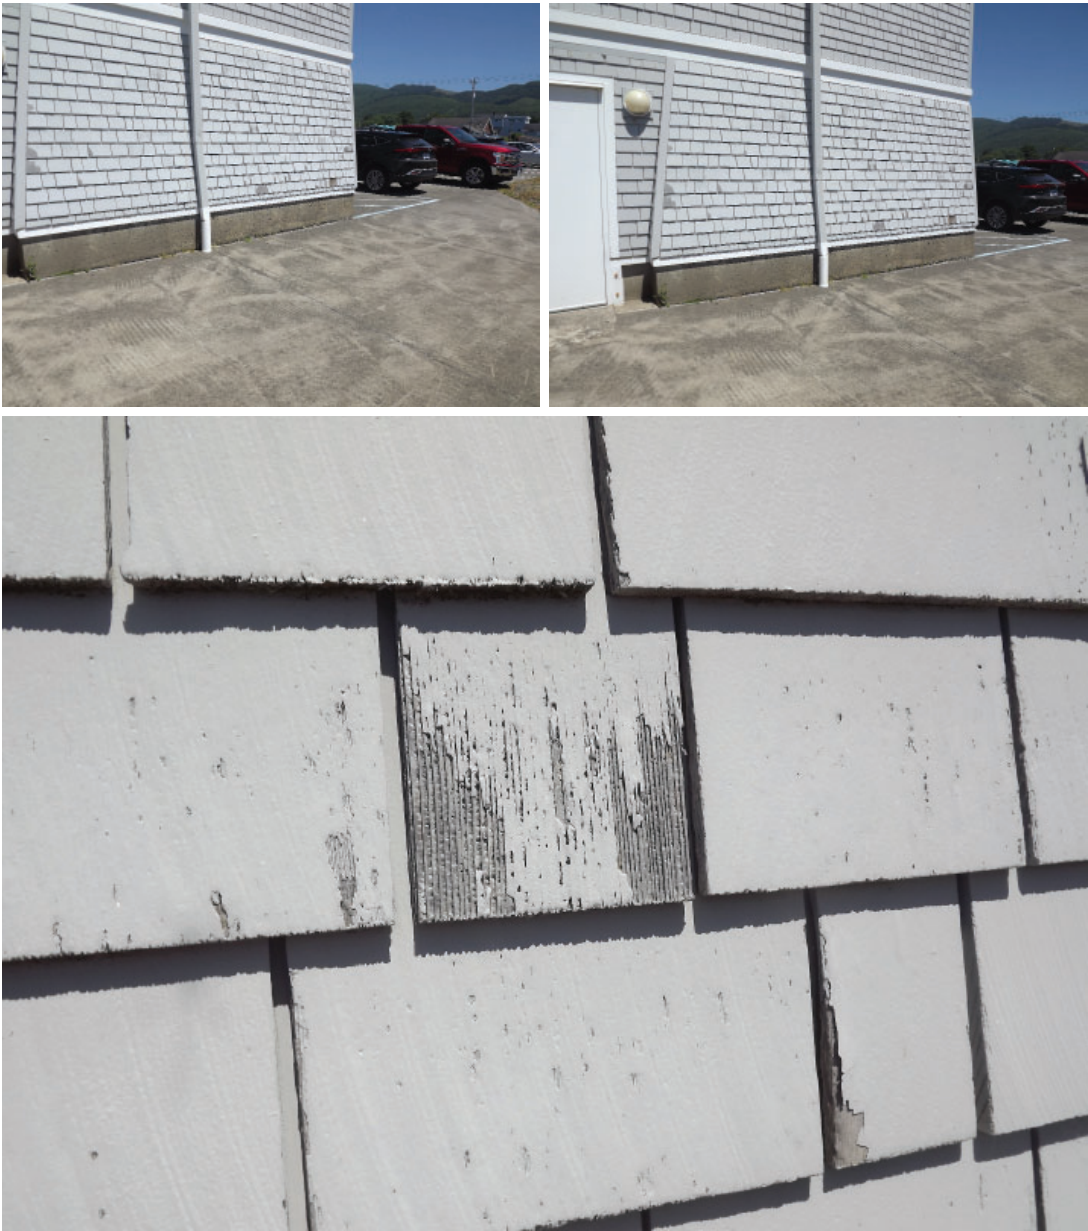
Shingles Are Dried & Paint Is Flaking, Indicates Time To Repaint.

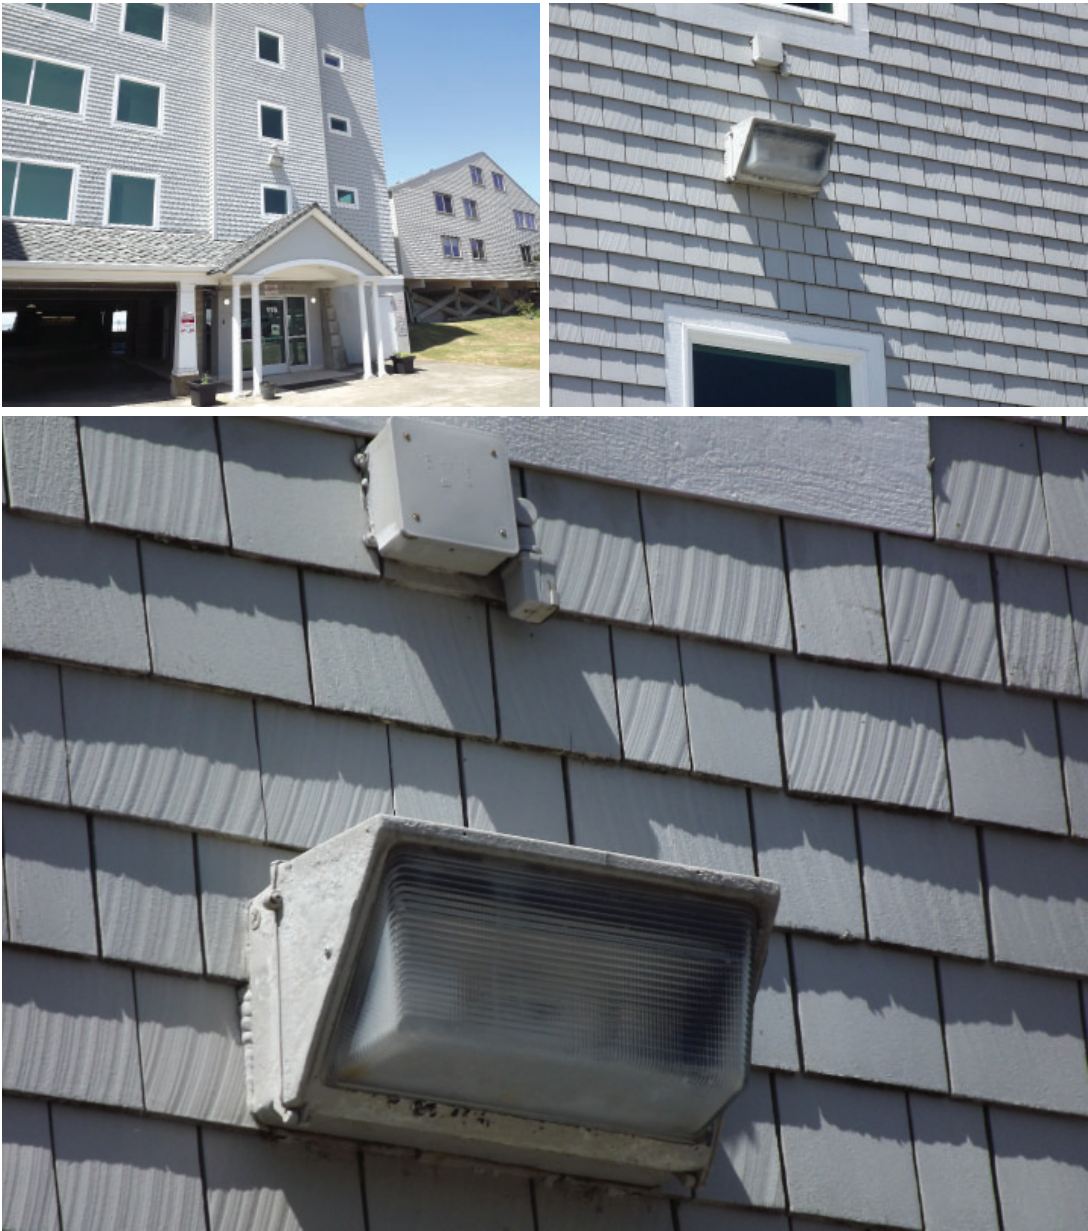
Mounting Blocks Are Missing At Fixtures.
